Attachment 2 Condition Assessment of Existing Grids

Summary of current grid conditions

Grid Conditions Reference Photos

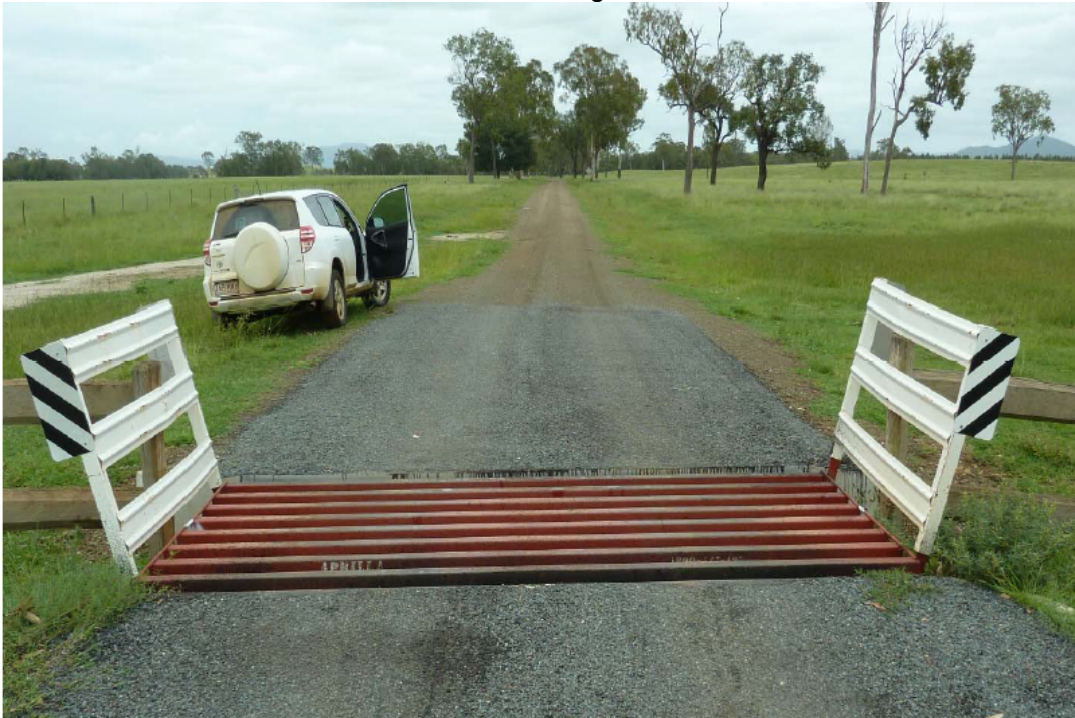
Compliant – This is an Aprilia grid manufactured from box section steel with concrete abutments, bitumen seal 10m either side of the grid.

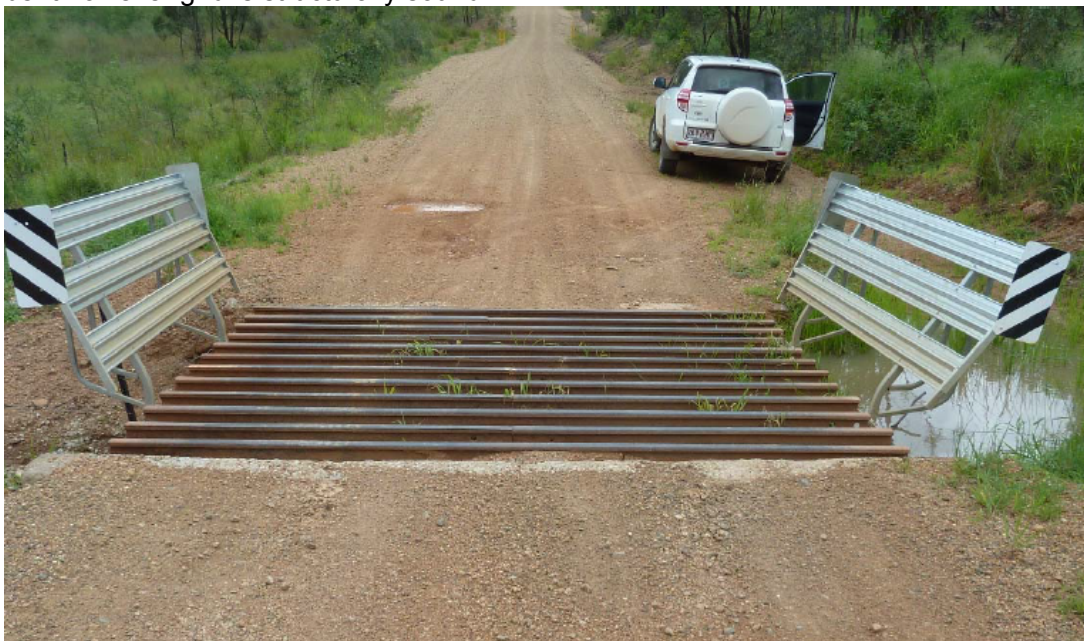
Acceptable Condition – This is a railway line grid with concrete abutments. RH wing is slightly bent however grid is structurally sound.

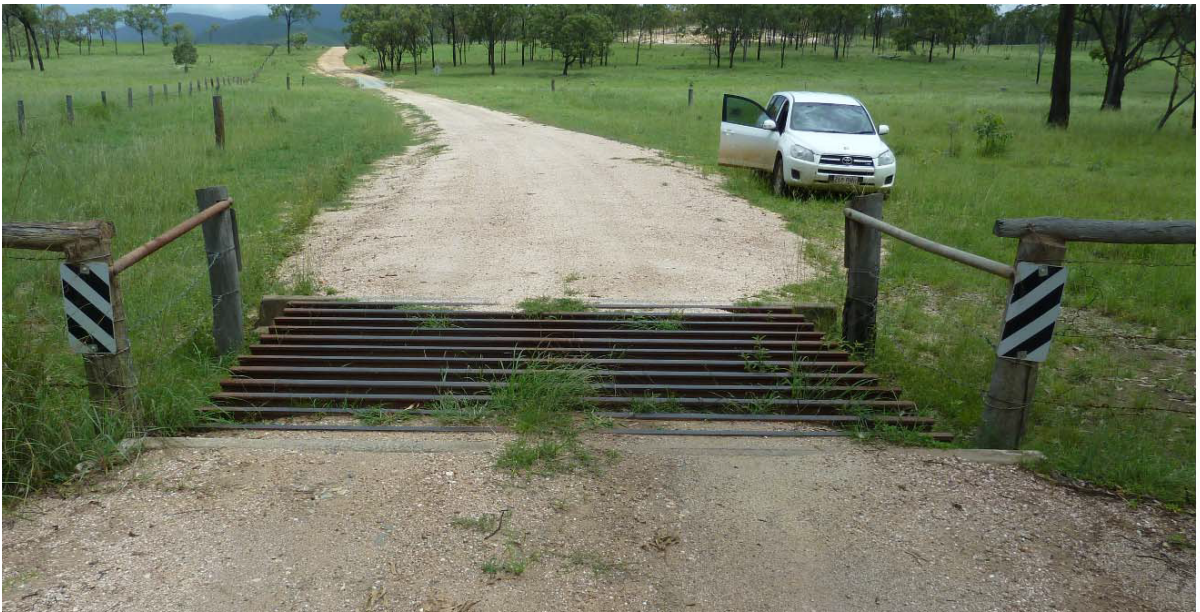
Fair Condition – This grid is considered fair but requires new side rails fitted, the concrete abutments look to be sound. Aprilia style siderails can be purchased and fitted as per the Compliant grid

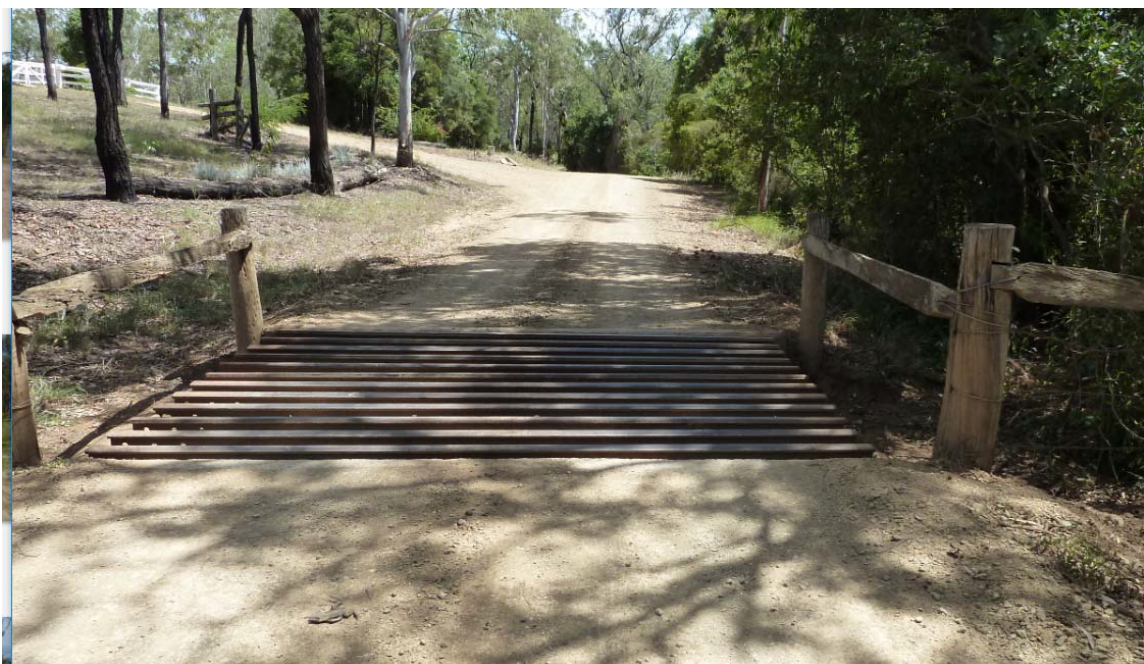
Fair Condition – Grid and abutments in sound condition however siderails and signs need to be fitted, once fitted this grid would be classed as acceptable condition.

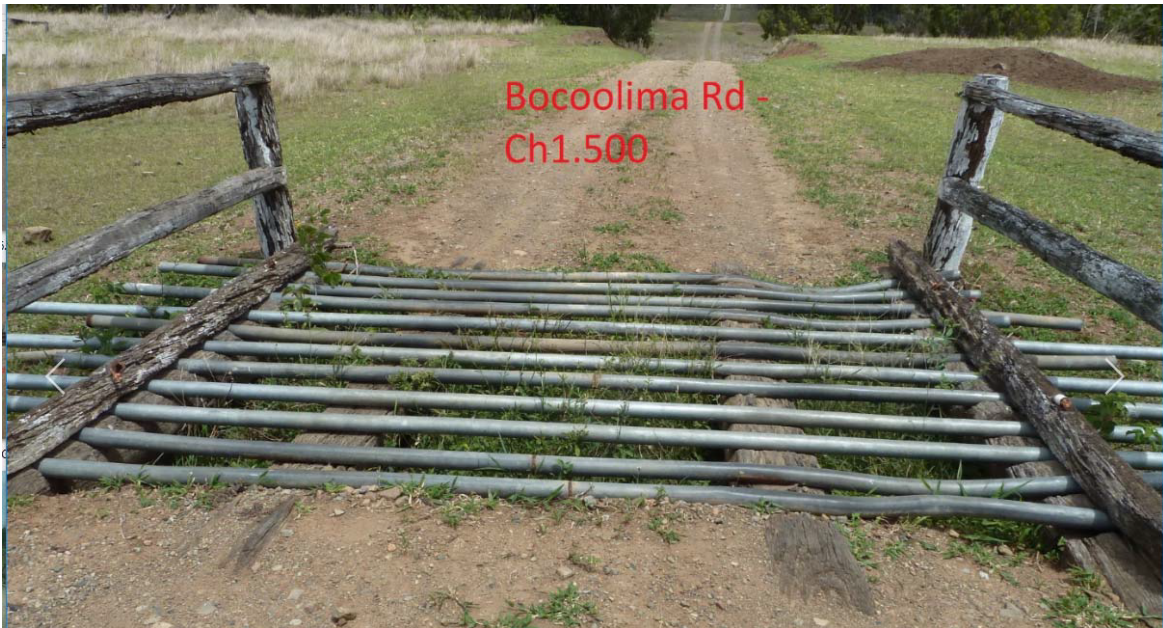
Poor Condition – This grid is made from pipe section that is not structurally capable of handling the vehicle traffic, it is constructed on wooden abutments that are susceptible to wood rot and termites.

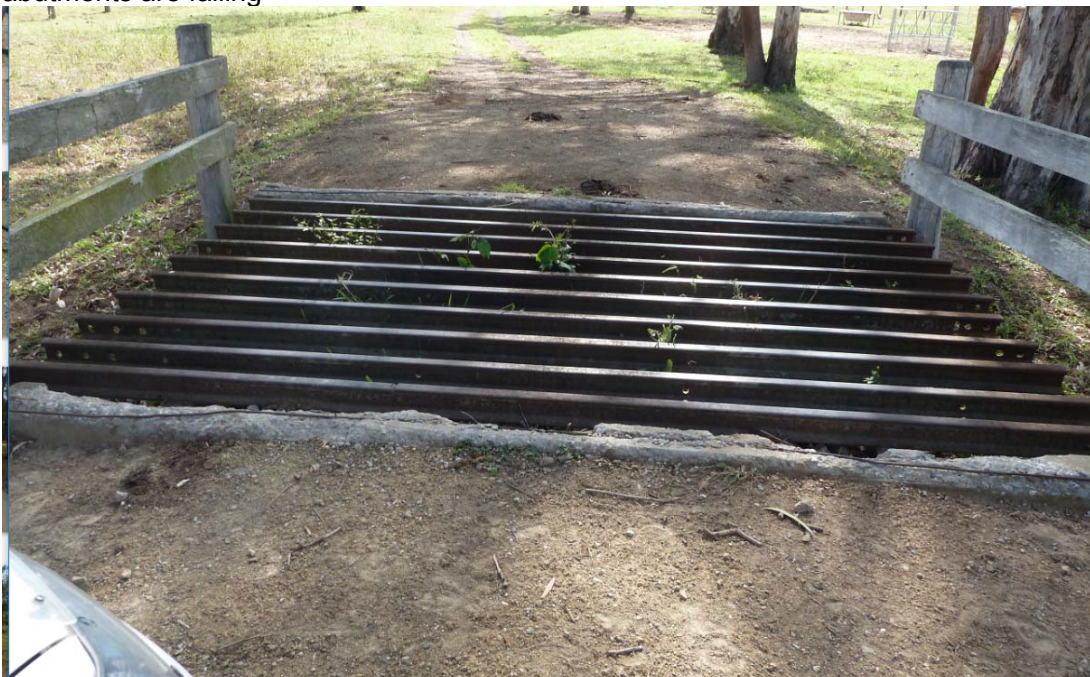
Poor Condition – This grid is of railway line construction with concrete abutments however the abutments are failing
