# Boyne Island and Tannum Sands Shoreline Erosion Management Plan (SEMP)

November 2022

This report has been prepared by Alluvium Consulting Australia Pty Ltd for **Gladstone Regional Council** under the contract titled '**127-22 Boyne Island and Tannum Sands Shoreline Erosion Management Plan (SEMP)**'.

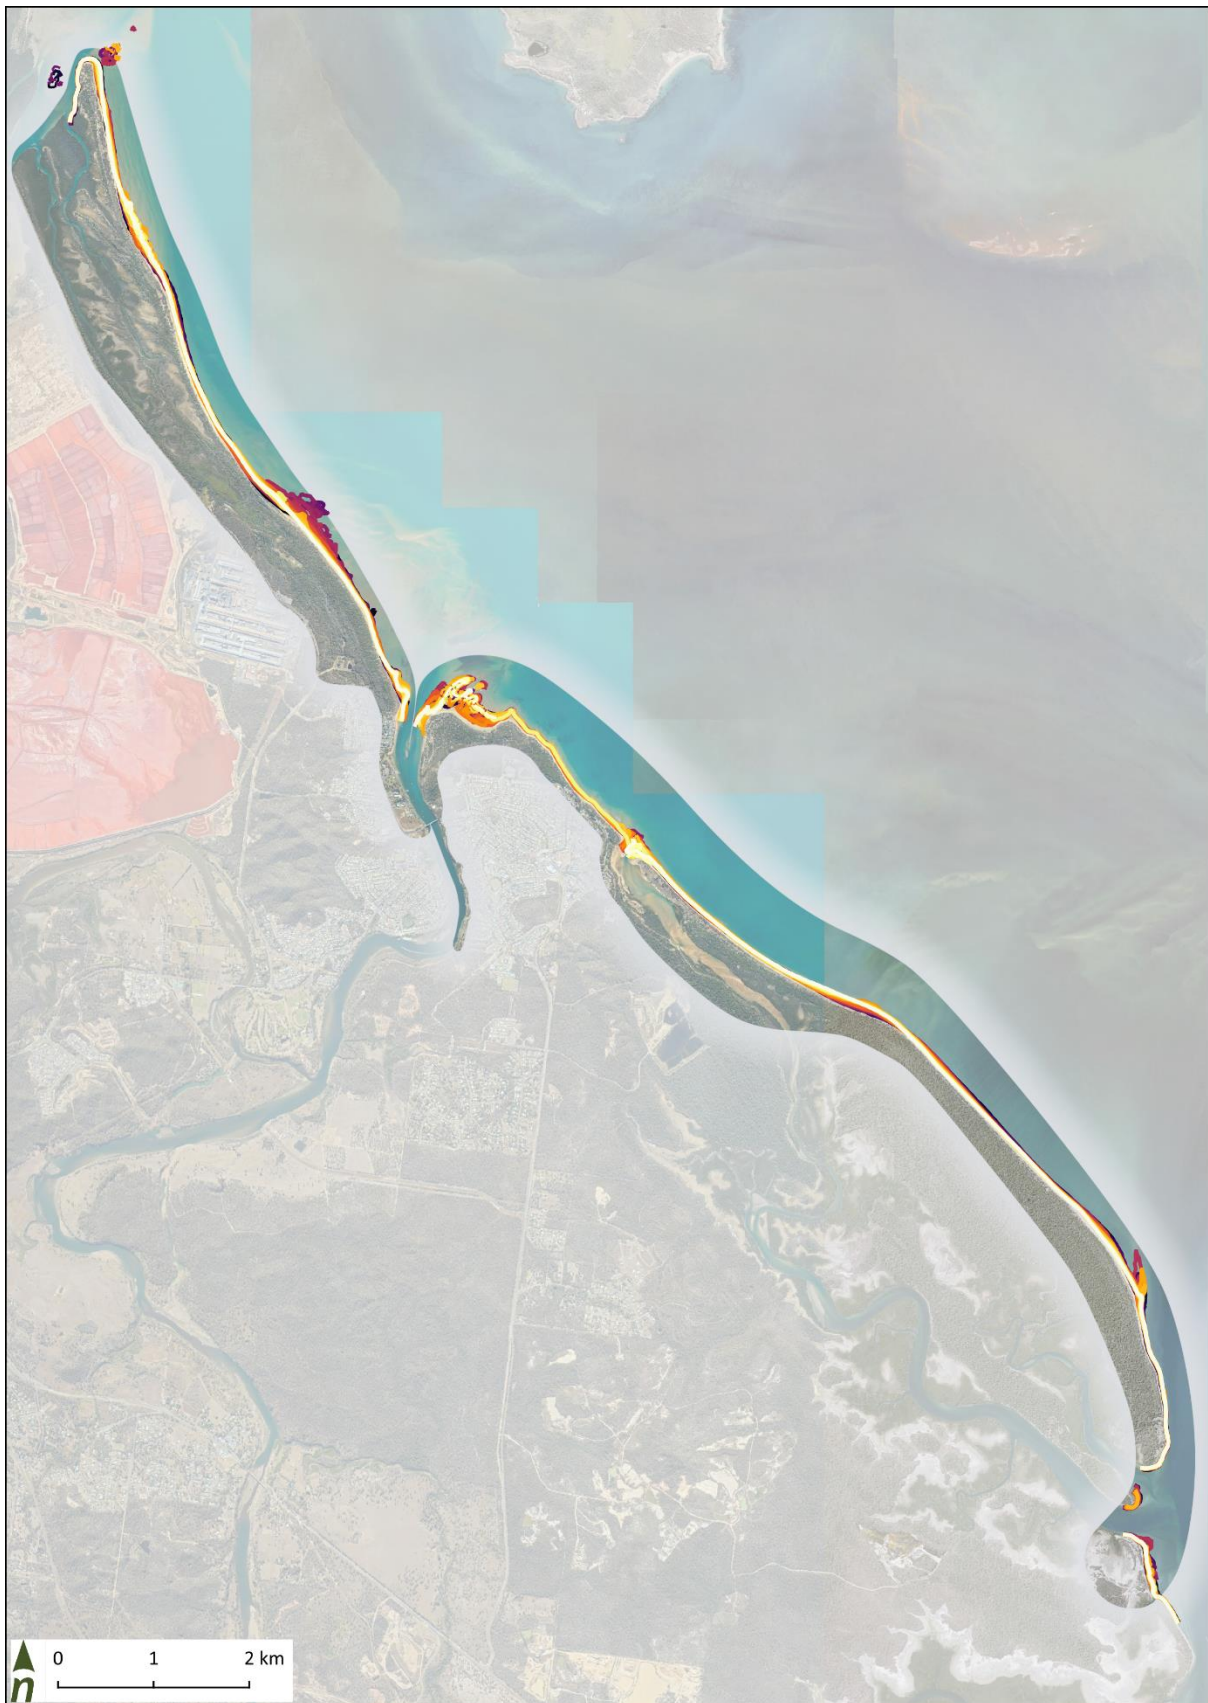
Figure 17. Annual shoreline movements from 1988 to 2021 (Source: DEA Coastlines).

End point rate and net shoreline movement measurements indicate that recession is most evident on the southern end of both Lilley's Beach and Wild Cattle Beach. The recession at Lilley's Beach has been gradual since 1988, but it is the most evident in 2009 and post-2013. As presented in Figure 17, the annual shoreline movements show that there is a long-term migration of longshore sand slugs along both Lilley's Beach and Wild Cattle Island. This is supported by the longshore accretion at the leeward side of the convex shoreline. Migration of sand is the key driver of long-term erosion along these coastlines however, it is considered as a natural process and not of concern. The accretion and recession rates are about 2.5 m/year at all locations, except Island Esplanade foreshore.

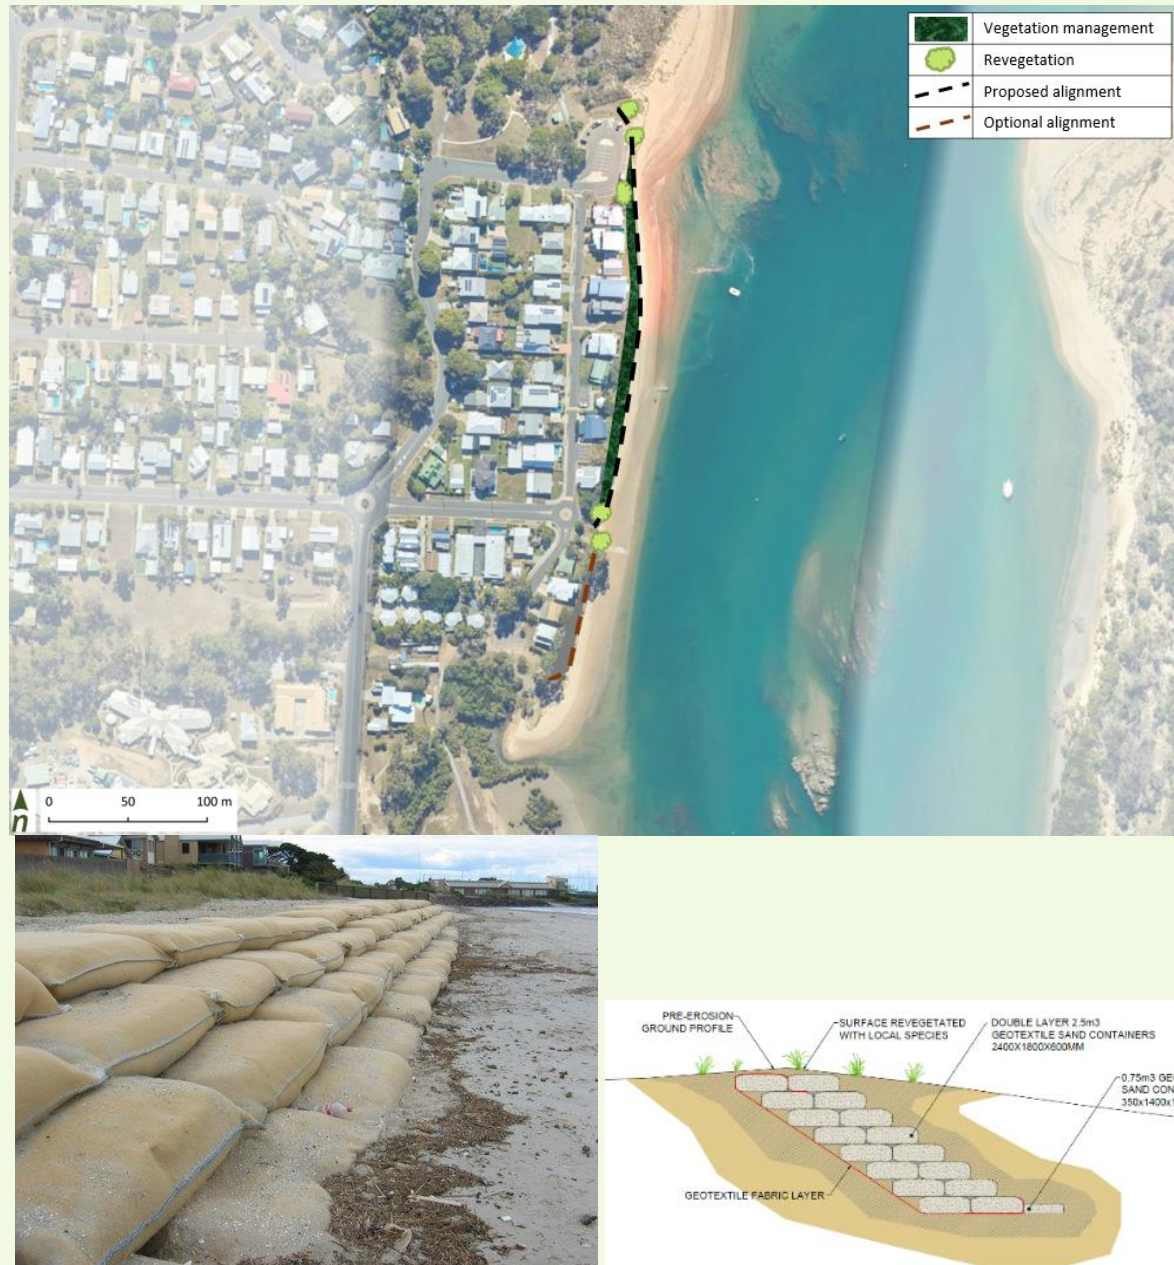
Figure 26. Island Esplanade foreshore – Option 2 – Concept plan and illustration of GSC seawall.

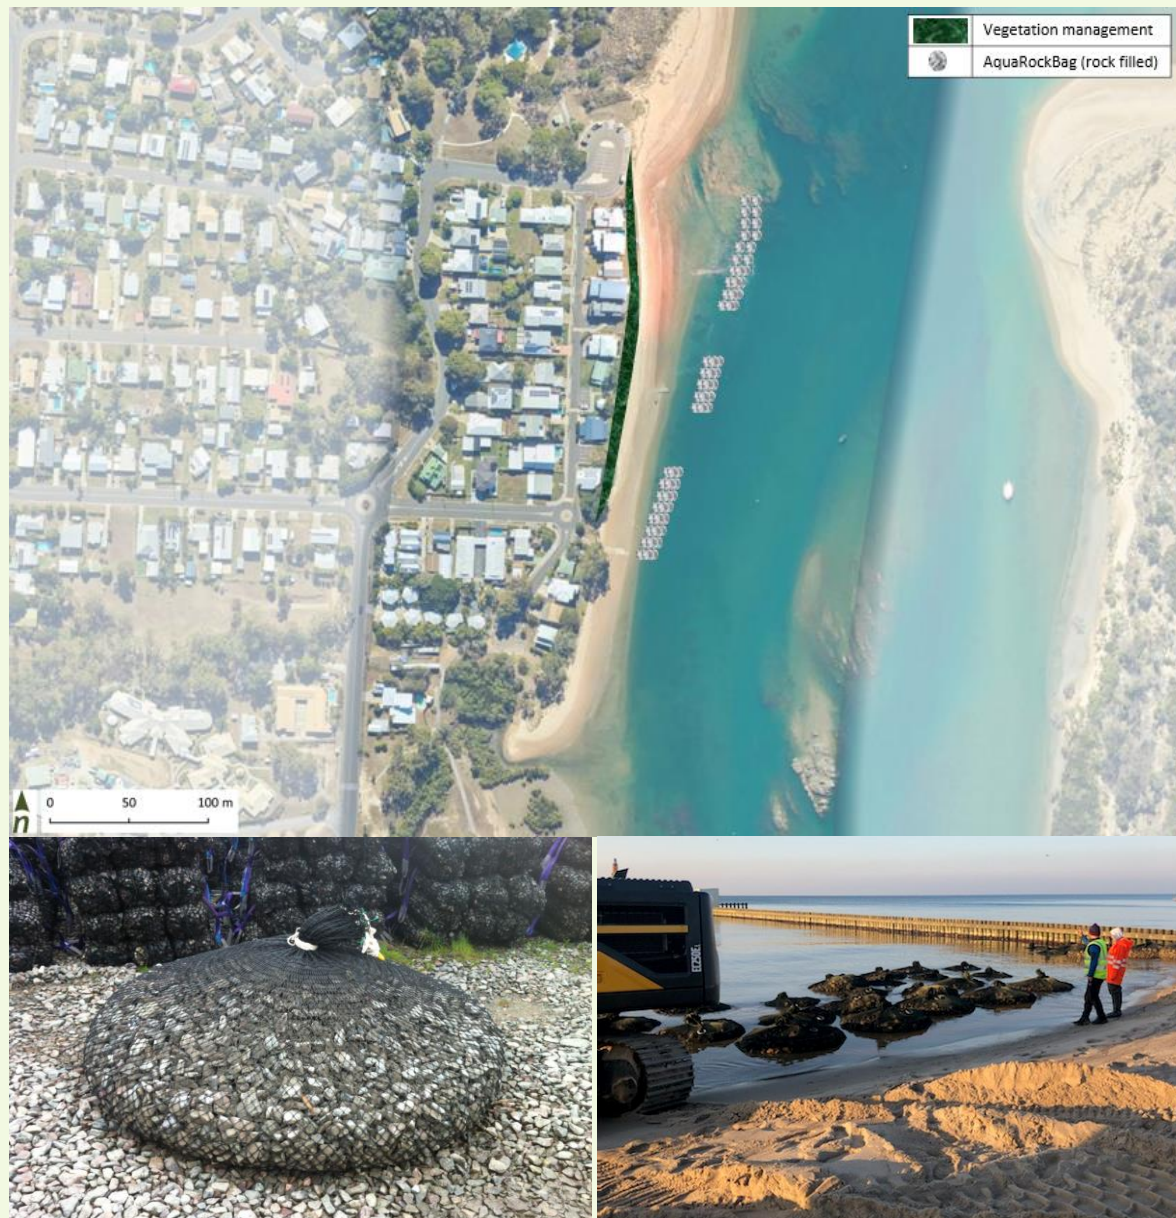
**Figure 29.** Island Esplanade foreshore – Option 5 – Concept plan of AquaRock Bags structure alignment. (Bottom) Photos sourced from Gabion Cages and Baskets.

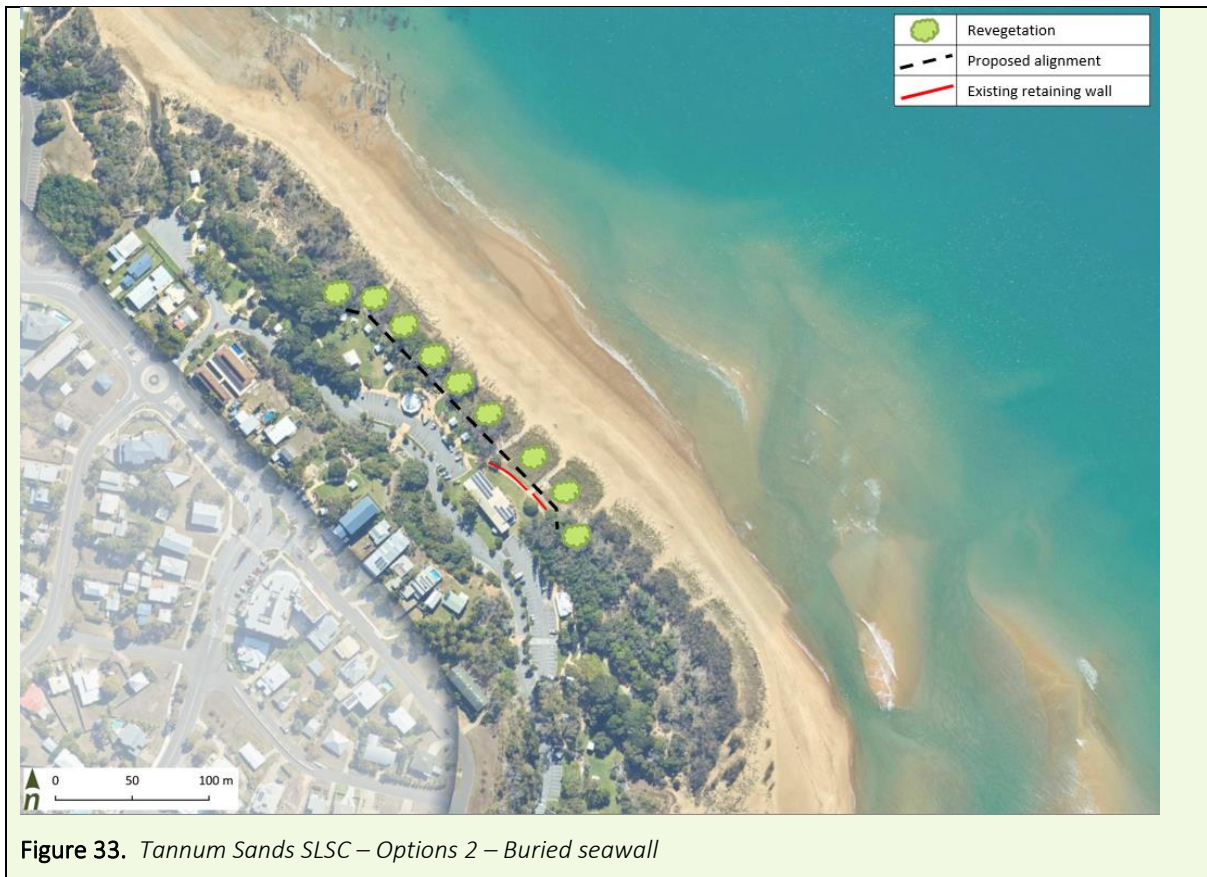
Figure 33. Tannum Sands SLSC – Options 2 – Buried seawall

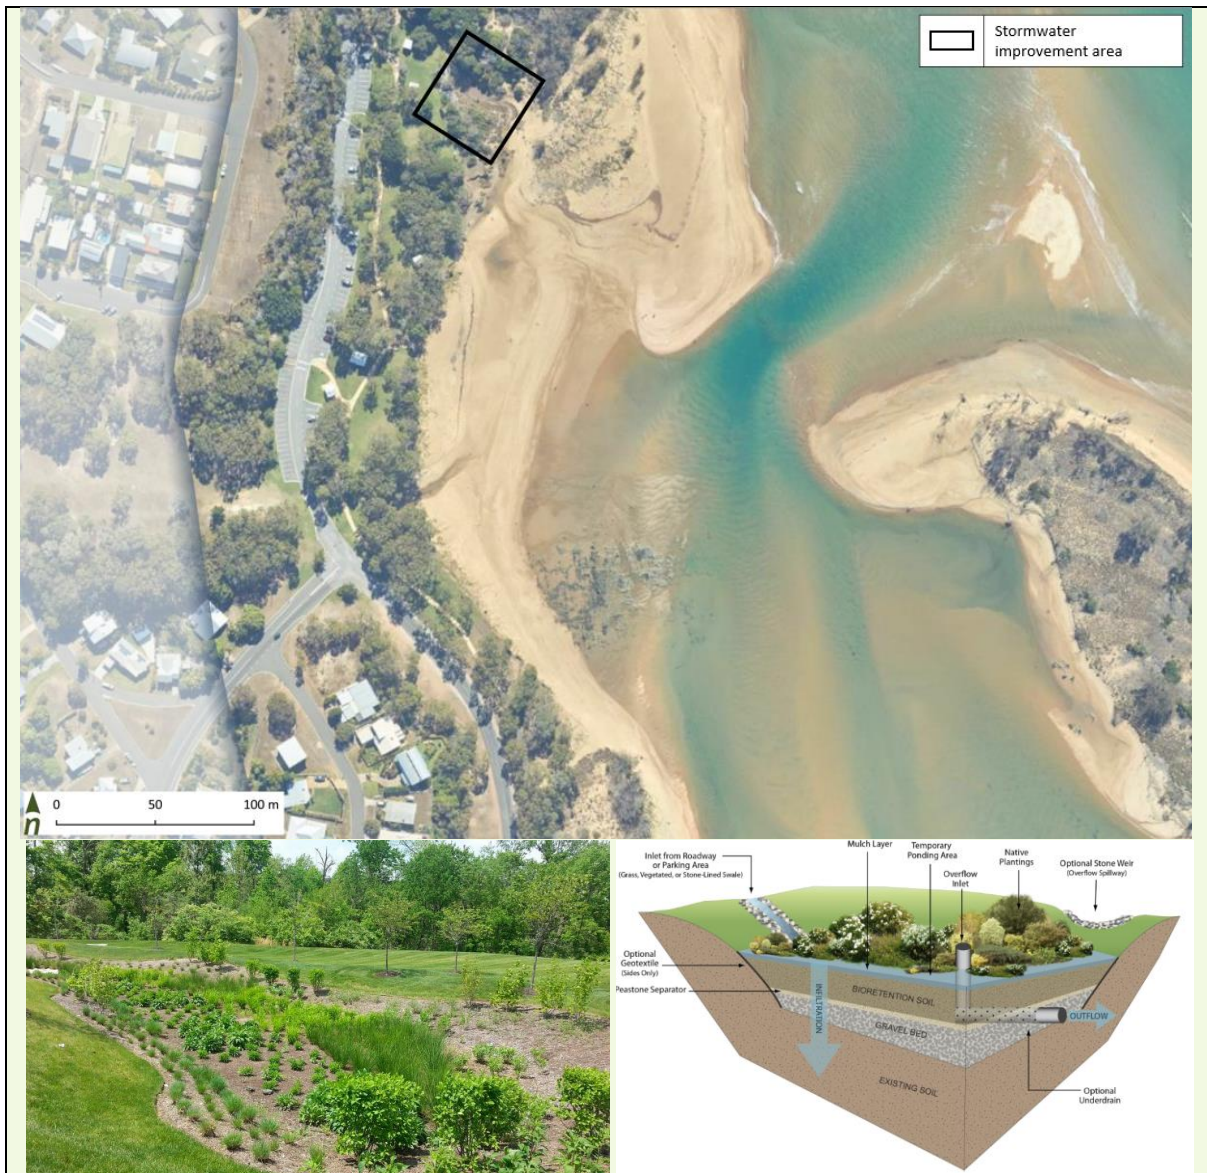
Figure 34. Millenium Esplanade – Options 2 – Stormwater management.

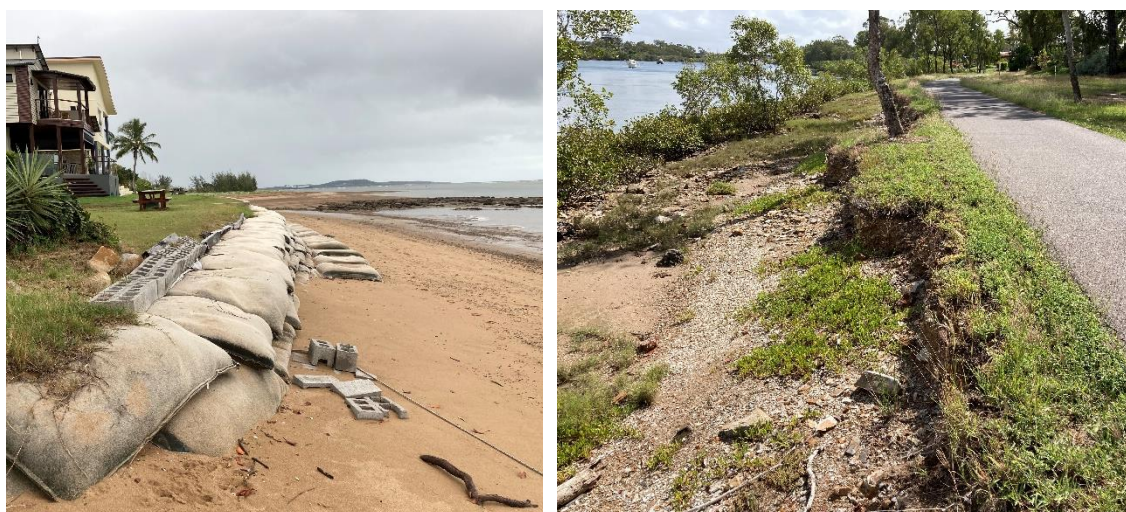
Figure 7-1: Field investigation of erosion at Island Esplanade (left) and Turtle Way cycle path (right)

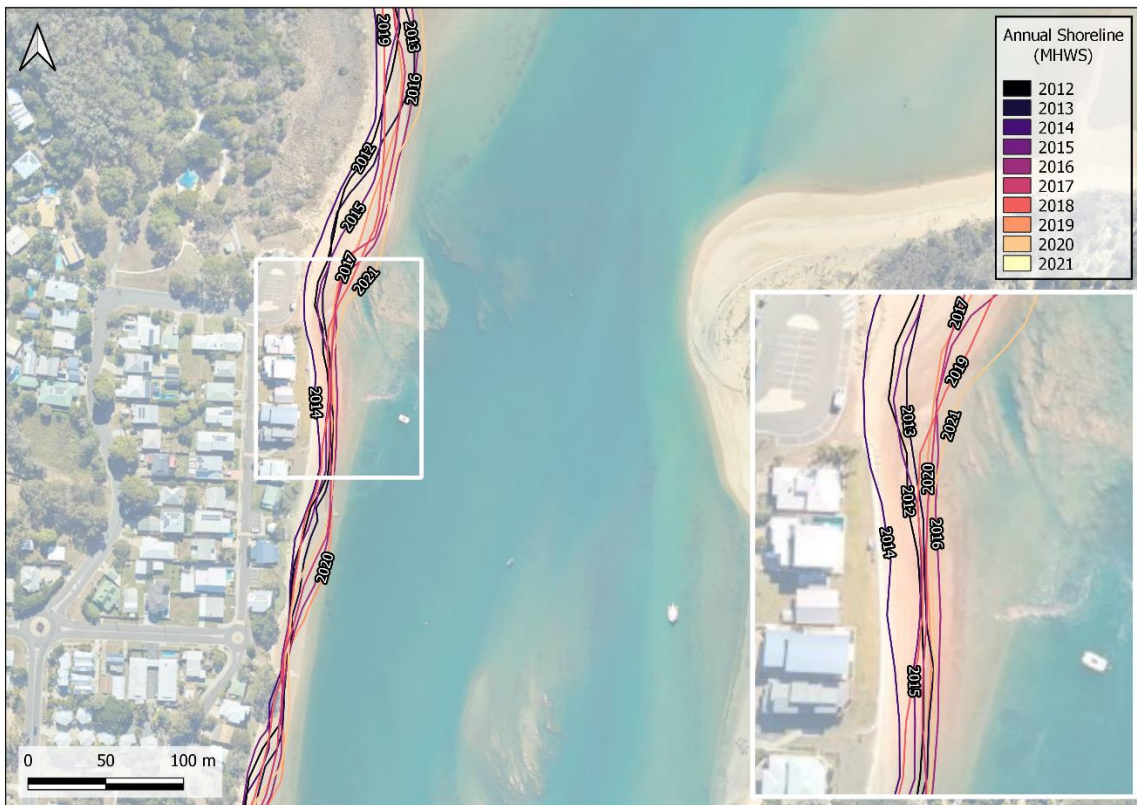
Figure 7-2: Shoreline positions at the Boyne River Inlet over a 10-year period.
