## Site Analysis Report

# **10 Canoe Point Road, Tannum Sands**

## Boyne Tannum Aquatic Recreation Centre Option Analysis

**REFERENCE NO: R2019066**

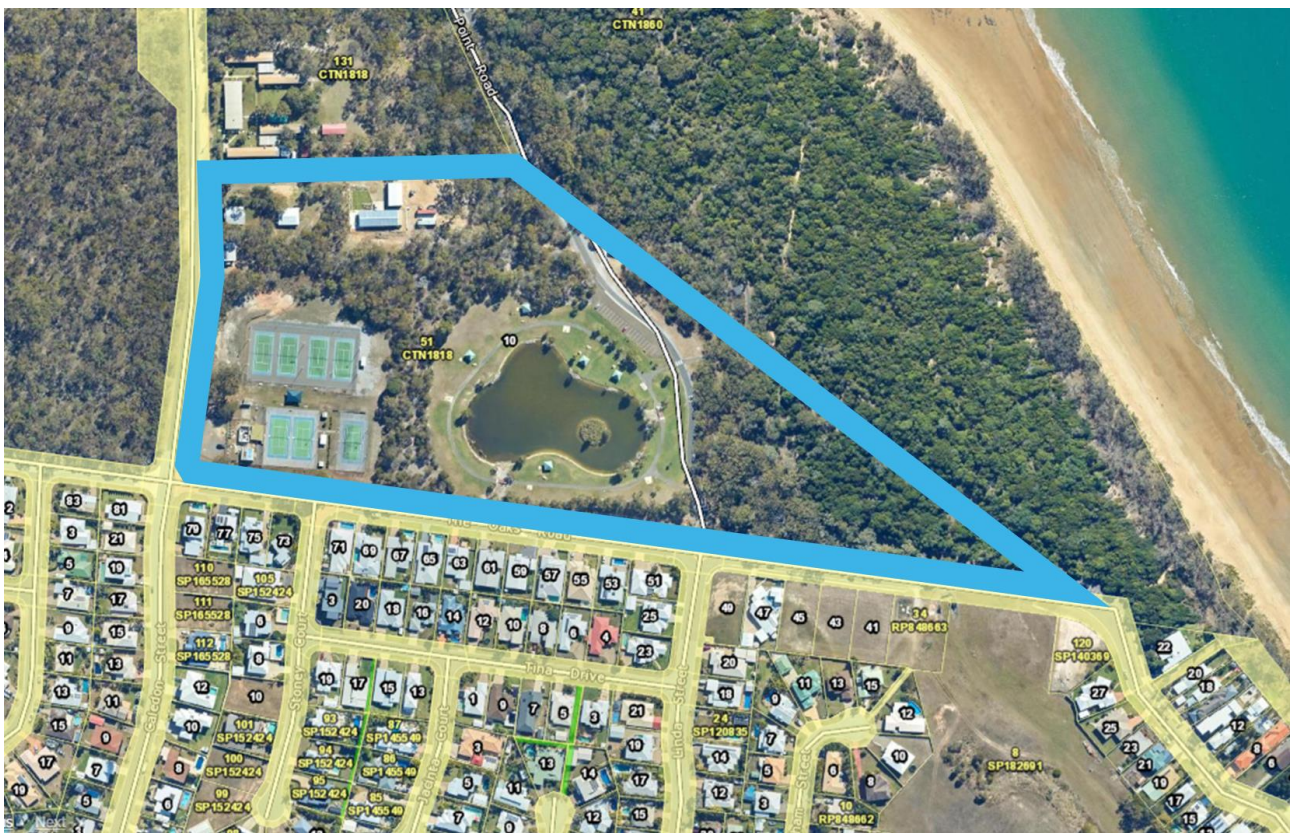
Figure 2-1 The Site

- > Established areas of residential development to the immediate south;
- > Tanyella Recreation and Conference Centre to the immediate north;
- > Canoe Point picnic area to the north;
- > Areas of coastline to the east and north, ranging in distance from approximately 100 metres to 400 metres from the site; and
- > St Francis Catholic Primary School, approximately 400 metres west of the site.

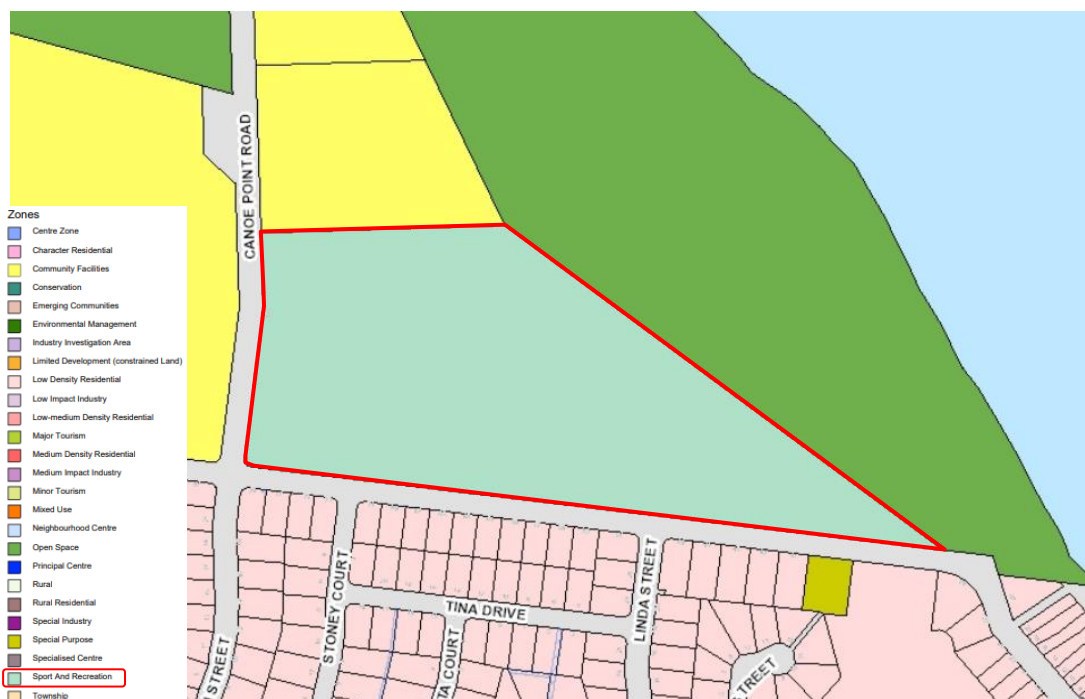
Figure 3-1 Zone Map

The site is located within the Sport and Recreation Zone. The site is not located within a zone precinct. Surrounding land to the north and west is included in the Community Facilities Zone, land to the east is within the Environmental Management Zone and land to the south is within the Low Density Residential Zone with one parcel (Lot 34 on RP848663) included in the Major Tourism Zone.

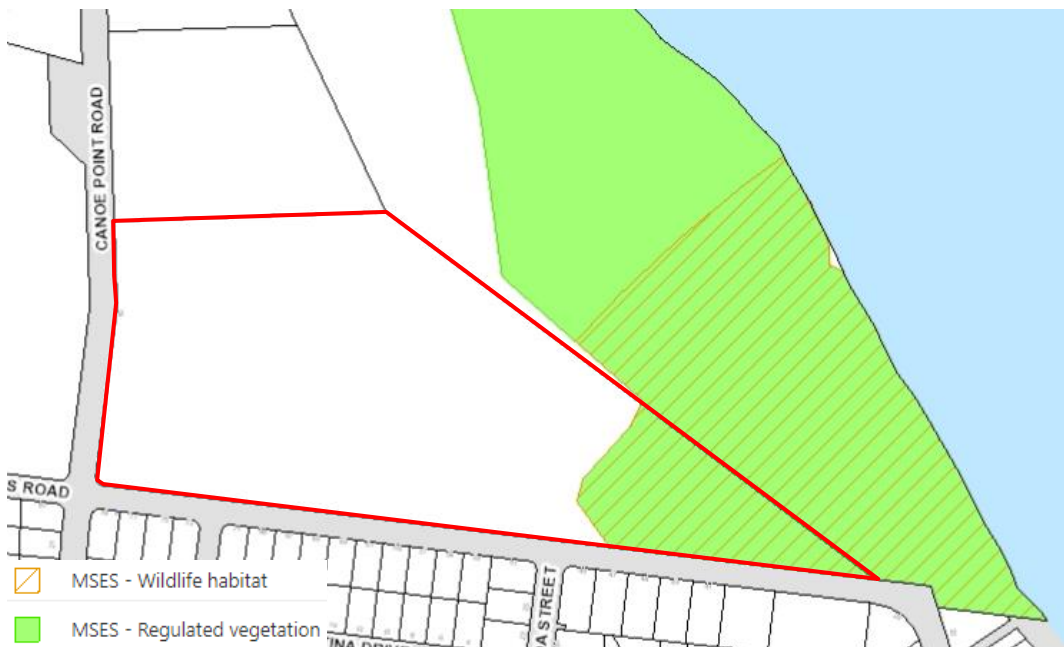
Figure 3-2 Biodiversity Overlay Map

The Biodiversity Overlay will categorise the proposal as Assessable Development that is subject to Code Assessment where any component of the use is located in the wildlife habitat area. The eastern corner of the site is affected by the wildlife habitat area as shown in **Figure 3-2**.

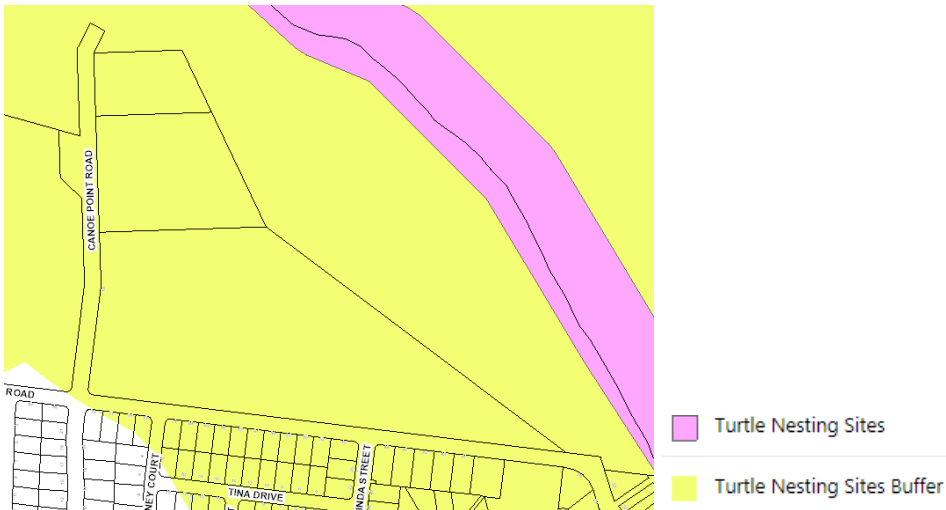
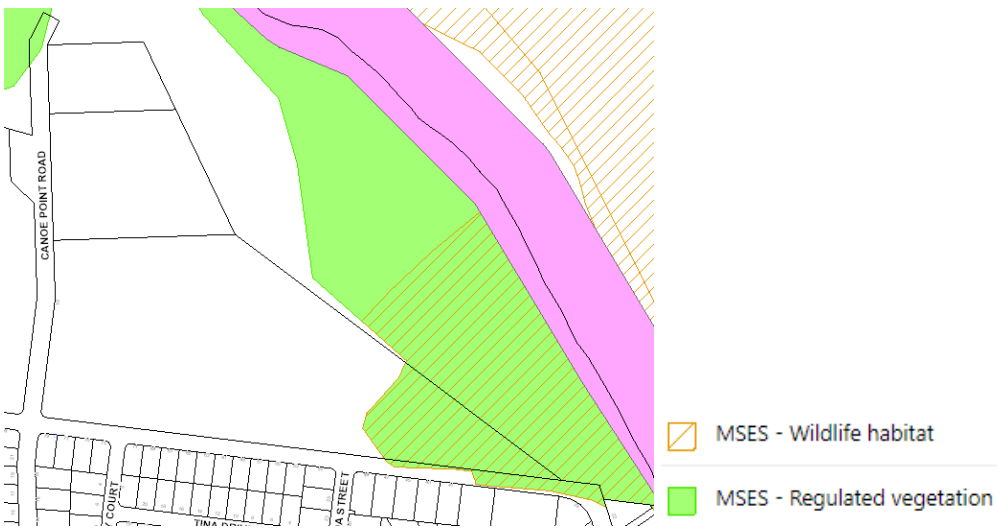
- > a Turtle Nesting Site Buffer;
- > MSES - Regulated vegetation; and
- > MSES - Wildlife habitat.

Mapping relevant to the above layers is shown in **Figure 5-3** and **Figure 5-4**.

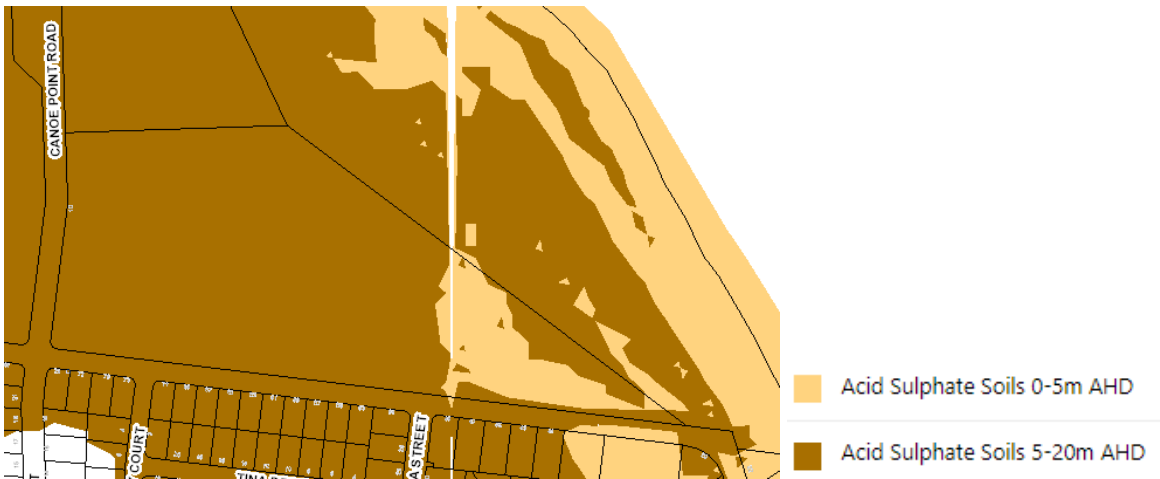
Figure 5-6 Acid Sulphate Soils Overlay mapping (Extract)

The site is mapped as including land at 0-5 metres AHD and 5-20 metres AHD which may contain Acid Sulphate Soils (ASS), as shown in **Figure 5-6**.

Section 5.10.1 of this report identifies the manner in which ASS Overlay mapping applies to the site. The site is mapped as including land at 0-5 metres AHD and 5-20 metres AHD which may contain Acid Sulphate Soils (ASS), as shown in **Figure 5-6**.

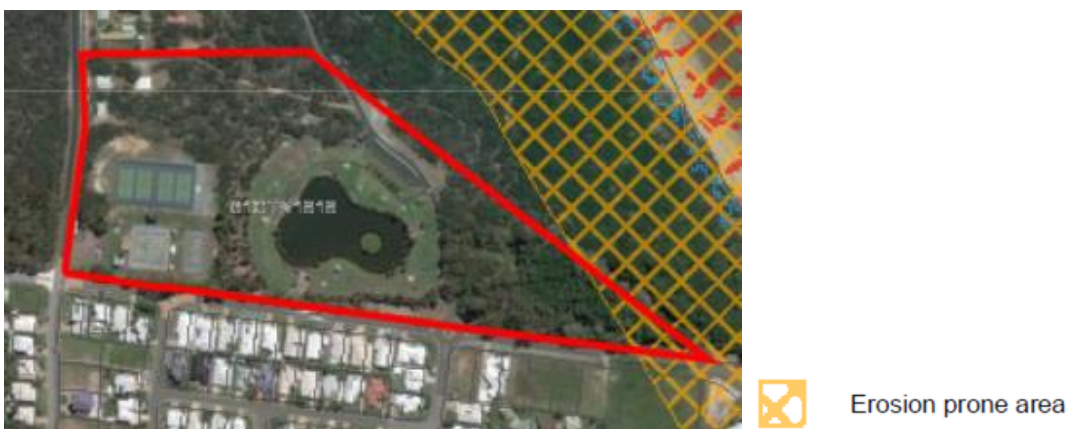
Figure 5-7 Erosion Prone Area mapping (Extract)

The south eastern portion of the site is mapped as Coastal area – erosion prone area, as shown in Figure 5-7.

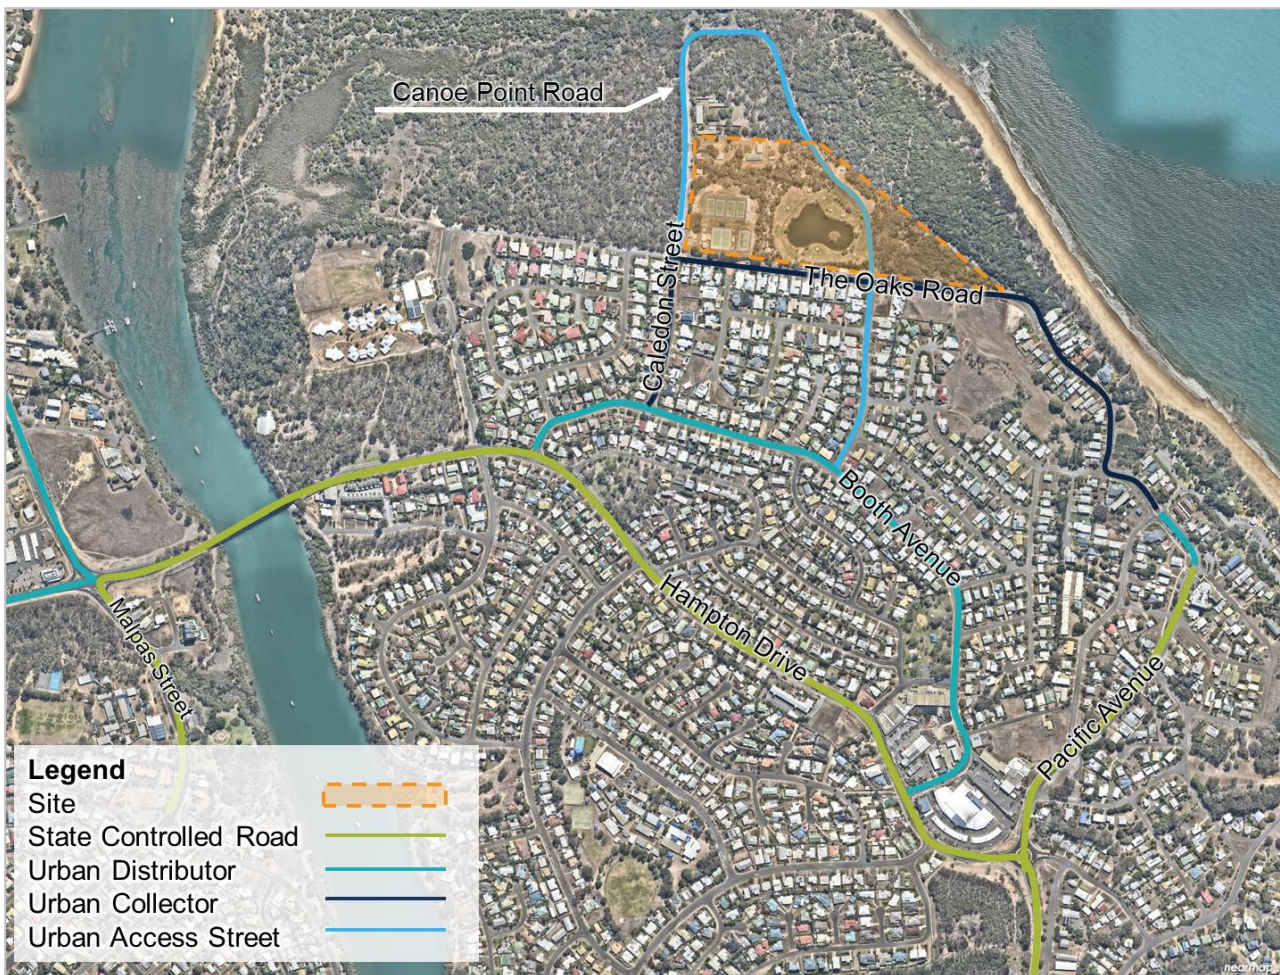
**Figure 6-1** illustrates the local context of the site, where **Figure 6-2** illustrates the broader road network in the vicinity of the site, highlighting Council’s Local Government Infrastructure Plan (LGIP) trunk works.

Figure 6-1 Local Site Context and Road Hierarchy  
 Note the site boundary is indicative only. Source: Nearmap.

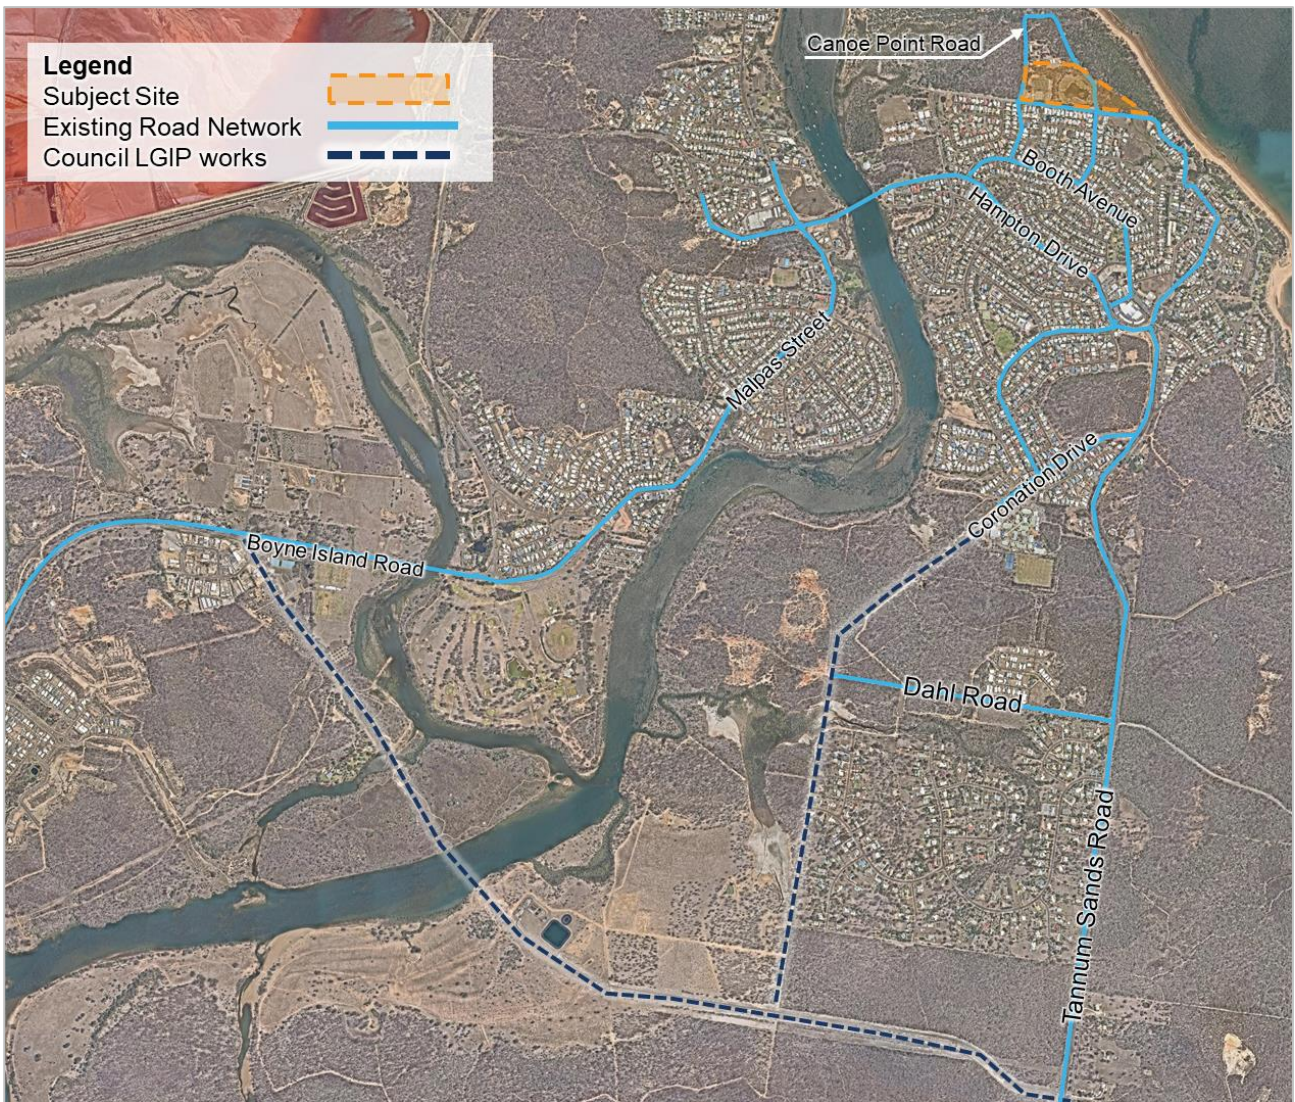
Figure 6-2 Surrounding Road Network and Council LGIP  
 Note the site boundary is indicative only. Source: Nearmap.

As shown in **Figure 6-2**, the LGIP trunk works introduce a new route for vehicles to travel between Coronation Drive, Boyne Island Road and Tannum Sands Road, which creates a bypass for vehicles to avoid travelling along Hampton Drive.

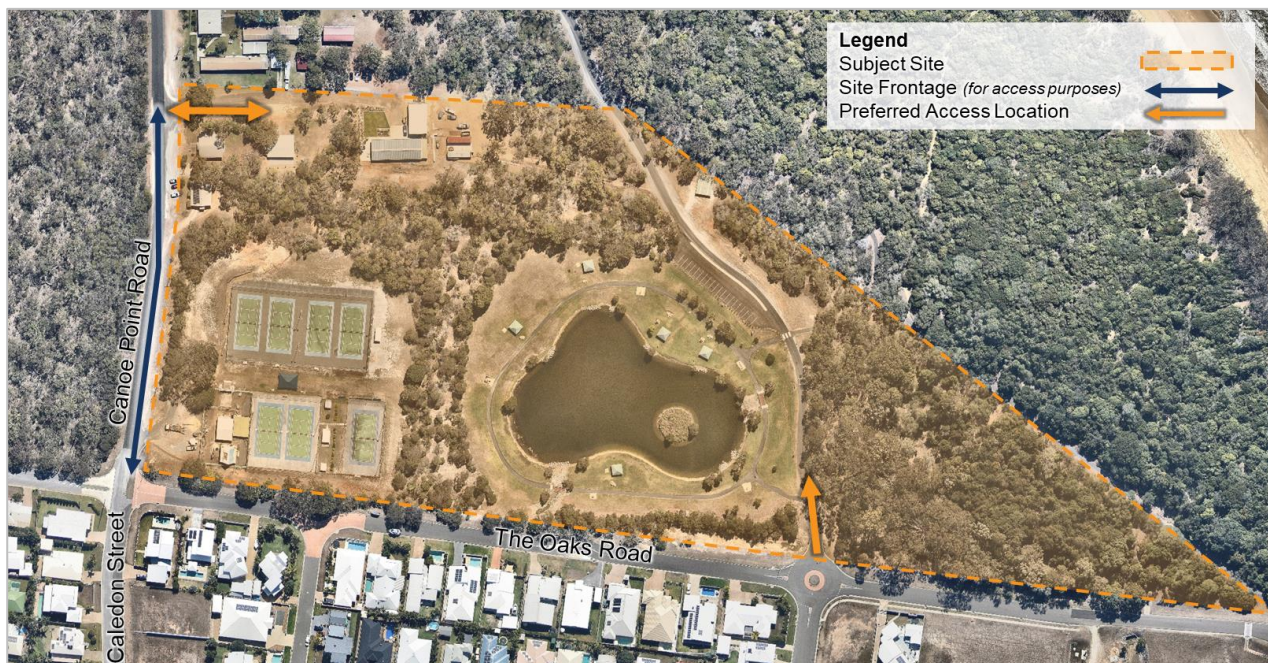
Figure 6-4 Site Frontage

As shown in **Figure 6-4**, the site has frontage to Canoe Point Road and The Oaks Road, with existing vehicular access via both roads. It is understood that access is preferred to be achieved via the existing northern driveway on Canoe Point Road and the roundabout on The Oaks Road.

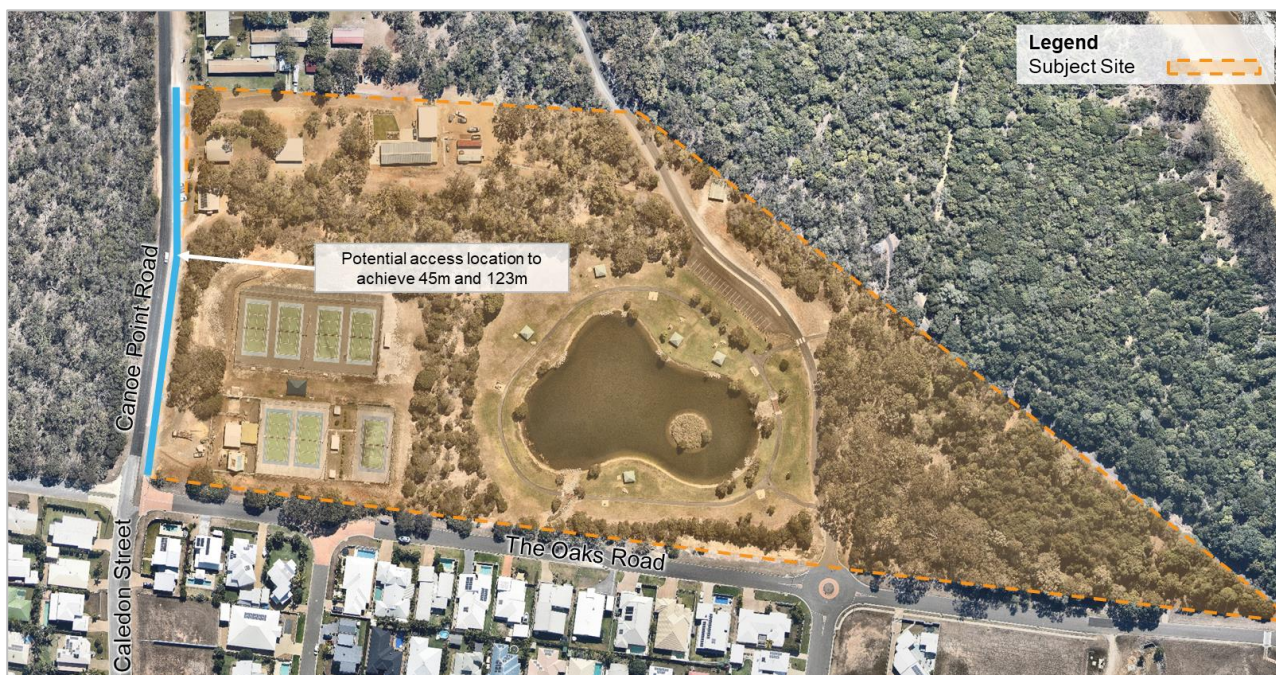
**Figure 6-5** illustrates the preferred location for the site to gain access, which indicates that the site achieves the minimum sight distance requirements along its entire frontage.

Figure 6-5 Potential access location to achieve sight distance  
 Note the site boundary is indicative only. Source: Nearmap.

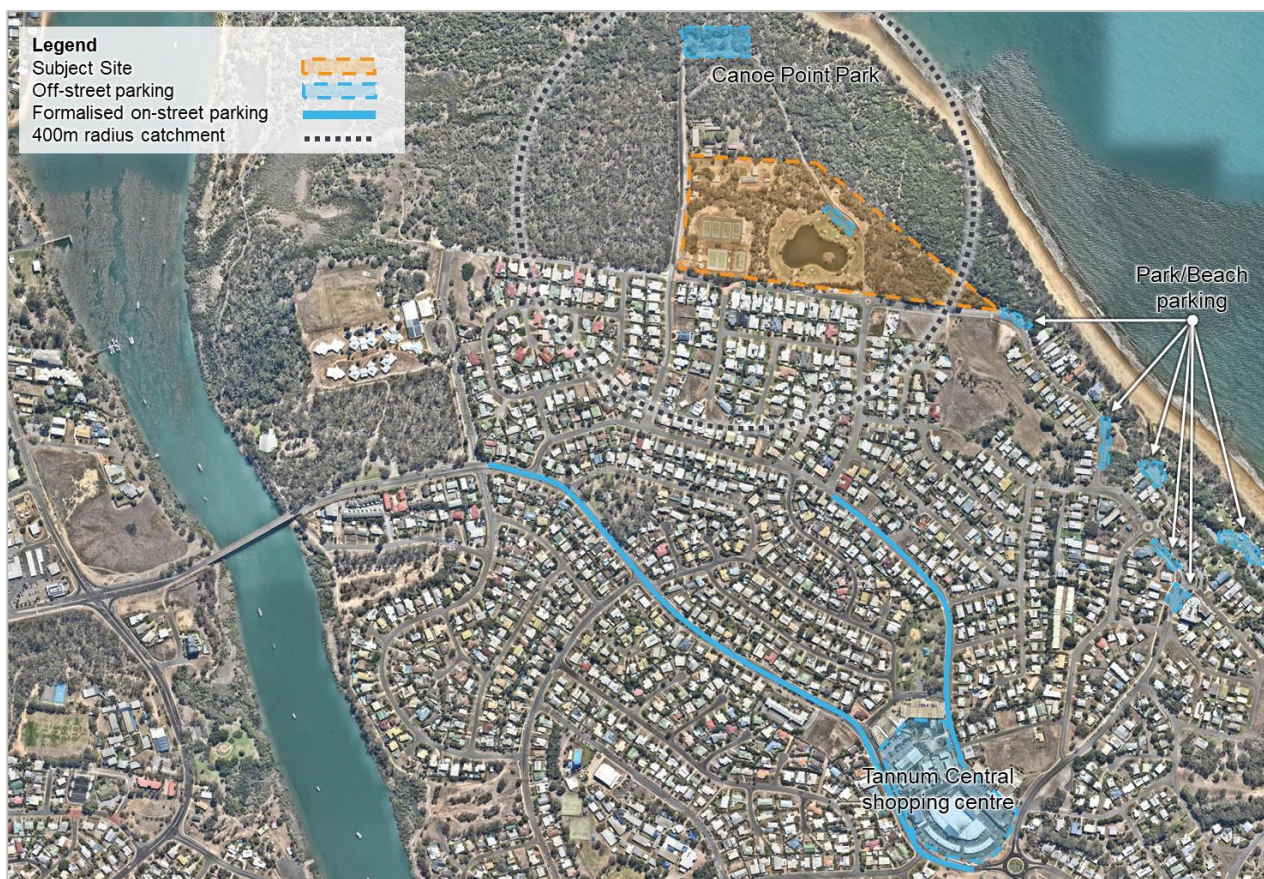
Figure 6-7 Available Car Parking Facilities  
 Note the site boundary is indicative only. Source: Nearmap.

As shown in **Figure 6-7**, there are limited car parking alternatives within proximity to the site. Therefore it is recommended that adequate car parking be provided on-site in accordance with the following parking rates (as per the Gladstone Planning Scheme SC6.10 Vehicle Parking Rates), and consideration of car parking at similar development sites.

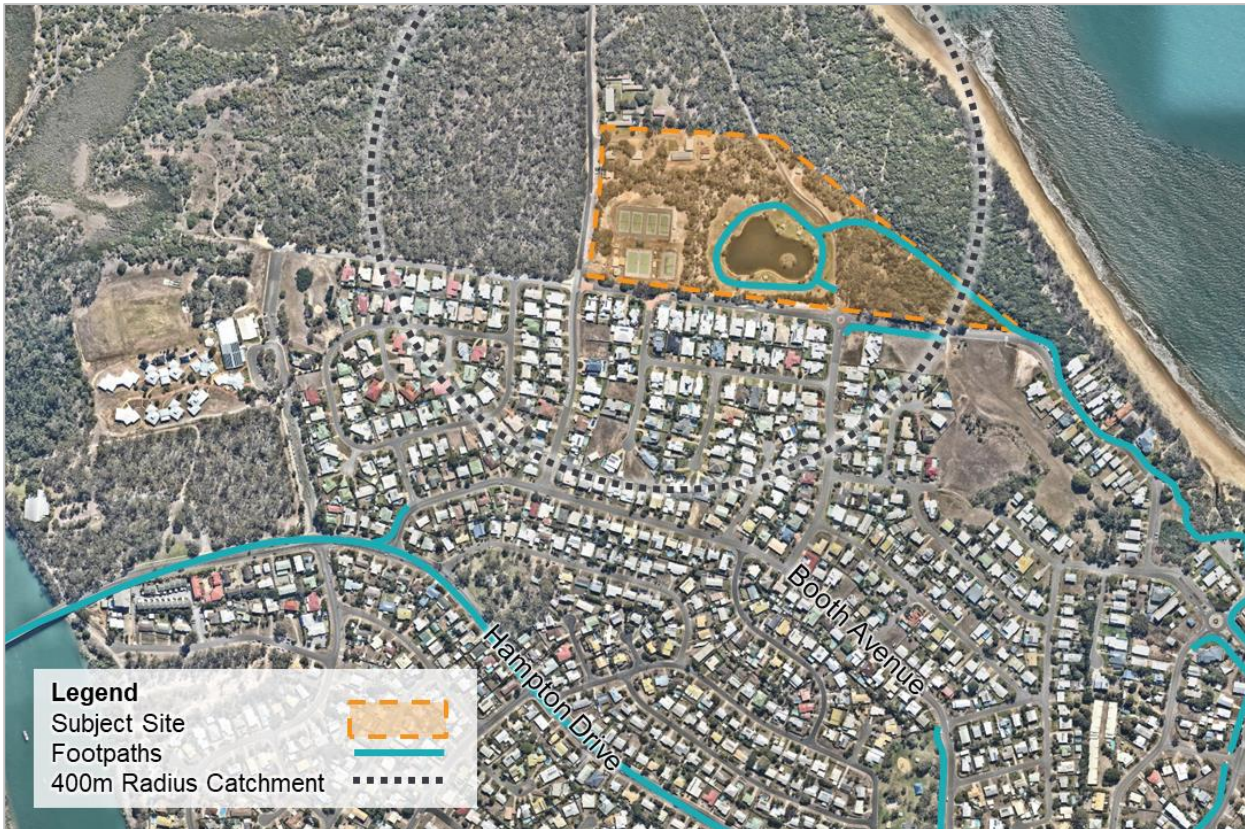
Figure 6-9 Active Transport Connections  
 Note the site boundary is indicative only Source: Nearmap.

As shown in **Figure 6-9**, the local area is well-connected with pedestrian footpaths eastward to the beach, however there are no connections southward to Booth Avenue and Hampton Drive. Therefore it is recommended to provide pedestrian connections to the south, to connect with the broader network.

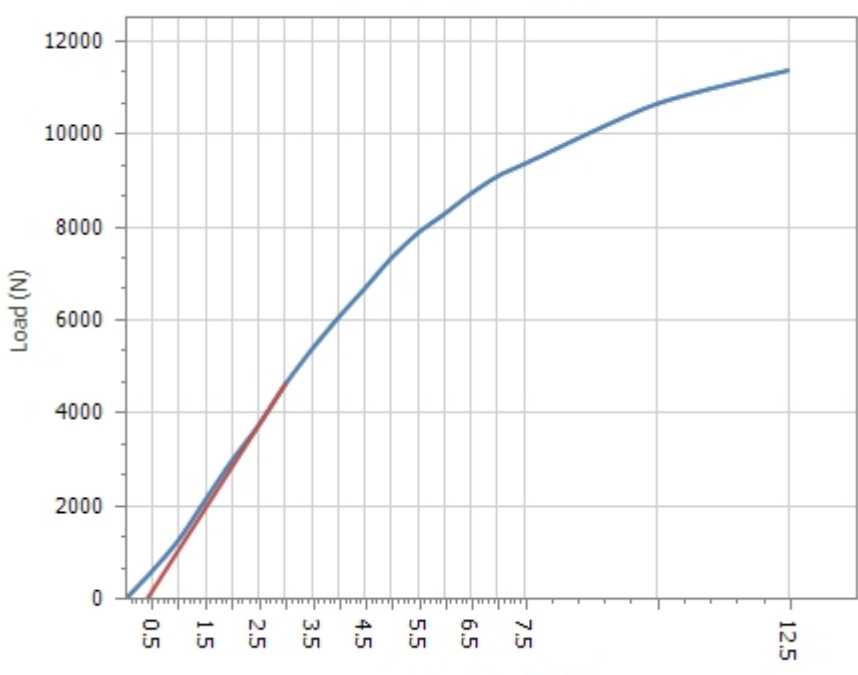
<b>Maximum Dry Density (t/m<sup>3</sup>):</b> 2.00 <b>Optimum Moisture Content (%):</b> 9.5 <b>Field Moisture Content (%):</b> 6.0 <b>Sample Percent Oversize (%):</b> 0.0 <b>Oversize Included / Excluded</b> Excluded <b>Target Density Ratio (%):</b> 100 <b>Target Moisture Ratio (%):</b> 100 <b>Placement Dry Density (t/m<sup>3</sup>):</b> 2.00 <b>Placement Dry Density Ratio (%):</b> 100.0 <b>Placement Moisture Content (%):</b> 9.9 <b>Placement Moisture Ratio (%):</b> 102.0 <b>Test Condition / Soaking Period:</b> Soaked / 4 Days <b>CBR Surcharge (kg)</b> 4.5 <b>Dry Density After Soak (t/m<sup>3</sup>):</b> 2.00 <b>Total Curing Time (hrs)</b> 28 <b>Liquid Limit Method</b> Estimation <b>Moisture (top 30mm) After Soak (%):</b> 9.6 <b>Moisture (remainder) After Soak (%):</b> 10.3 <b>CBR Swell (%):</b> 0.0 <b>Minimum CBR Specification (%):</b> - <b>CBR Value @ 5.0mm (%):</b> <b>40</b>	<p><b>CBR PENETRATION PLOT</b></p>

<table><tr> <th>Penetration (mm)</th> <th>Load (N)</th> </tr></table>
