Site Analysis Report

Jacaranda Drive, Boyne Island

Boyne Tannum Aquatic Recreation Centre Option Analysis

**PREPARED FOR
GLADSTONE REGIONAL COUNCIL
REFERENCE NO: R2019066**

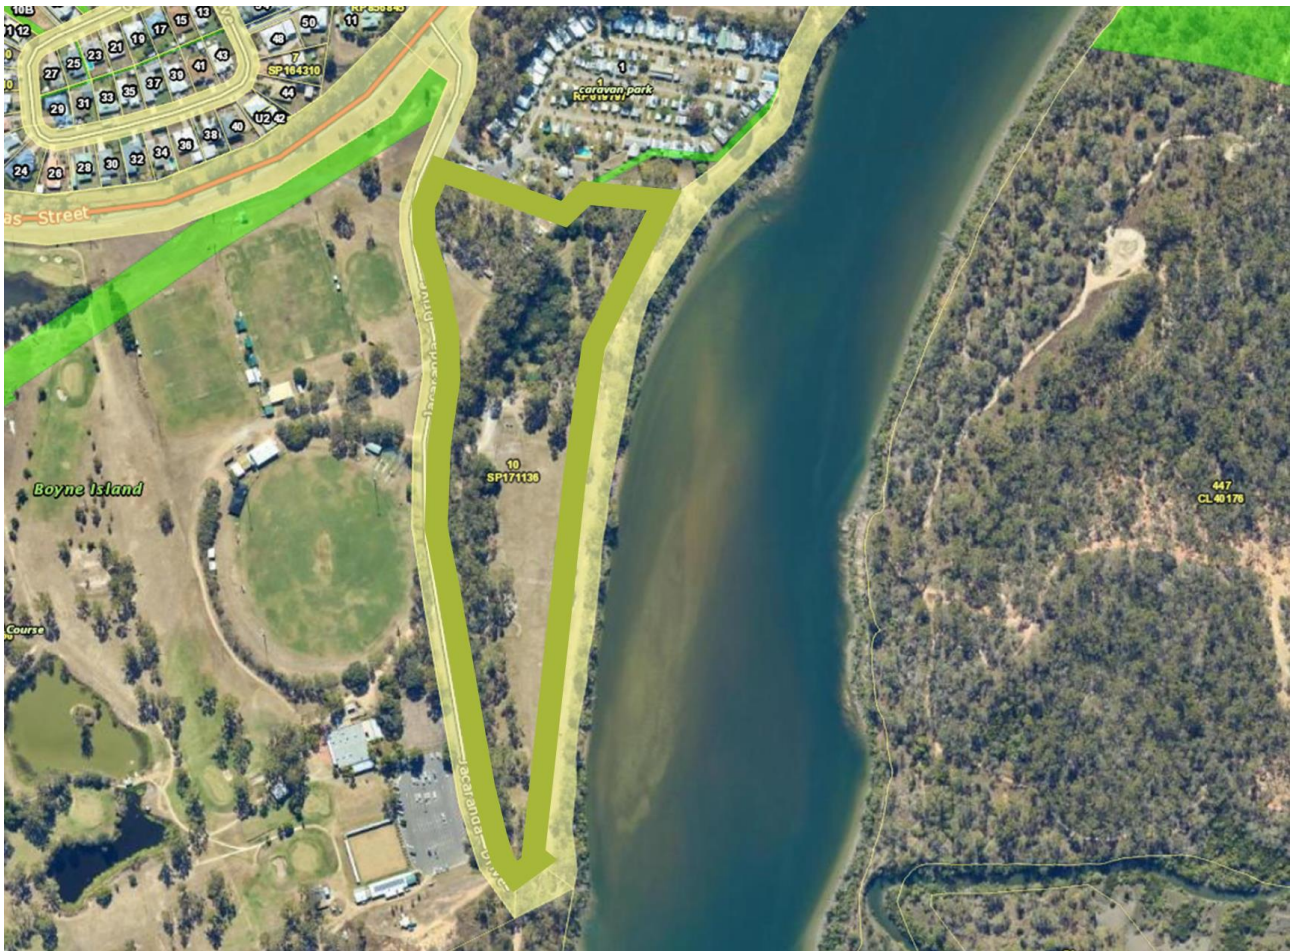
Figure 2-1 The Site

The site is shown in **Figure 2-1** below.

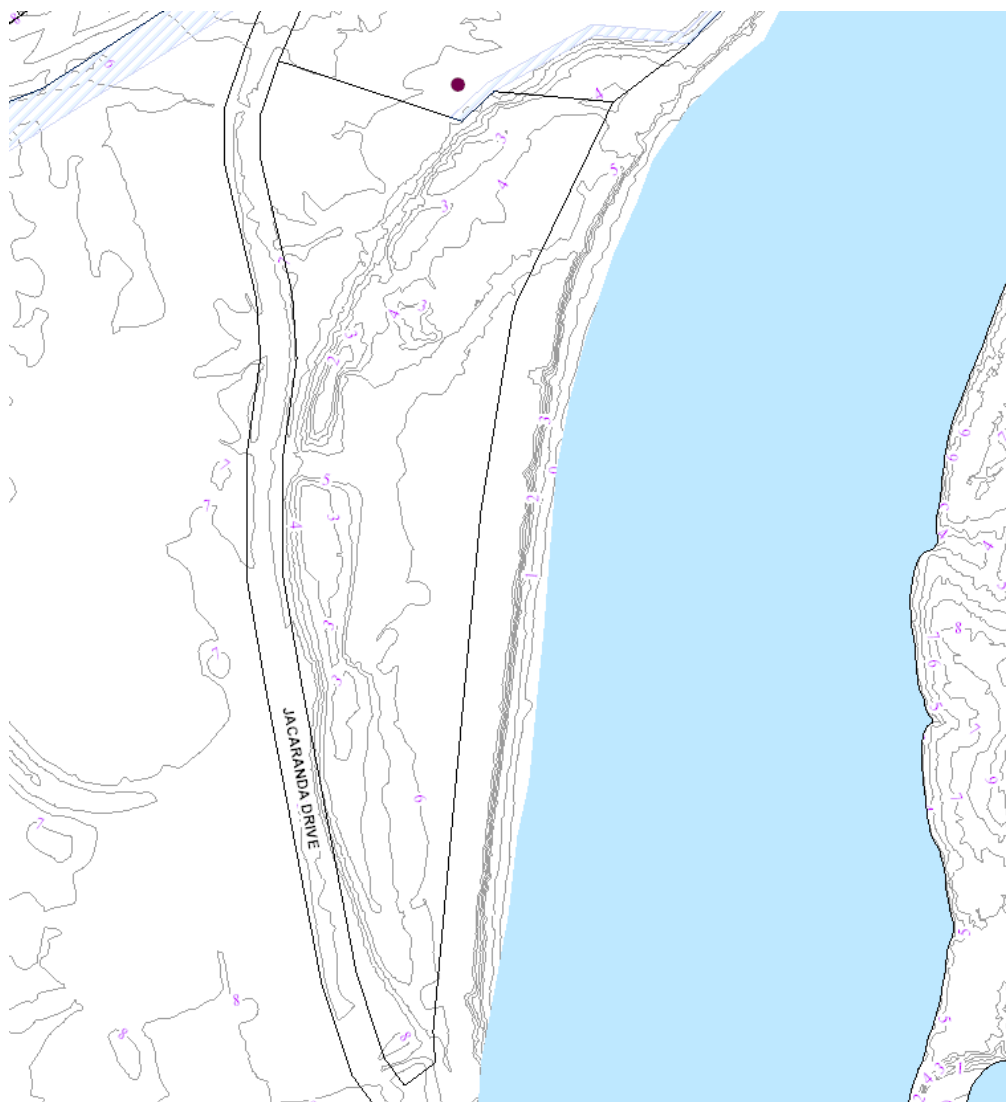
Figure 4-1 Contour map (1 metre)

There is currently no existing stormwater drainage infrastructure within the site. At present, stormwater will sheet flow via natural flow paths to the gully on the western section of the site which then flows both north and south to the Boyne River. This is shown in the contour map provided as **Figure 4-1**. There are no local drainage networks present in the surrounding area that can be easily connected to. As the current site is under developed there are few impermeable areas.

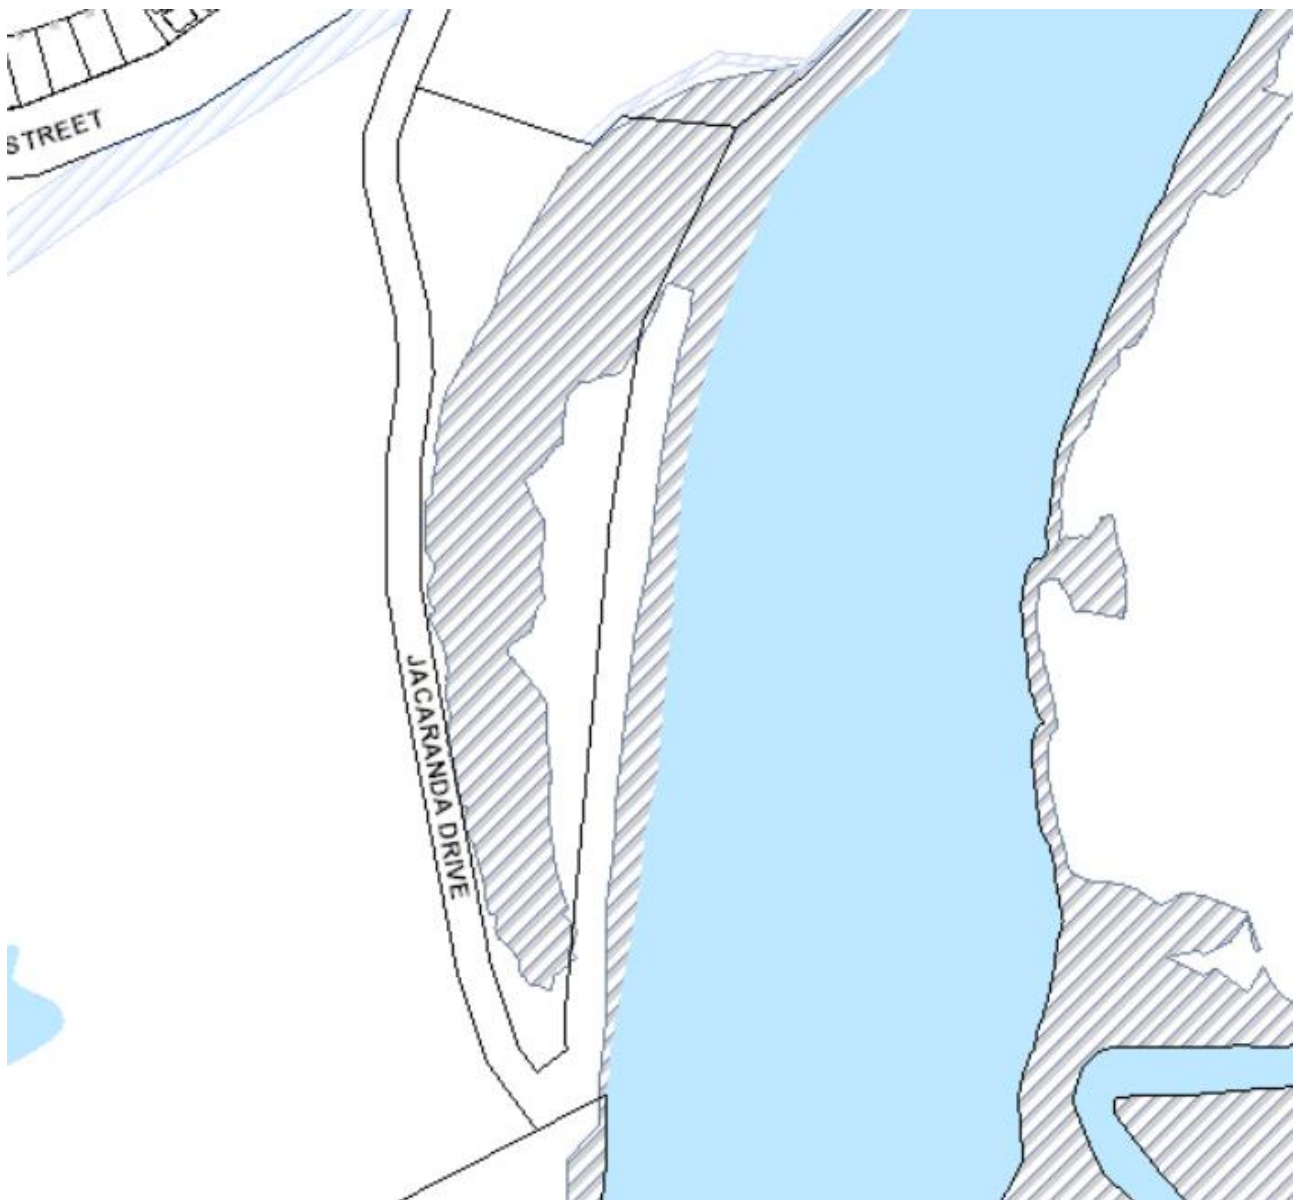
Figure 4-2 Boyne River Flood Extent

Council's online mapping indicates that a large proportion of the site is subject to flooding from the Boyne River during Q100 flood events, as shown in **Figure 4-2**. Significant filling of the site would be required to establish a building pad above this level. A flood study is recommended to determine the impact on adjacent properties caused by this filling.

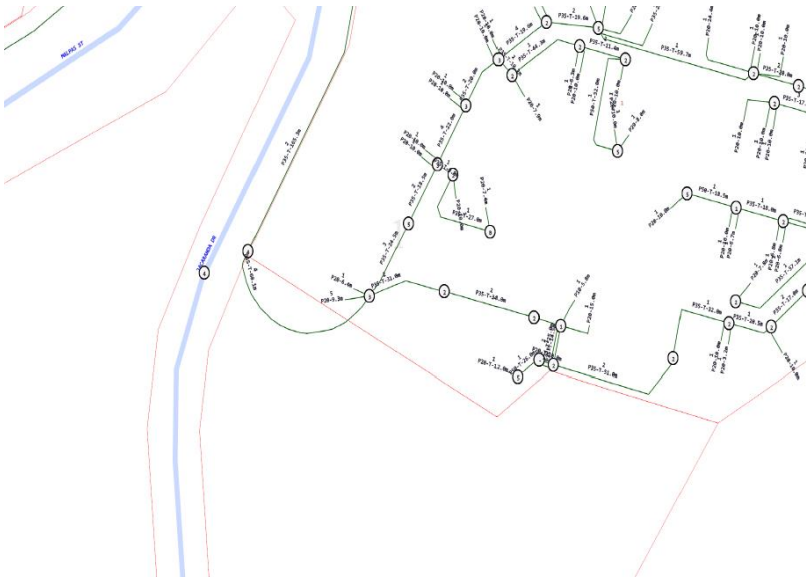
Figure 4-6 NBN DBYD

There is currently no Telstra or NBN infrastructure traversing the site (see **Figure 4-6** and **Figure 4-7**), although there is NBN infrastructure located directly to the north of the site that can be extended to service the proposed development.

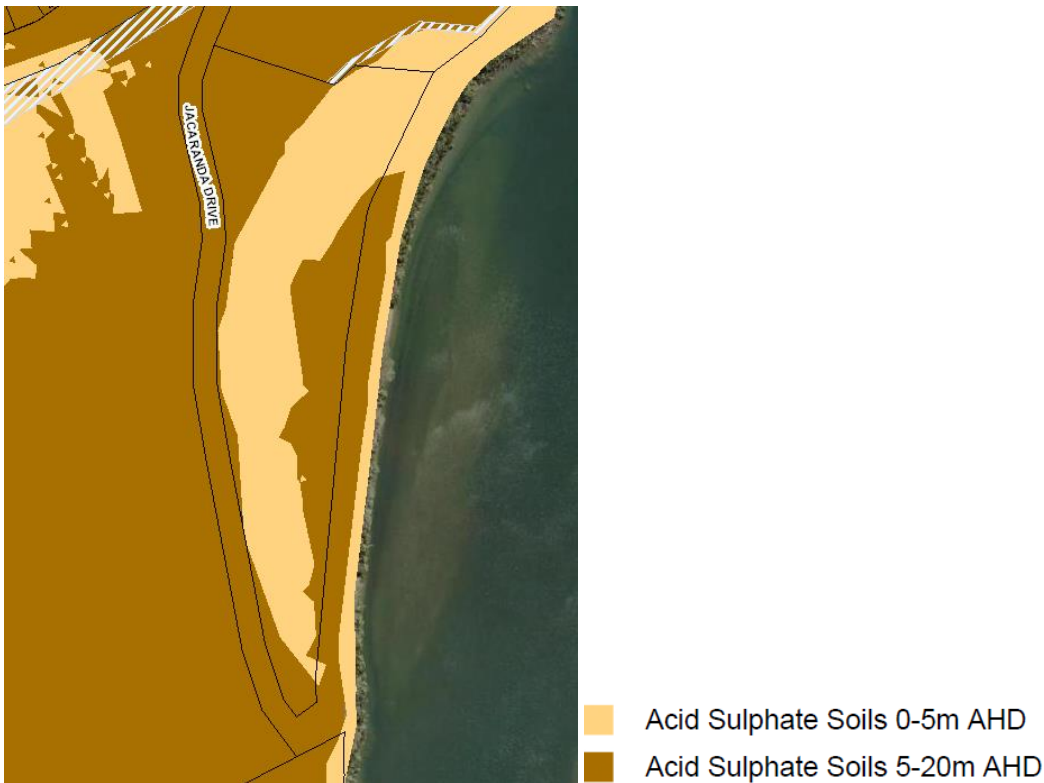
The site is mapped as including land at 0-5 metres AHD and 5-20 metres AHD which may contain Acid Sulphate Soils (ASS), as shown in **Figure 5-3**.

Figure 5-3 Acid Sulphate Soils Overlay mapping (Extract)

Section 5.10.1 of this report identifies the manner in which ASS Overlay mapping applies to the site. The site is mapped as including land at 0-5 metres AHD and 5-20 metres AHD which may contain Acid Sulphate Soils (ASS), as shown in **Figure 5-3**.

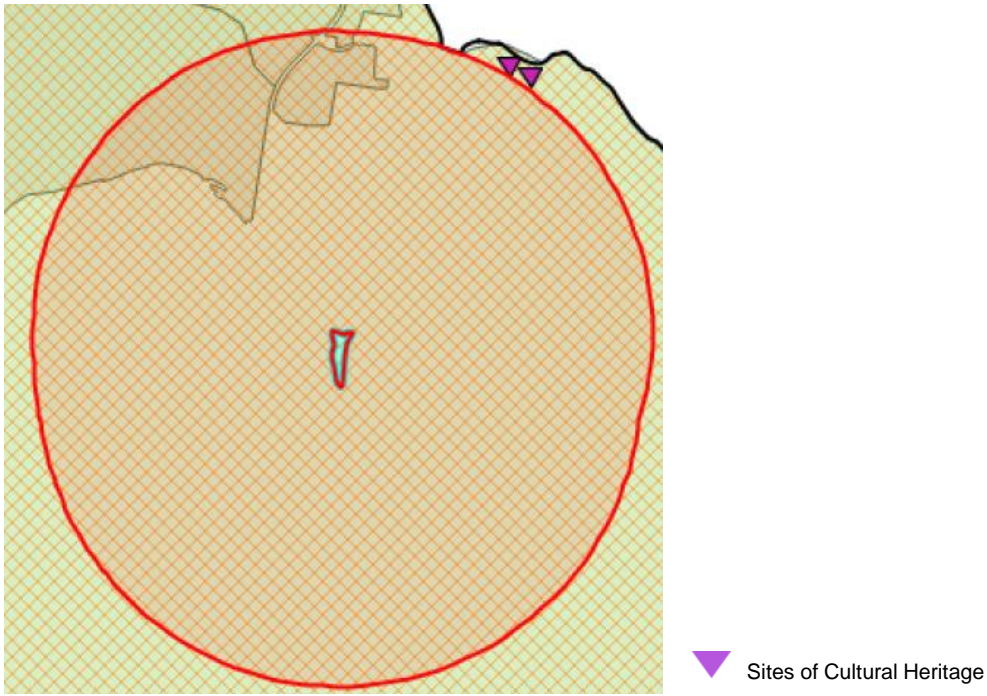
The Cultural Heritage Database and Register desktop search indicates that two cultural heritage artefacts points have been recorded within the search area, being shell middens along the east coast, as shown in **Figure 5-5**.

Figure 5-5 Cultural Heritage mapping (Extract)

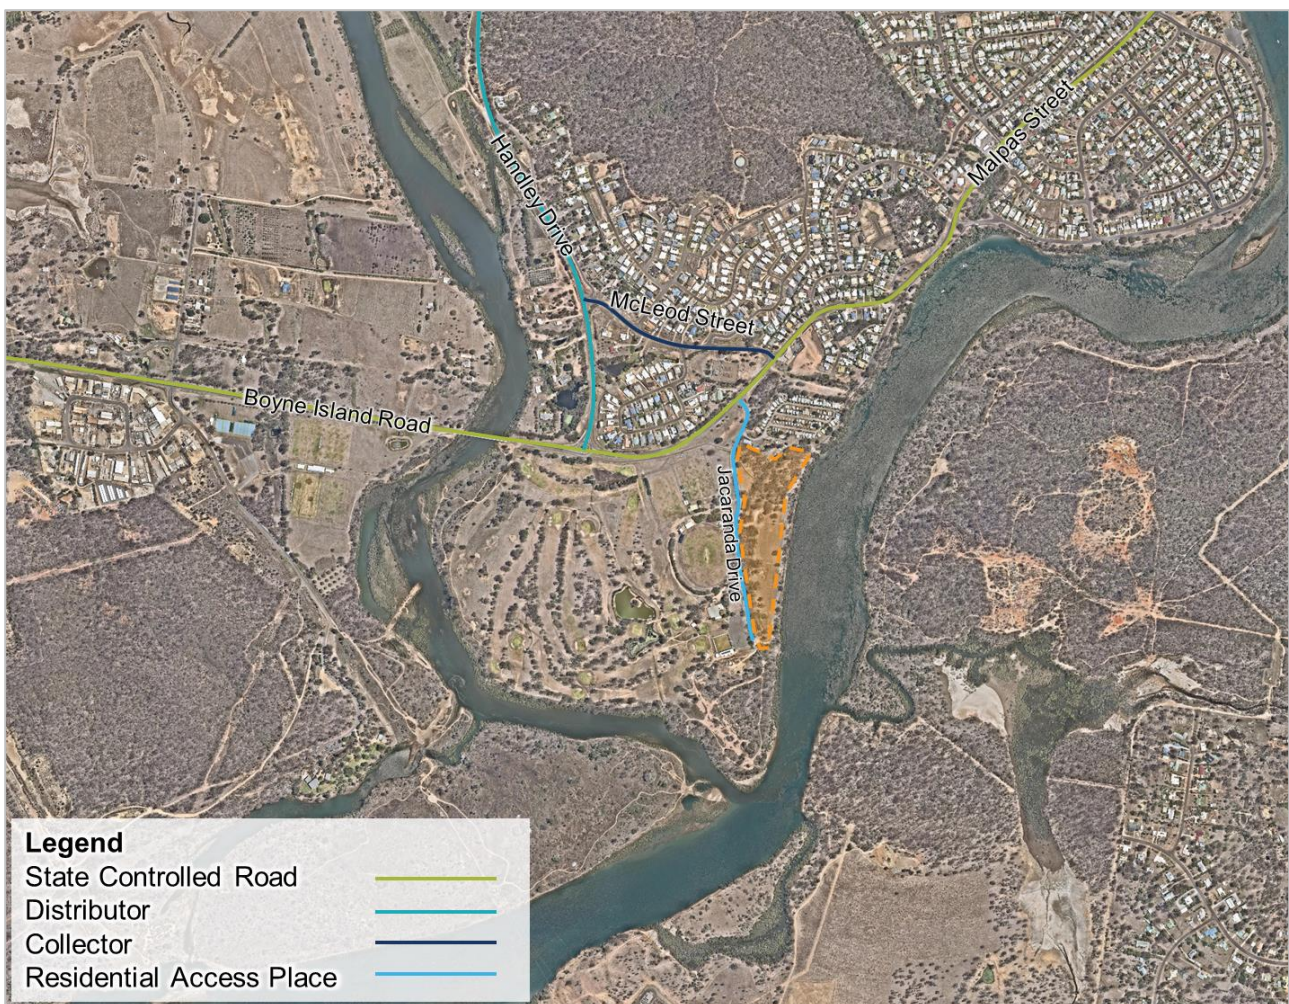
Figure 6-1 Local site context and road hierarchy
 Note the site boundary is indicative only. Source: Nearmap.

Figure 6-1 illustrates the local context of the site, where **Figure 6-2** illustrates the broader road network in the vicinity of the site, highlighting Council’s Local Government Infrastructure Plan (LGIP) trunk works.

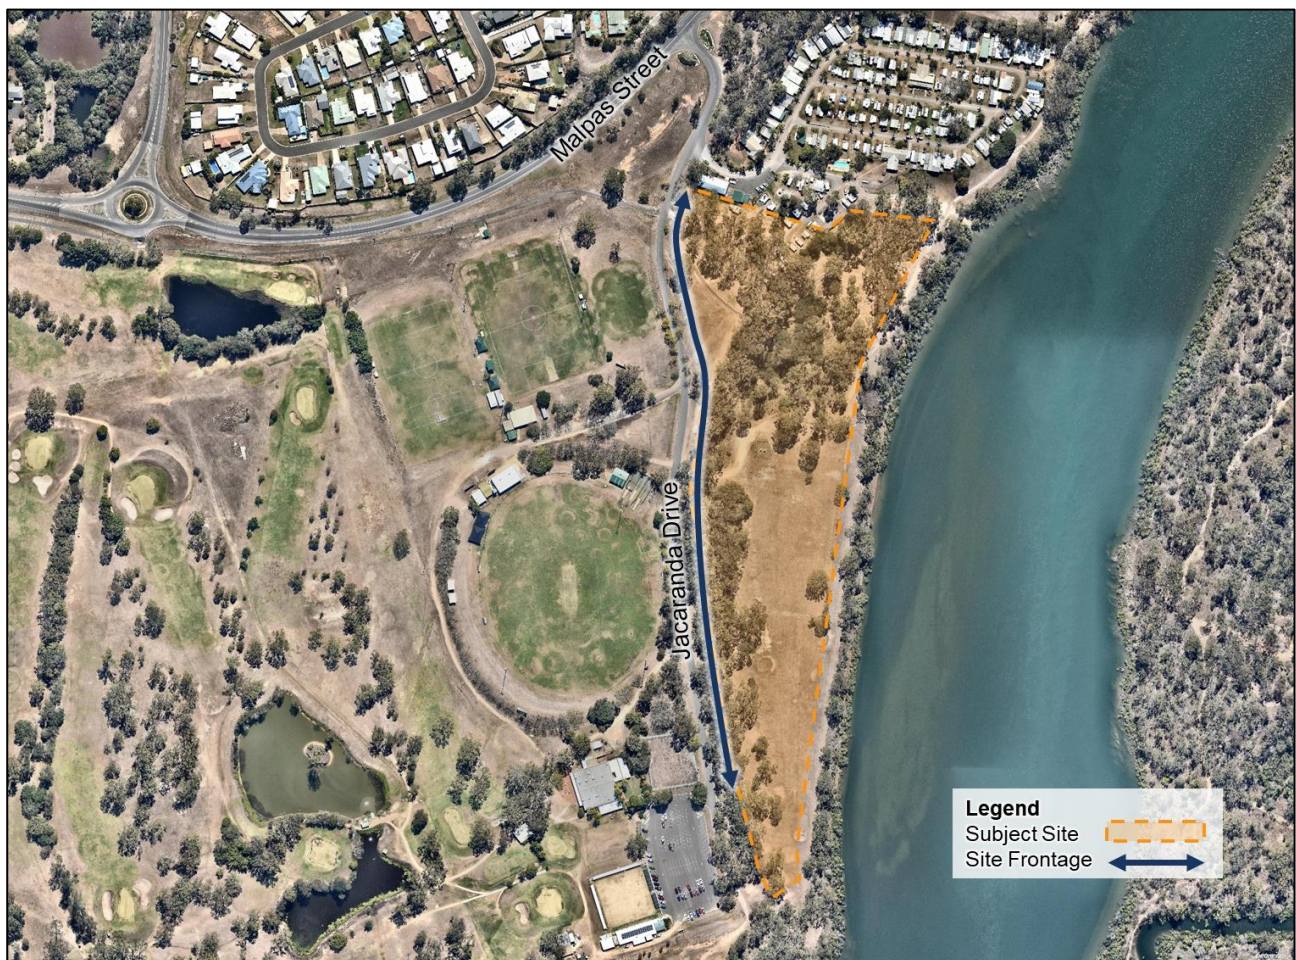
Figure 6-4 Site Frontage

As shown in **Figure 6-4**, the site has direct road frontage to Jacaranda Drive along its western boundary, with no existing driveways that provide vehicular access to the site.

With direct frontage to only one road, primary vehicular access will have to be achieved via Jacaranda Drive via new driveway crossovers. Given the length of road frontage, there is potential for multiple access points, ensuring adequate sight distance and intersection spacing is achieved, as outlined below.

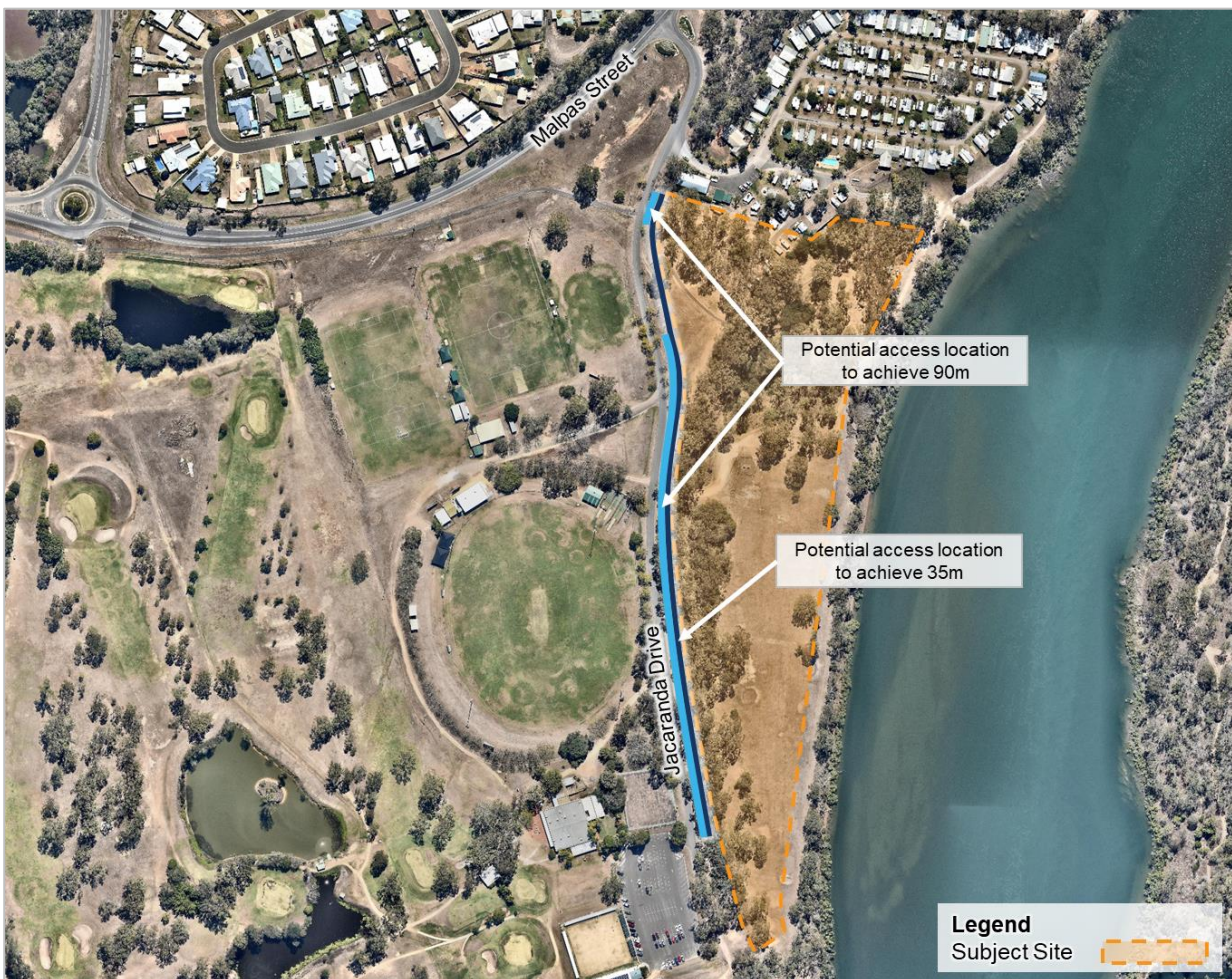
Figure 6-5 Potential access location to achieve sight distance
 Note the site boundary is indicative only. Source: Nearmap.

Figure 6-5 illustrates the preferred locations for the site to gain access, highlighting which locations will achieve 35 metres and 90 metres sight distance.

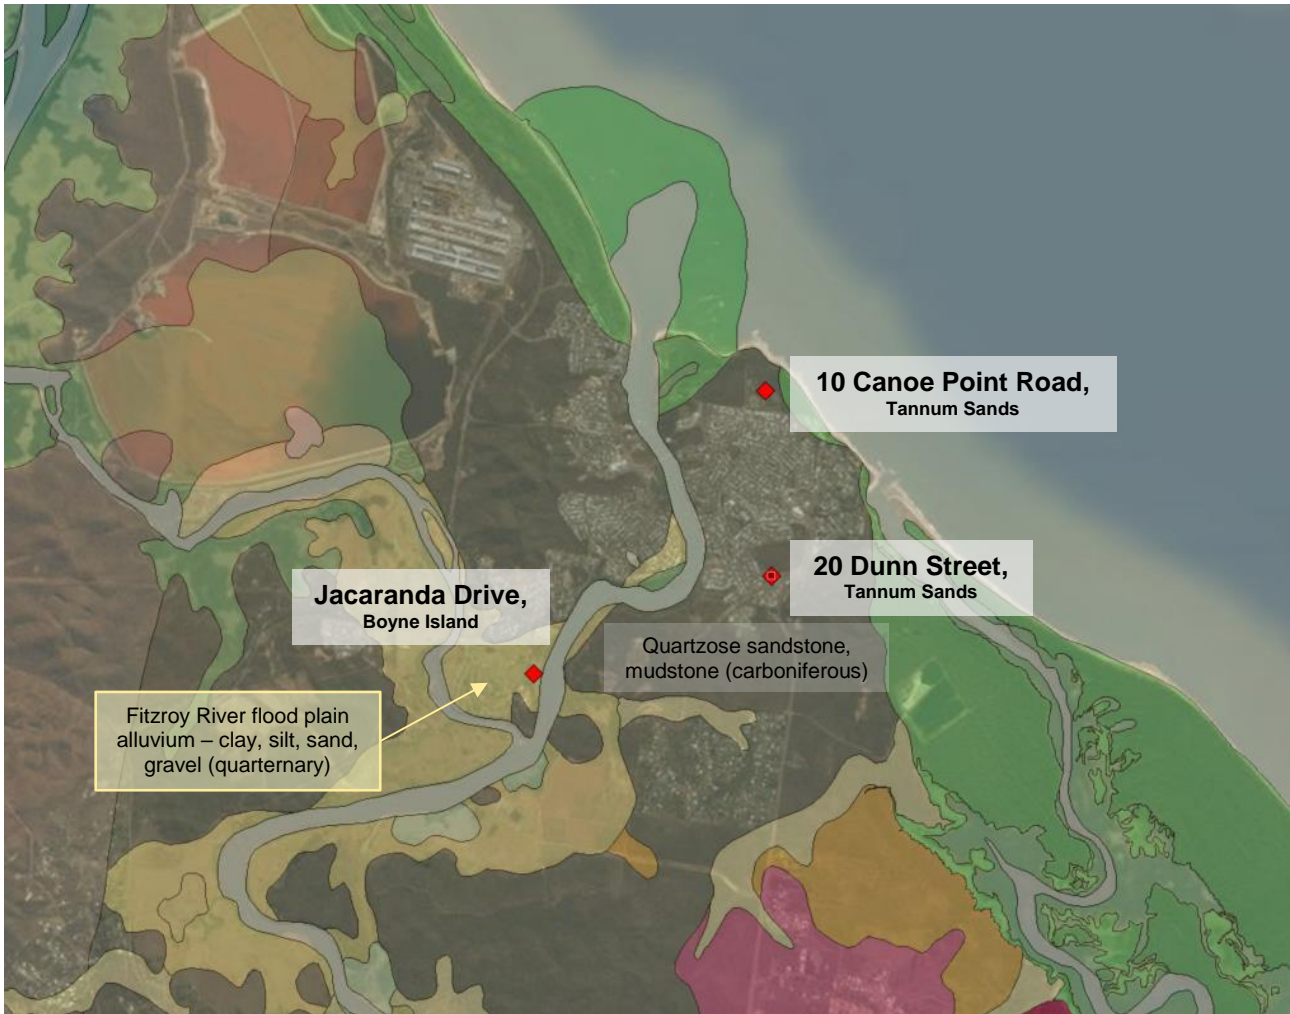
Figure 7-1 Regional Geology of Boyne Island and Tannum Sands (source MapInfo, Bing Maps)

The site is comprised of Quaternary aged clays, silts and gravels of the Fitzroy River flood plain alluvium. This is likely overlying Early Carboniferous residual soils and weathered rock, primarily recovered as clays, gravels and sands from the Shoalwater Formation, part of the Curtis Island Group. Additionally, quartzose sandstone, mudstone and localised quartz-muscovite-biotite schists are likely the likely bedrock material (sourced from MapInfo). **Figure 7-1** shows the regional geology with approximate locations of the three (3) potential aquatic centre sites shown in red.

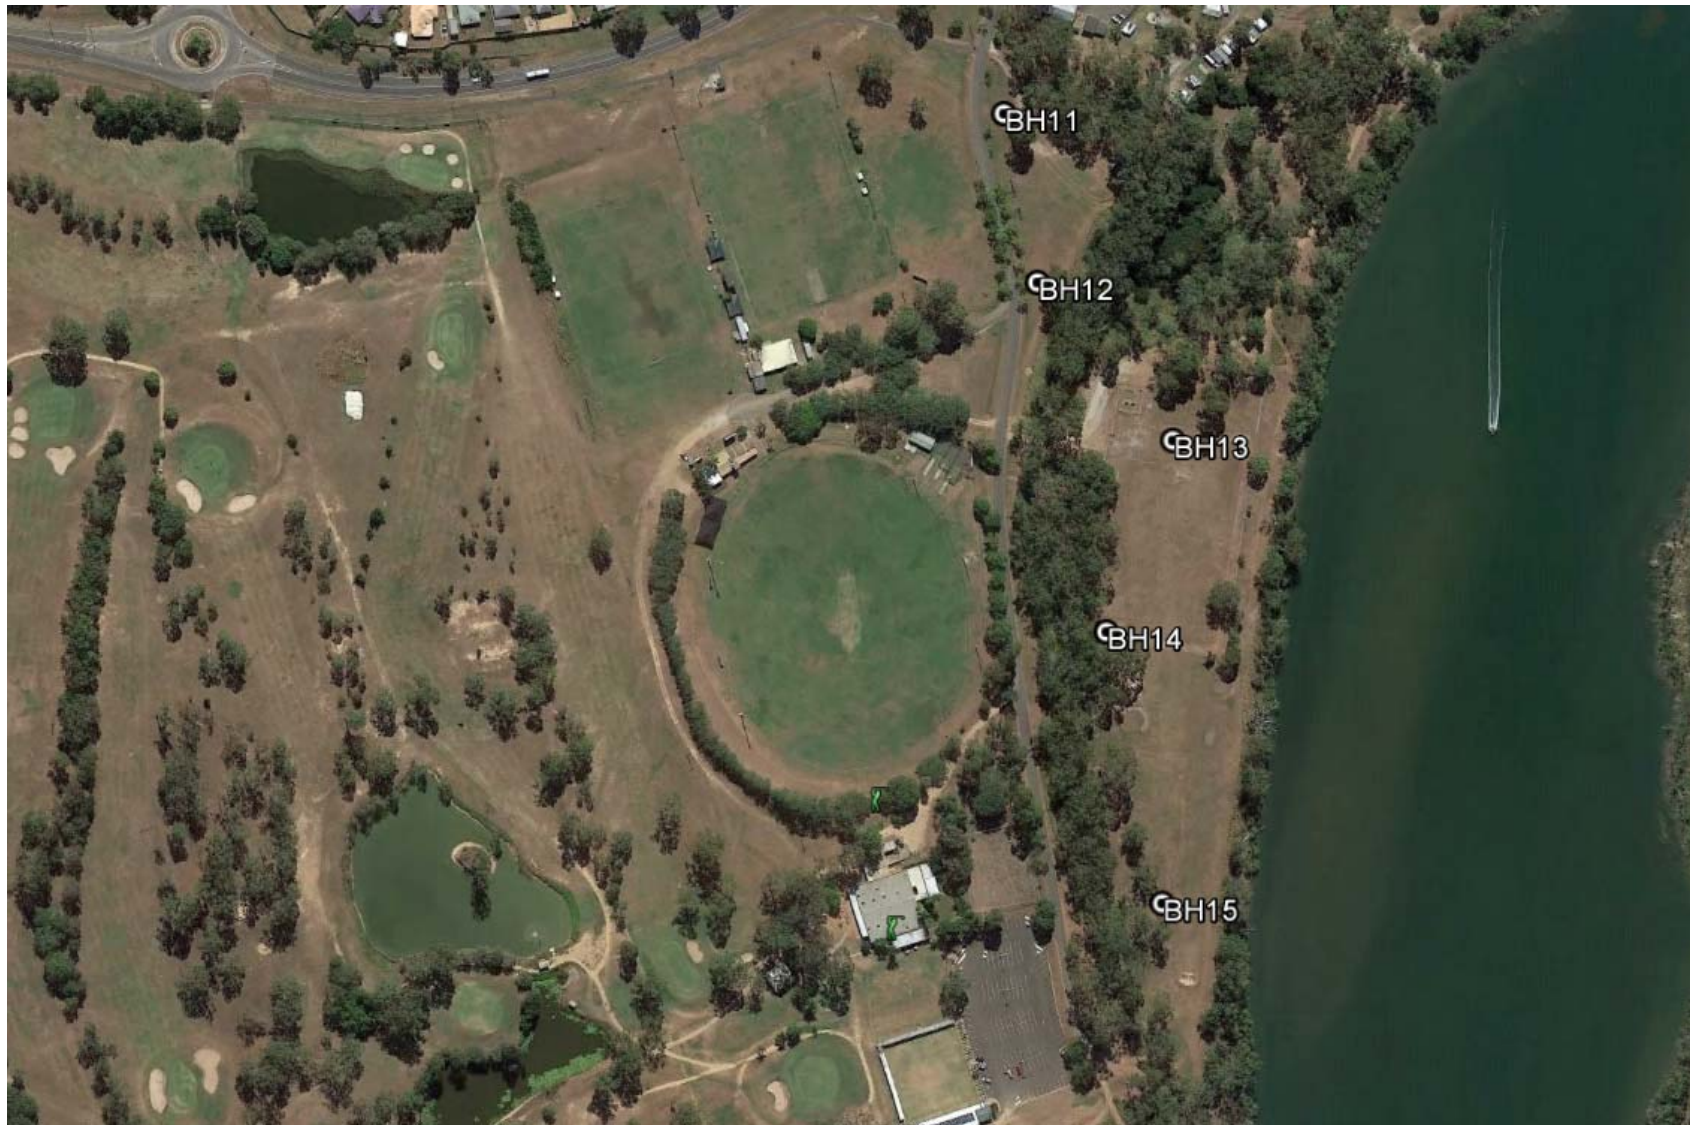
Proposed Boyne Tannum Aquatic Centre (Location 3) – Jacaranda Drive

Enc: Site Plan, Borehole Logs, Laboratory Test Results

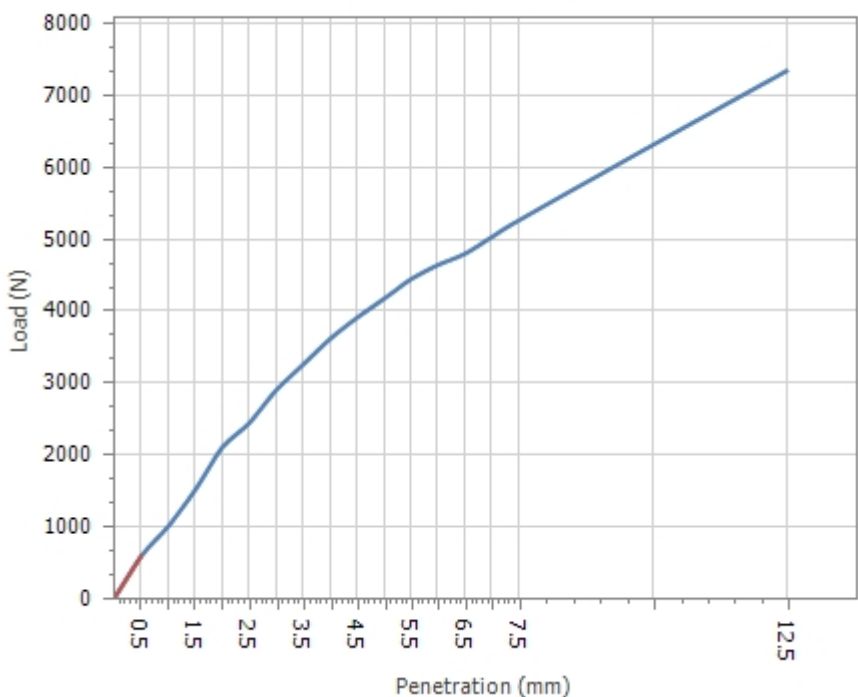
Maximum Dry Density (t/m ³):	1.78																																										
Optimum Moisture Content (%):	11.0																																										
Field Moisture Content (%):	4.6																																										
Sample Percent Oversize (%):	0.0																																										
Oversize Included / Excluded	Excluded																																										
Target Density Ratio (%):	100																																										
Target Moisture Ratio (%):	100																																										
Placement Dry Density (t/m ³):	1.77																																										
Placement Dry Density Ratio (%):	99.5																																										
Placement Moisture Content (%):	11.2																																										
Placement Moisture Ratio (%):	103.0																																										
Test Condition / Soaking Period:	Soaked / 4 Days																																										
CBR Surcharge (kg)	4.5																																										
Dry Density After Soak (t/m ³):	1.77																																										
Total Curing Time (hrs)	19																																										
Liquid Limit Method	Estimation																																										
Moisture (top 30mm) After Soak (%)	15.6																																										
Moisture (remainder) After Soak (%)	15.0																																										
CBR Swell (%):	0.0																																										
Minimum CBR Specification (%):	-																																										
CBR Value @ 5.0mm (%):	20

The pavement subgrade is likely to be in the alluvium soil profile where a CBR of 17% and 20% were found in the BH12 and BH15 samples, respectively. The CBR of the soil across the site is likely to be in excess of CBR 10%. A design subgrade of 10% may be adopted for preliminary pavement design.

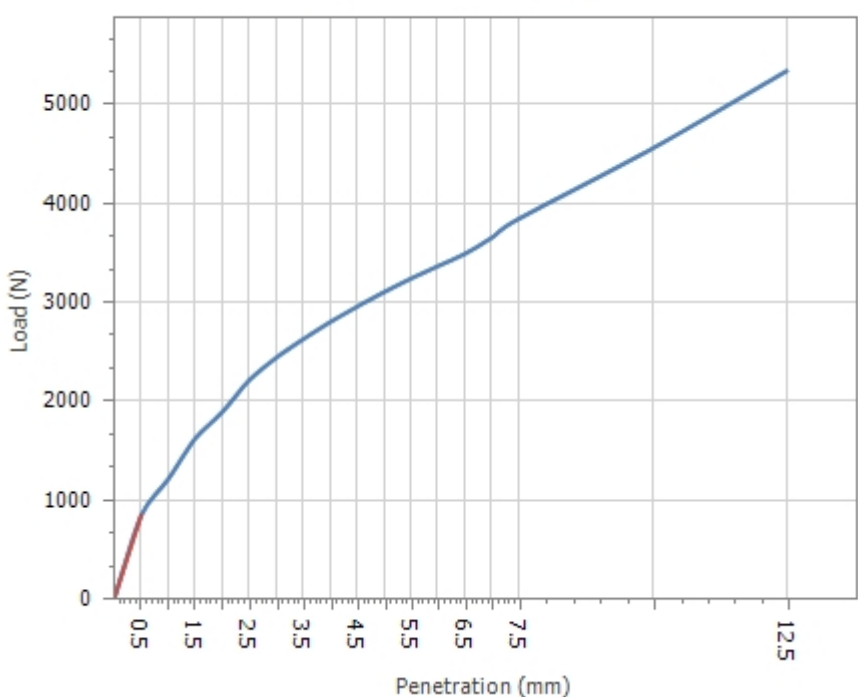
Maximum Dry Density (t/m ³):	1.74																																										
Optimum Moisture Content (%):	10.5																																										
Field Moisture Content (%):	4.5																																										
Sample Percent Oversize (%):	0.0																																										
Oversize Included / Excluded	Excluded																																										
Target Density Ratio (%):	100																																										
Target Moisture Ratio (%):	100																																										
Placement Dry Density (t/m ³):	1.74																																										
Placement Dry Density Ratio (%):	99.5																																										
Placement Moisture Content (%):	10.9																																										
Placement Moisture Ratio (%):	103.0																																										
Test Condition / Soaking Period:	Soaked / 4 Days																																										
CBR Surcharge (kg)	4.5																																										
Dry Density After Soak (t/m ³):	1.73																																										
Total Curing Time (hrs)	n/a																																										
Liquid Limit Method	Estimation																																										
Moisture (top 30mm) After Soak (%)	15.2																																										
Moisture (remainder) After Soak (%)	16.1																																										
CBR Swell (%):	0.0																																										
Minimum CBR Specification (%):	-																																										
CBR Value @ 2.5mm (%):	17
