PROJECT TITLE
BOYNE BURNETT INLAND
RAIL TRAIL
CONCEPT DESIGN
BULLYAN TO KALPOWAR

CLIENT
GLADSTONE
REGIONAL COUNCIL

BOYNE BURNETT INLAND
RAIL TRAIL
Project Masterplan

Boyne Burnett Inland Rail Trail - Project Masterplan

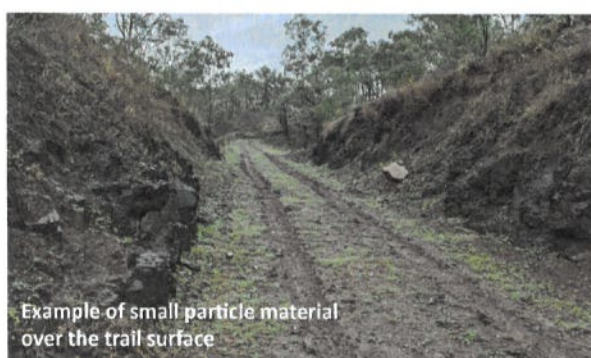
Trail Surface Treatment Type 4

- Mechanical removal of surface vegetation to 3.5m width
- Spraying out vegetation to stop it growing back through the trail surface to 3.5m width.
- Grading the surface to remove large rocks and detritus to 3.5m width.
- Lightly rolling the surface to compact the existing gravel profile to 3.5m width.
- Add 200mm depth of locally sourced crushed stone to the surface, 100mm of CBR 80 material; over 100mm of CBR 35 material (to 2.5m width).
- Add 1m wide of 200mm depth of locally sourced crushed stone to the surface, 100mm of finely graded stone over (CBR 80), 100mm of coarsely graded stone (CBR 35) to create the bridle trail.
- Trim, shape and compact.
- Apply two-coat spray seal system (to 2.5m width only).

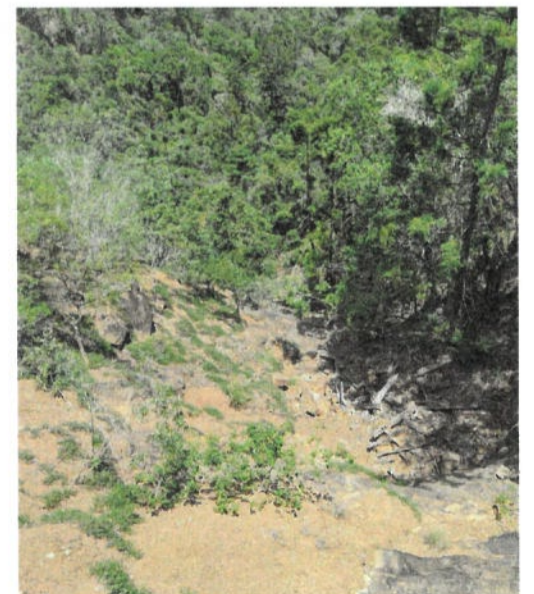
Typical steep embankments around existing retaining structure

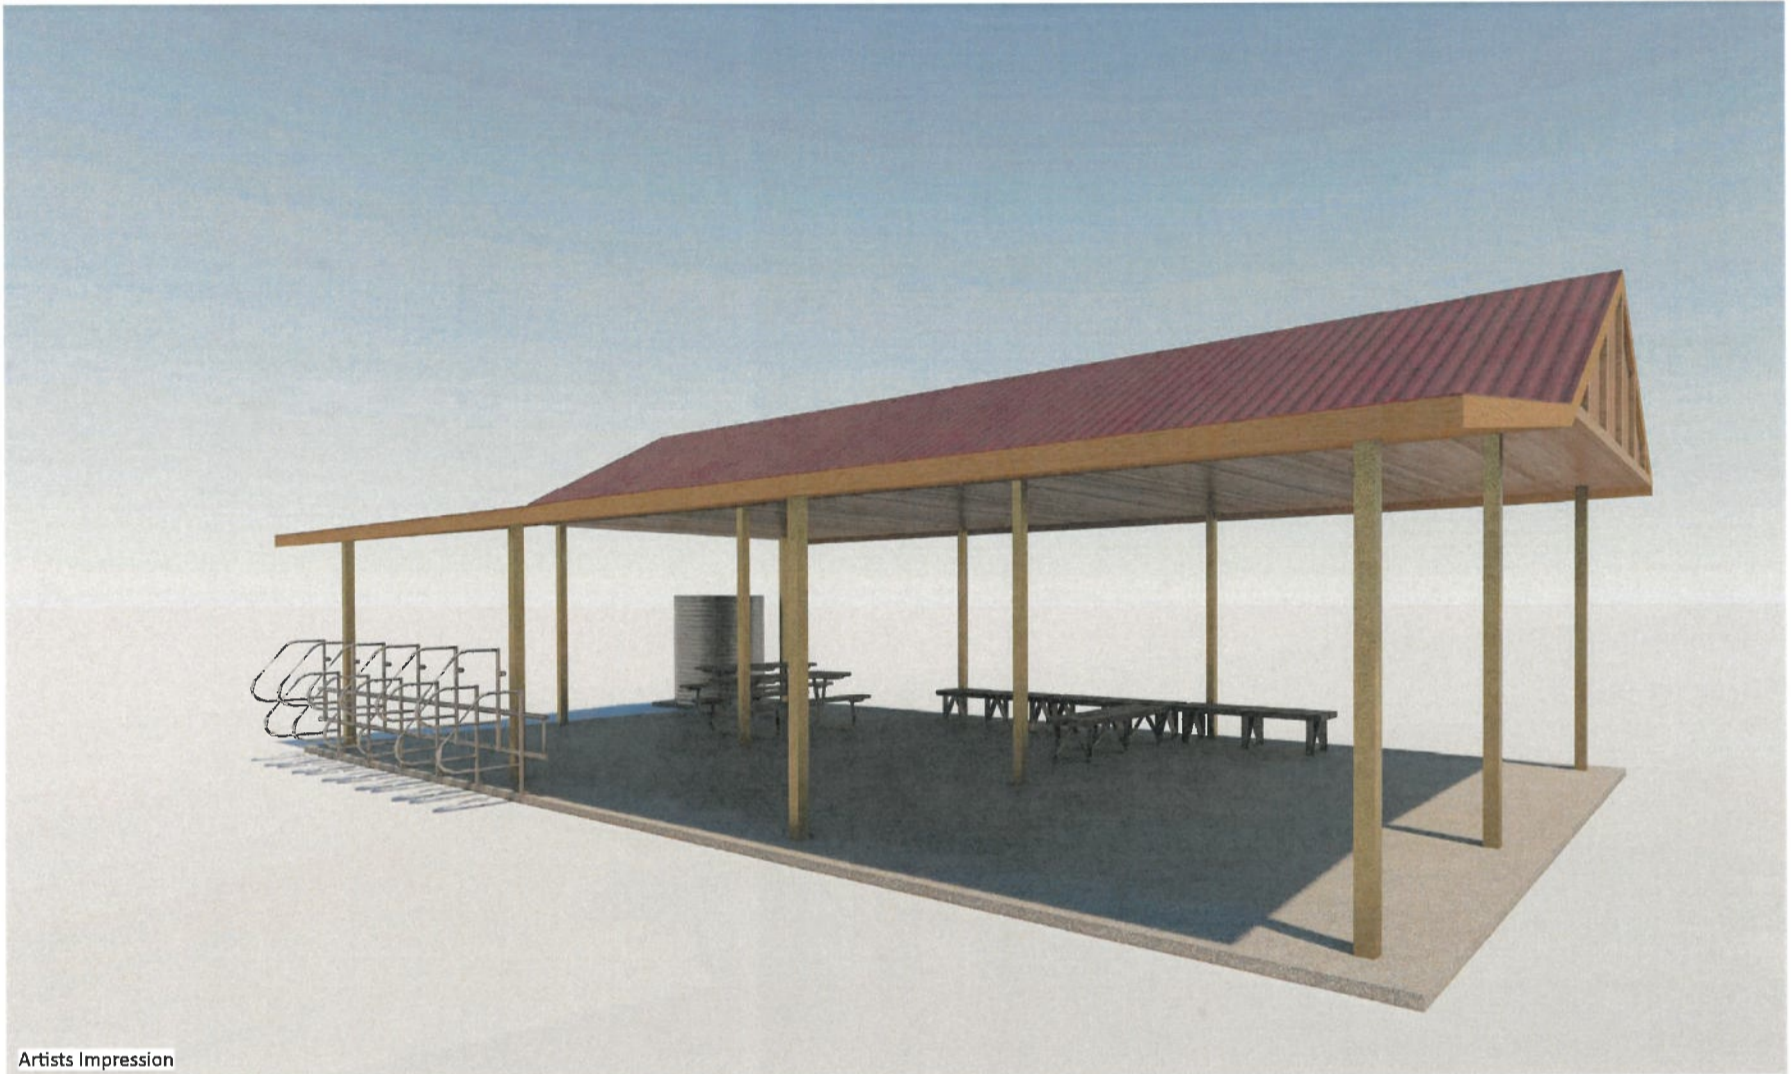
Detail - Shelter - Station House Shelter

- ① **FRAME:** Lightweight Galvanised SHS steel Frame.
Finish: White powder coat finish to all exposed framing
- ② **ROOF:** Lightweight Steel Frame
"QR" Red colourbond sheeting
- ③ **WATER TANK:** 5000L Galvanised water tank with tap outlet
- "NOT POTABLE" Sign
All roof water to be captured for reuse.

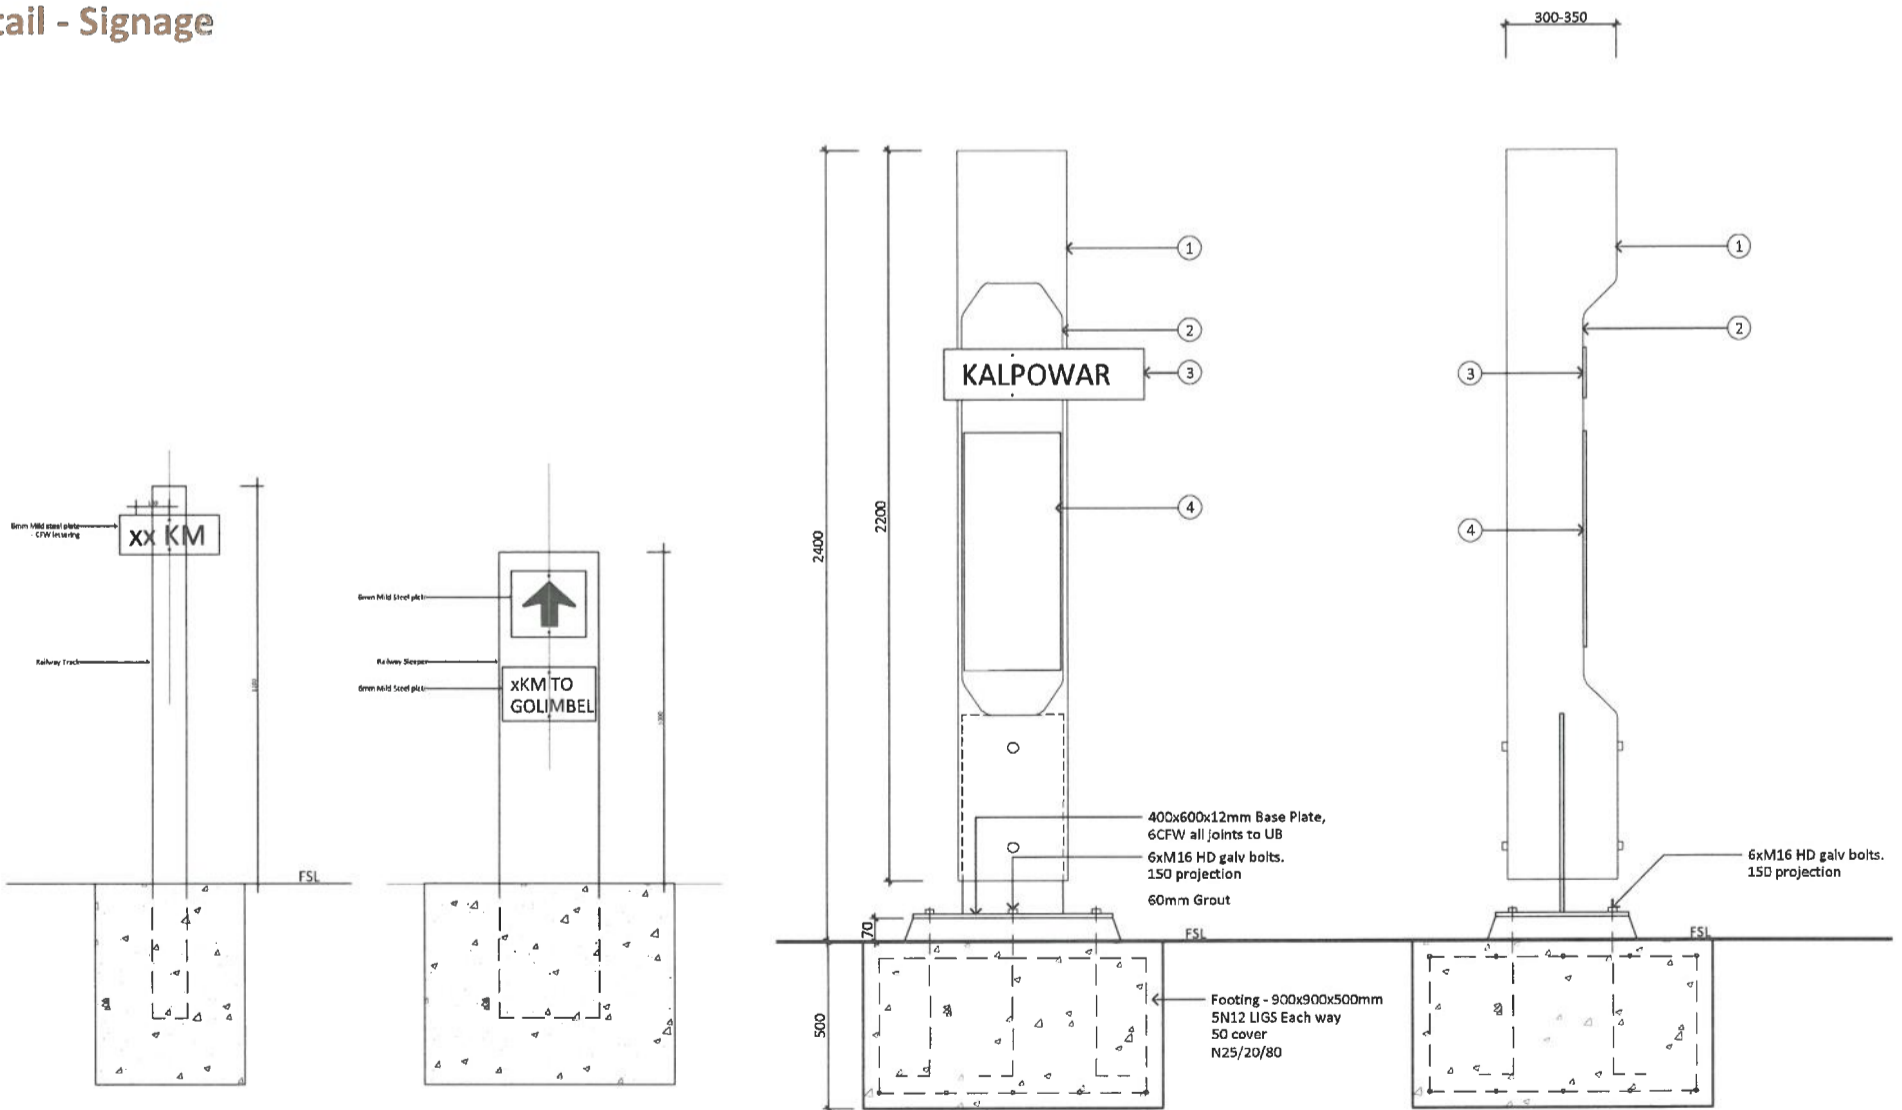
Detail - Signage

- ① **TIMBER POST - ROUND:** Ironbark Bush Pole, 300-350mm diameter fixed to frame with 4 M16 4.6/5 Bolts.
(2 top, 2 bottom)
Finish: Wire brushed and Light Sanded finish. No Oil to achieve "aged" look
- ② **ROUTED 'HOG BACK' STYLE CAVITY:**
- ③ **LOCATION SIGN:**
One for each town. To both sides of sign.
Lettering: 3mm, Laser cut, Powder-coated Aluminium plate mounted on the backing plate to sizes shown on details. Colour: TBC
Backing Plate: 3mm Galv. Steel Plate to sizes shown on details.
Fixed to Timber Sleepers with vandal proof screws
- ④ **SIGNAGE PLATE:**
600x420mm (A2 Paper size) signage panel
- Artwork and materials TBC
Fixed to Timber Sleepers with vandal proof screws
