FINAL REPORT:

Turkey Beach Shoreline Erosion Management Plan (SEMP)

April 2020

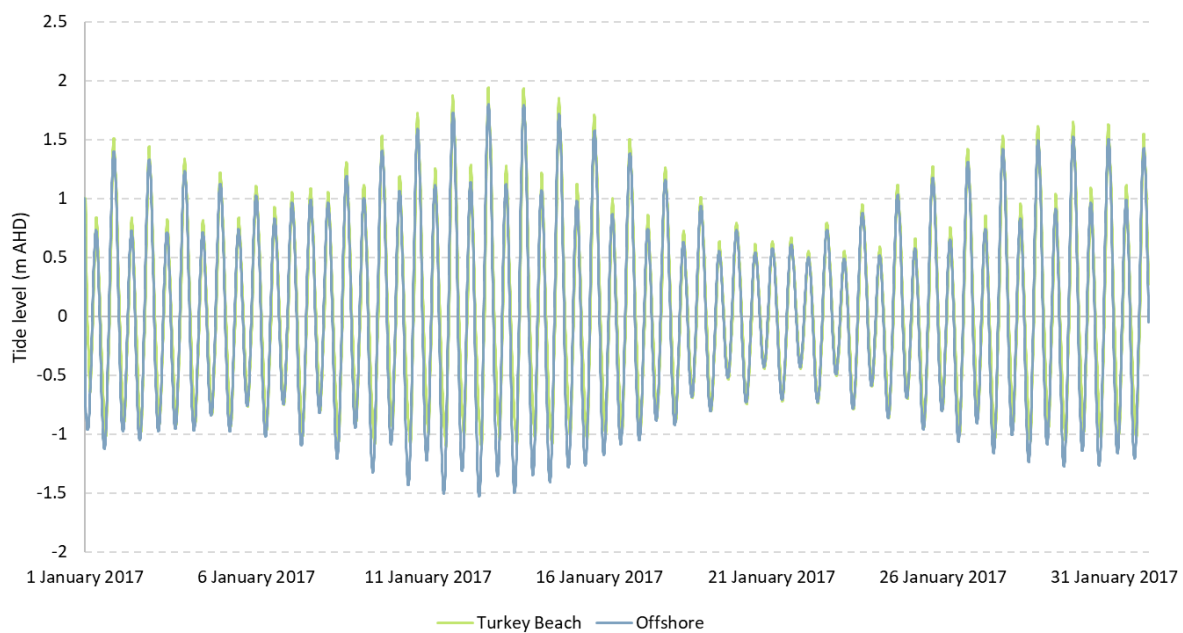
Turkey Beach experiences a semi-diurnal, macro-tidal signature (Figure 6). The tidal plane at the open coastline is found to increase as it propagates across Rodds Bay, with tide levels at Turkey Beach being approximately 0.15 m higher than the open ocean. Tidal planes at the closest tidal gauge, Pancake Creek, are shown in Figure 7. Pancake Creek is located approximately 12 km due east of Turkey Beach near the open coastline.

Figure 6. Tide level simulation within Rodd's Bay (simulated using a Delft3D numerical model, refer to Attachment B for model setup)

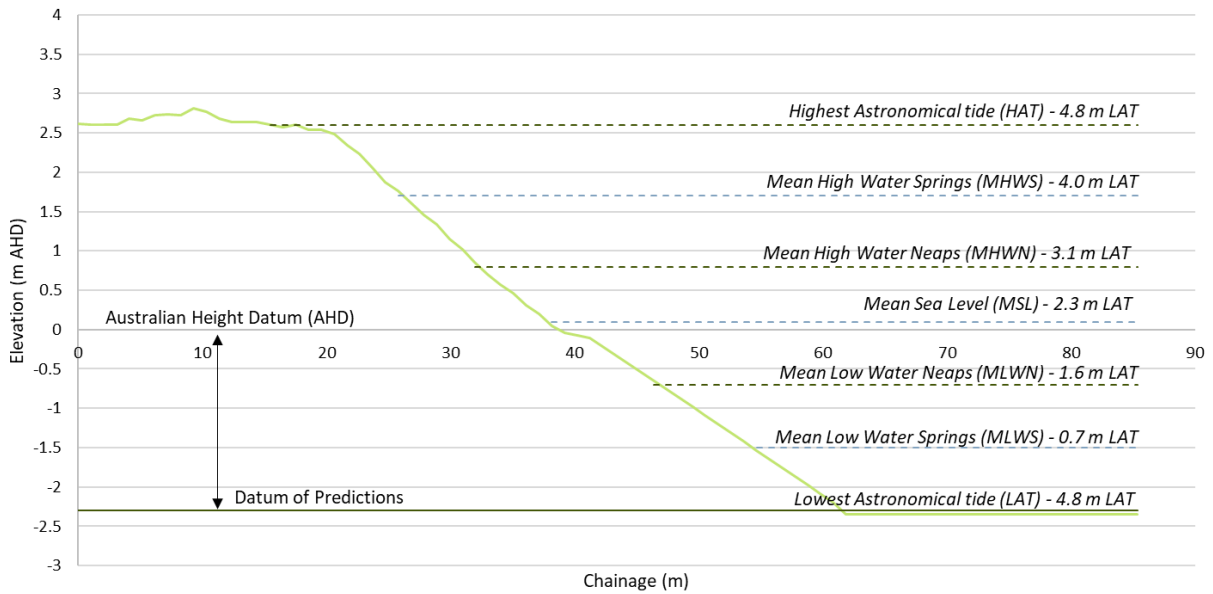
Figure 7. Tide conditions at Pancake Creek - tide levels shown in Australian Height Datum (AHD) with corresponding Lowest Astronomical Tide (LAT) levels labelled

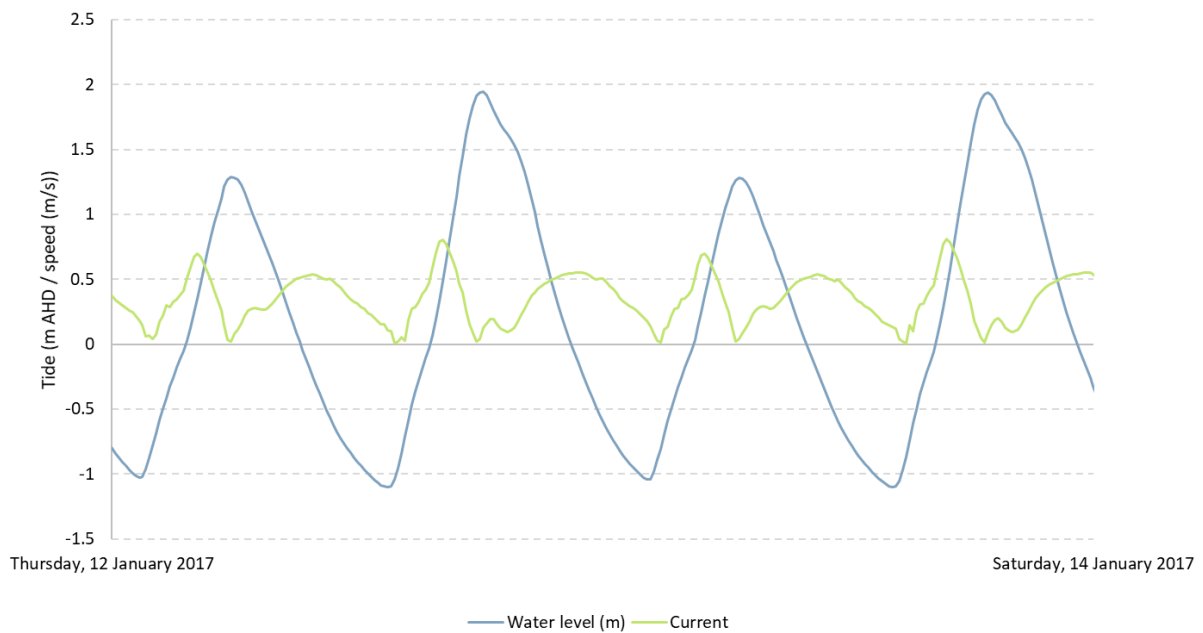
Tidal currents are typically stronger on the south-east flowing flood tide (rising tide) compared to the northward ebb currents (falling tide) (Figure 8). The flood tide currents can reach around 0.5 - 0.6 m/s during neap tides and increase to over 1 m/s during spring tides (Figure 9).

Figure 8. Tide/current relationship at Turkey Beach

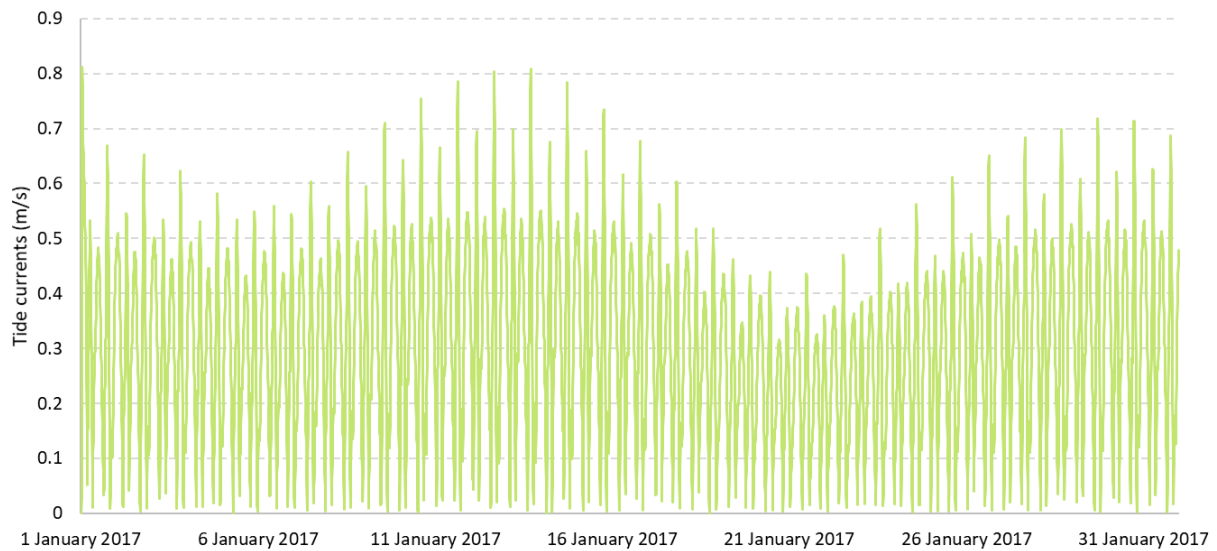
Figure 9. Modelled tidal currents within the channel to the east of Turkey Beach

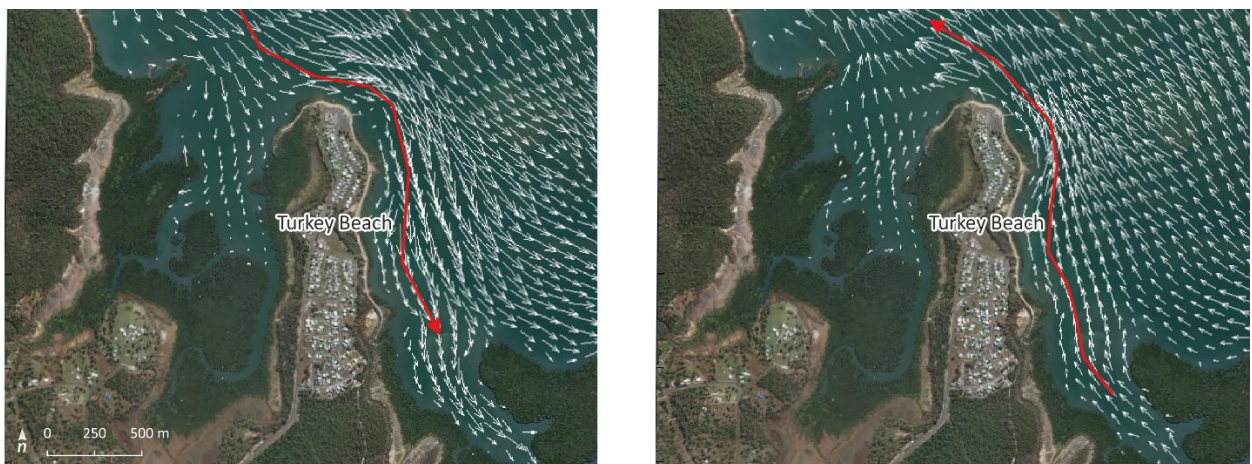
The northern beach (adjacent to the Esplanade) is prone to strong tidal currents in both directions, with the west and eastern shorelines being more sheltered from tidal currents.

Figure 10. Modelled tidal patterns around Turkey Beach showing peak flood-tide (Left) and ebb-tide (Right) (white arrows) and overall dominant direction (red arrows)

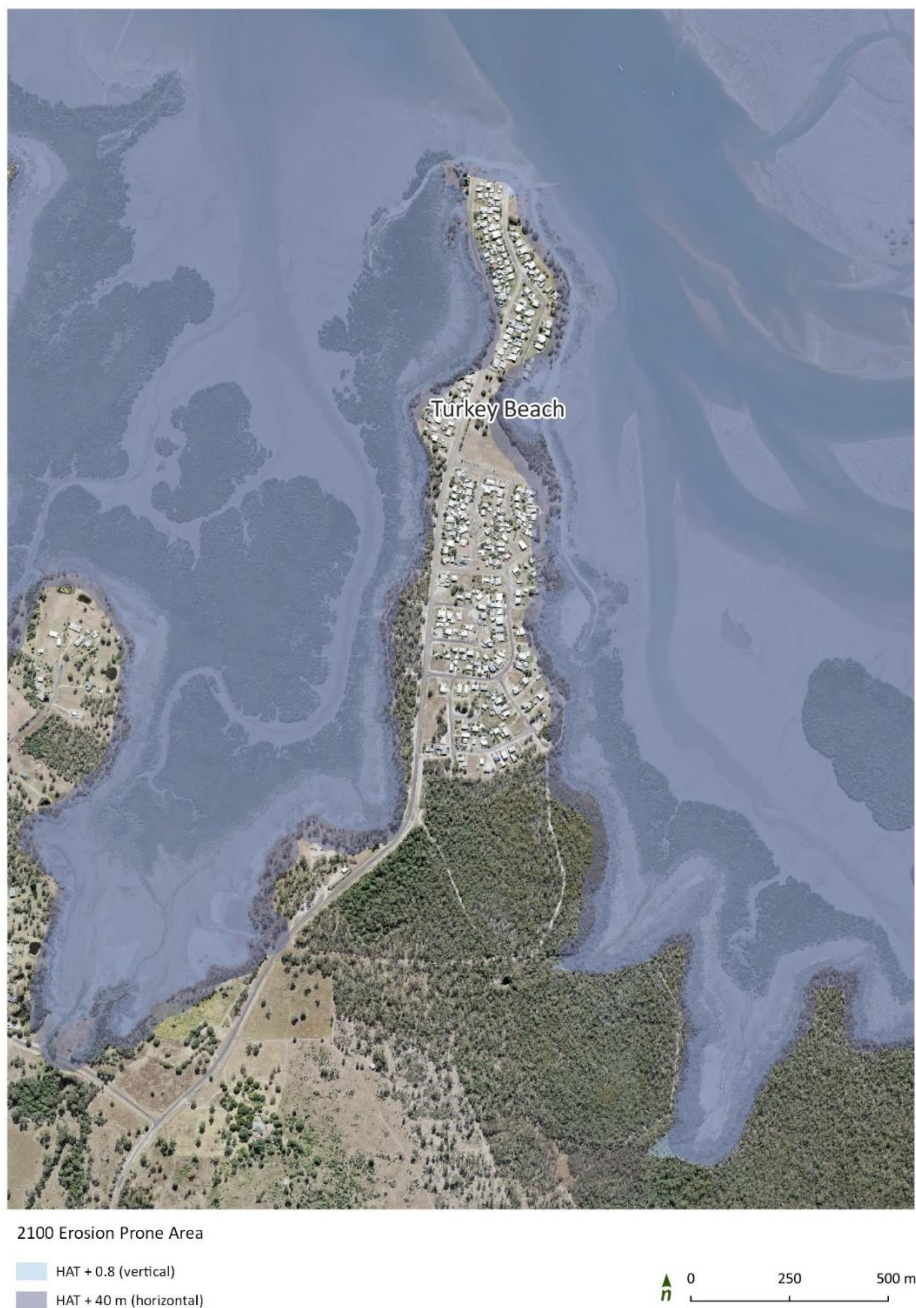
The EPA extent for the Turkey Beach peninsula includes areas likely to be exposed to tidal inundation by 2100, represented by the combined mapping of Highest Astronomical Tide (HAT) plus 0.8 m sea level rise, and a HAT plus 40 m (horizontal) default zone. The majority of the township is outside of the 2100 EPA, however the shorelines, open space areas and some limited residential areas on the margins are likely to be exposed to increasing tidal areas in the absence of intervention. Longer term adaptation options are considered in the Coastal Hazard Adaptation Strategy currently being developed by Council. For the SEMP process, the EPA assists to highlight areas that may be increasingly prone to the emerging coastal hazards from present day to 2100. Notable areas include the northern point and sections of the eastern shoreline (Figure 14).

Figure 14. State Erosion Prone Area

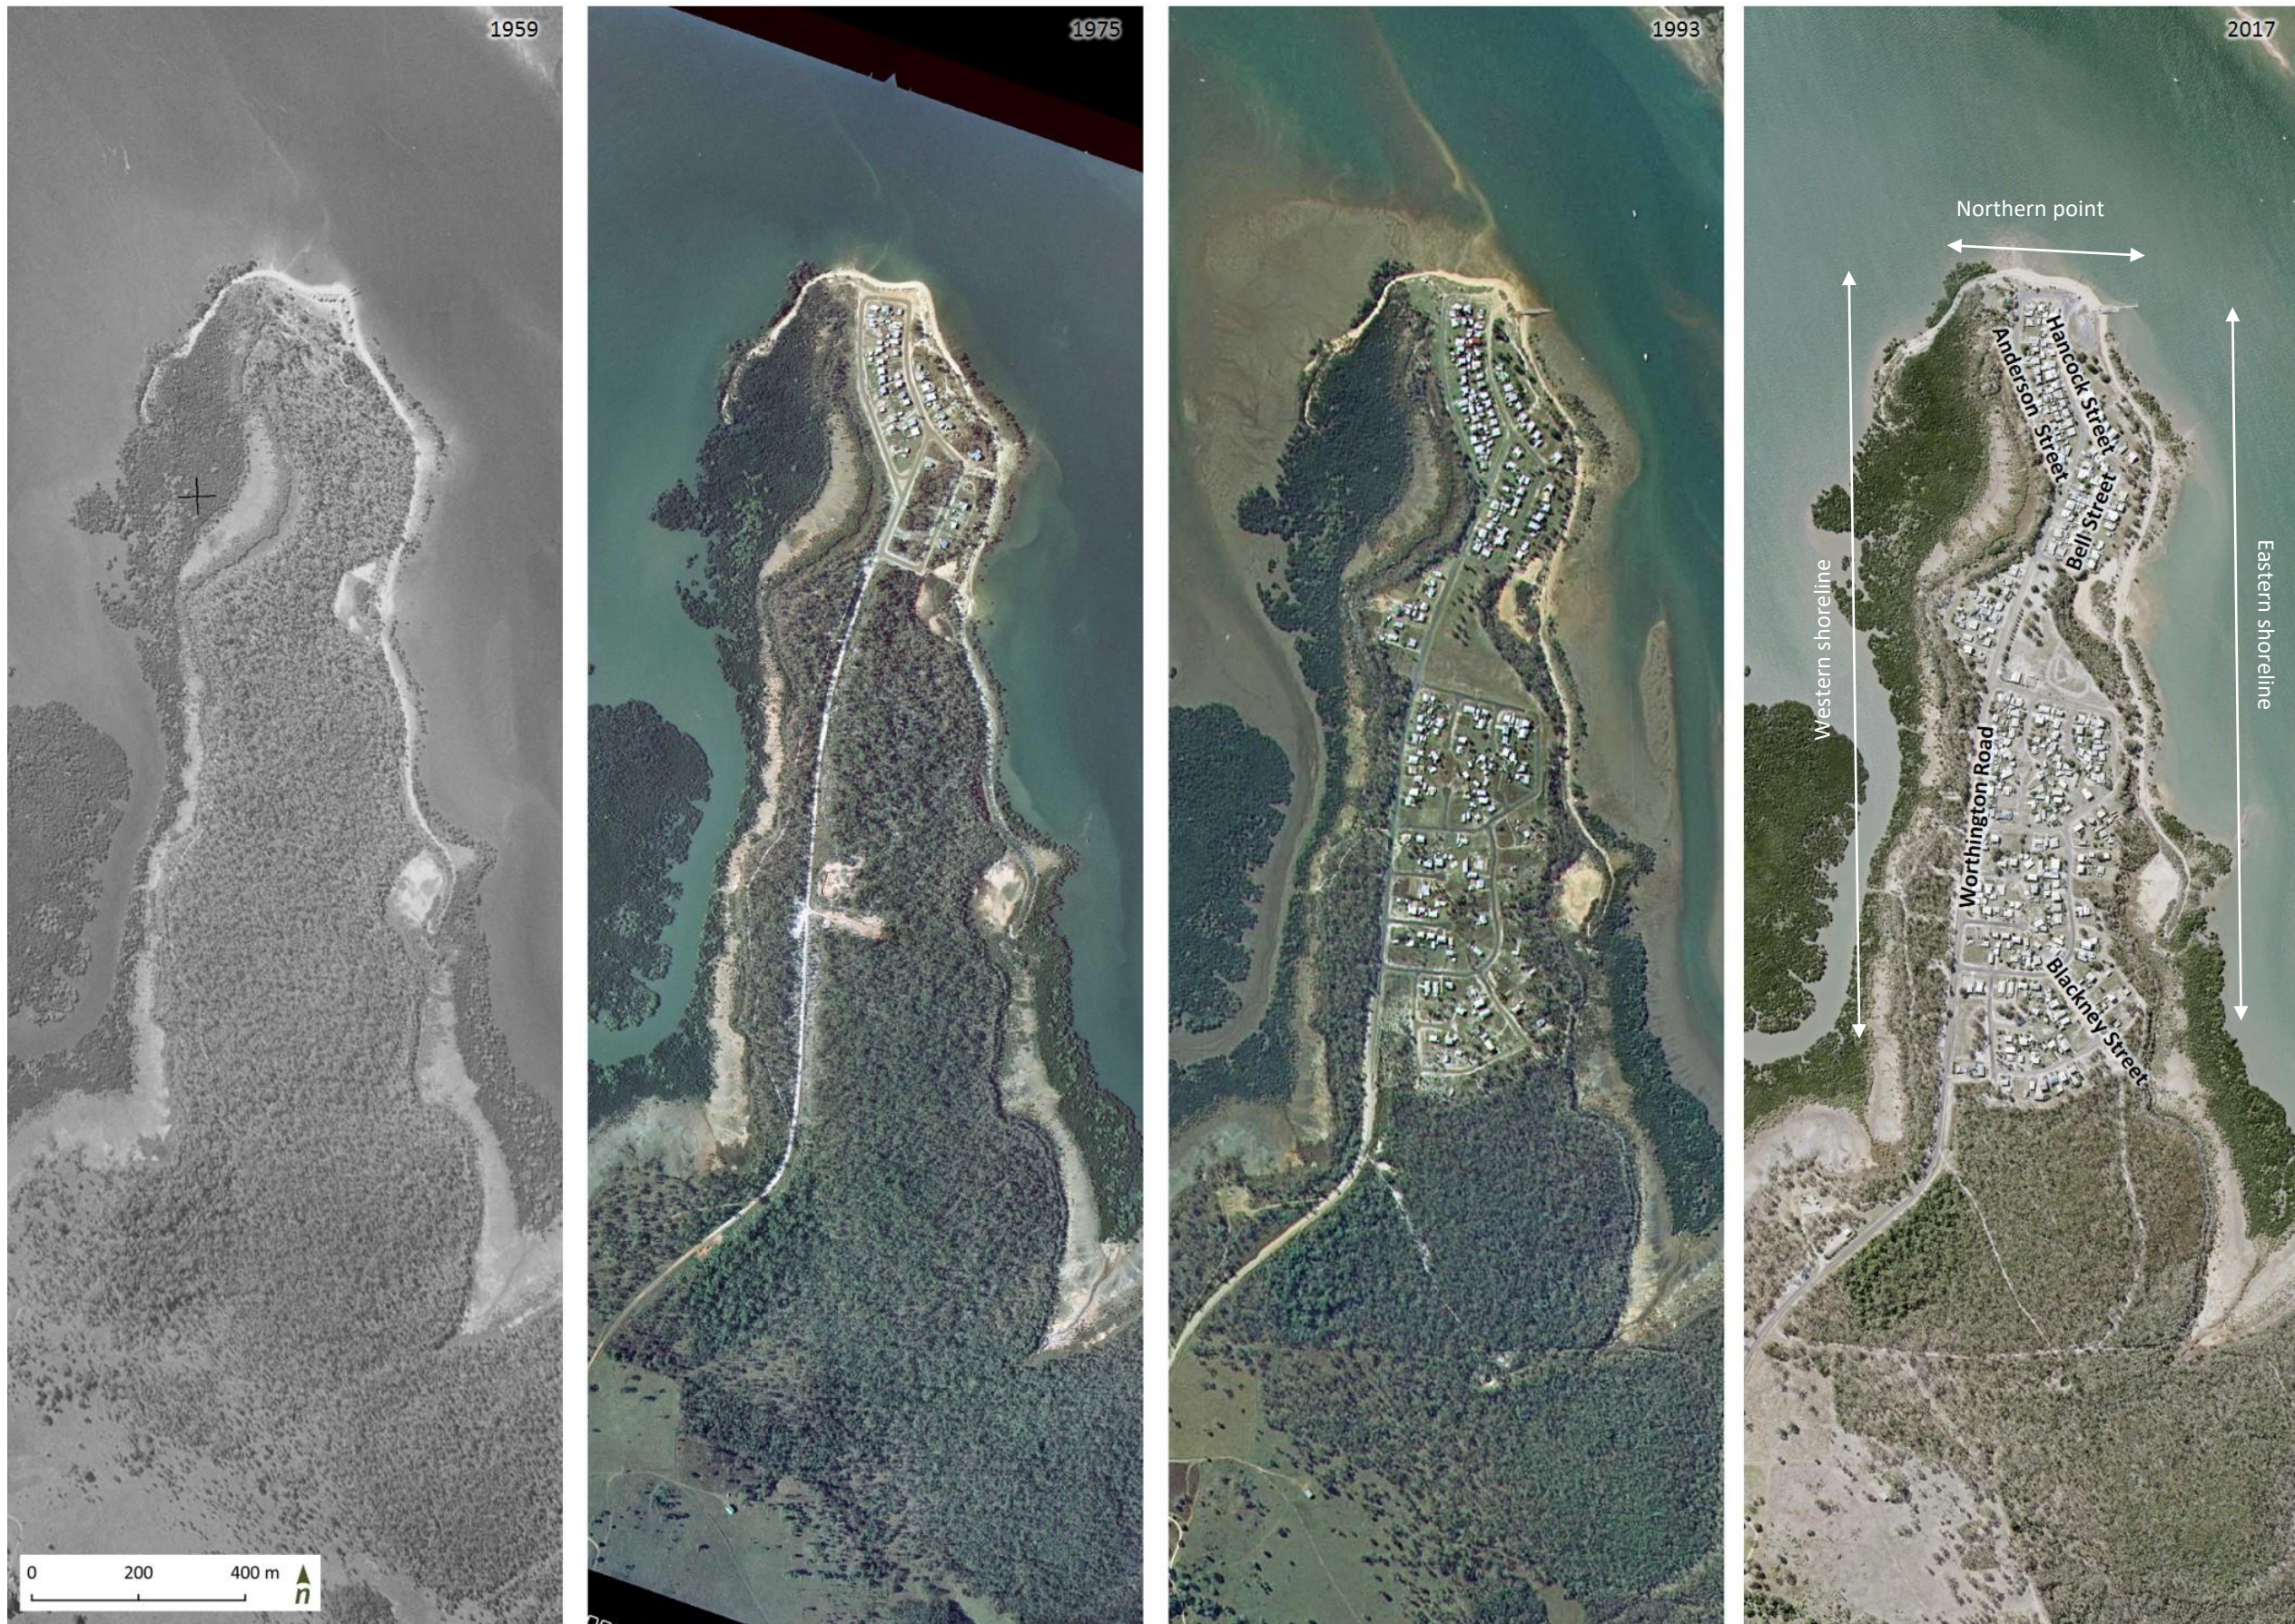
Figure 15. Historical aerial imagery (1959 to 2017)

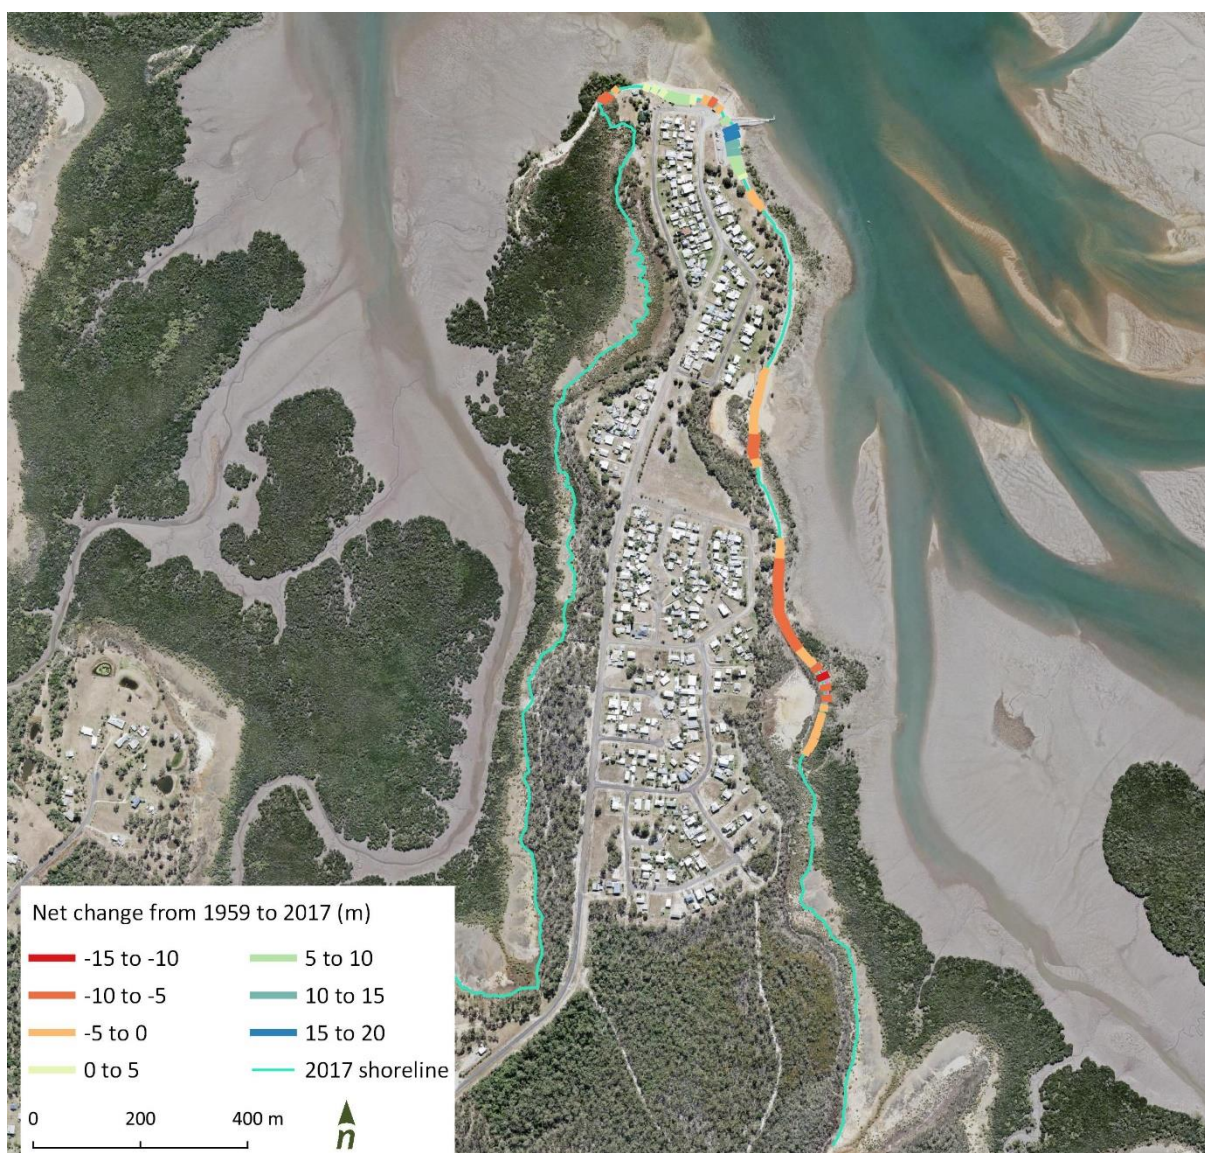
In areas that have experienced recession, the End Point Rate of change (over 1959 – 2017) is relatively low, in the order of 20 cm/yr. Linear Regression Rates of change are also relatively low, in the order of -0.2m to +0.3m per year. Attachment C provides additional detail on rates of change along the full Turkey Beach shoreline.

Figure 16. Net shoreline movement from 1959 to 2017 (m) – seaward accretion (+ change) or landward recession (-ve change) measured from transects spaced at 20 m intervals along the shoreline

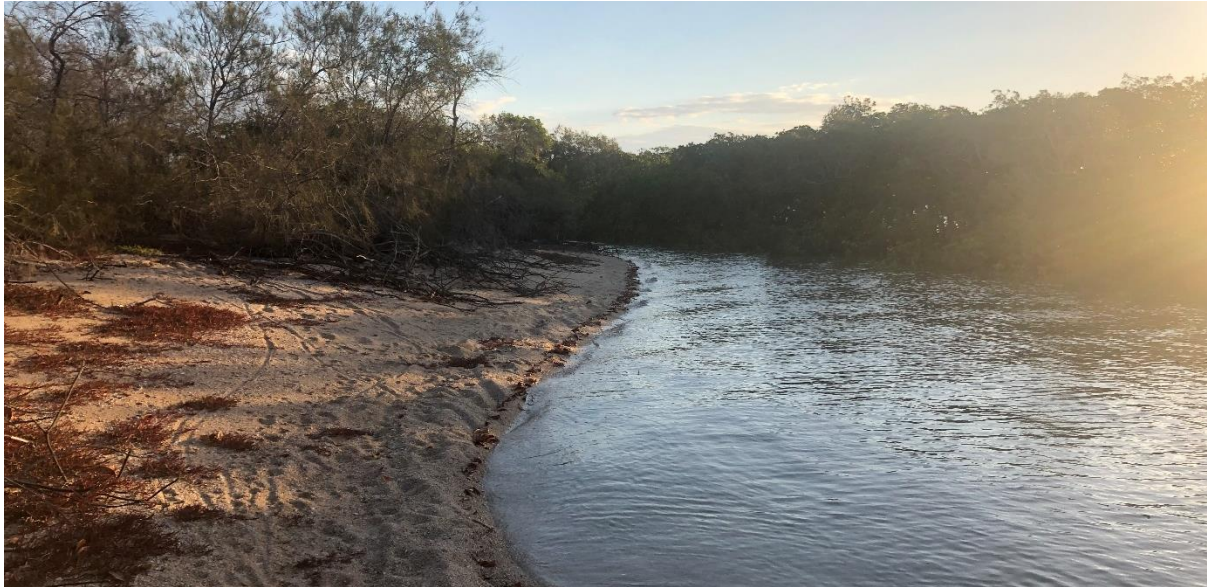
Figure 17. *Western shoreline – tidal channel*

The western shoreline is a sheltered environment lined with extensive mangrove communities. A tidal channel runs parallel to the shoreline, however there are no formal boat access points. Some informal access to the channel occurs, with associated local disturbance to the sandy shoreline and vegetation communities. The mangroves provide protection to the shoreline from wind and wave energy.

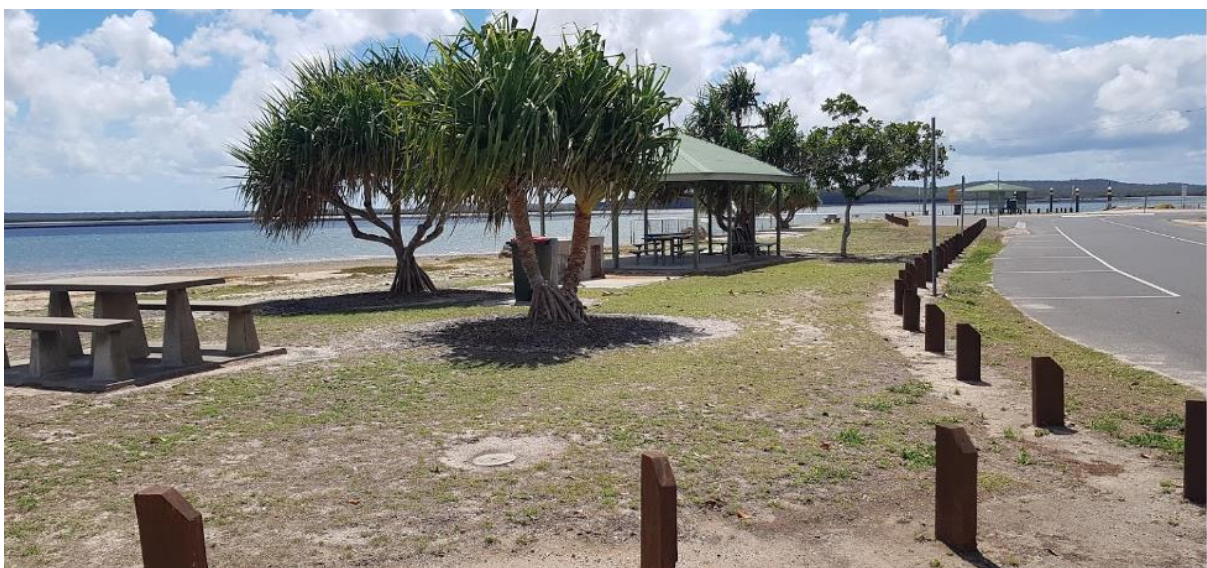
Figure 18. *Northern point shoreline recreation area (Source: Google maps – Brian Clarke Oct 2019)*

The northern point is a relatively exposed section of coast, influenced by strong tidal currents and prevailing easterly winds (refer Section 2.2). This is the main recreational zone for Turkey Beach, including an informal swimming enclosure (not approved or managed by Council), boat ramp, war memorial, car parking, amenities block and picnic area (e.g. Figure 2, Figure 18).

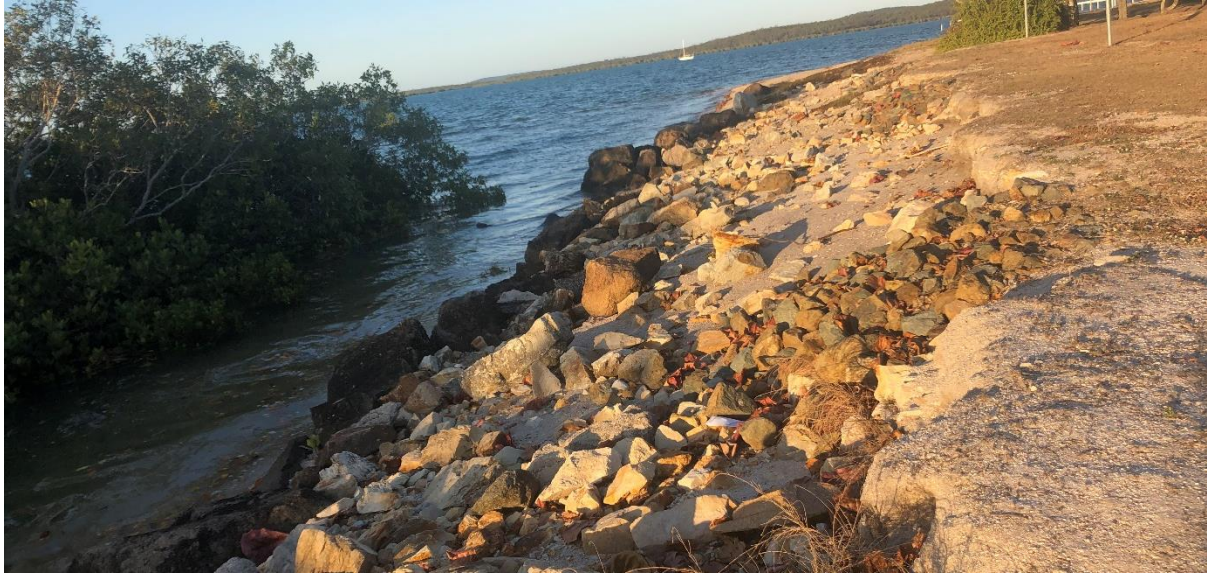
Mangroves are present only to the far western side of the point, along with some informal rock protection work (where minor recession has occurred – refer Section 2.4) (Figure 19).

Figure 19. Northern point shoreline – informal rock protection at far western side of the point

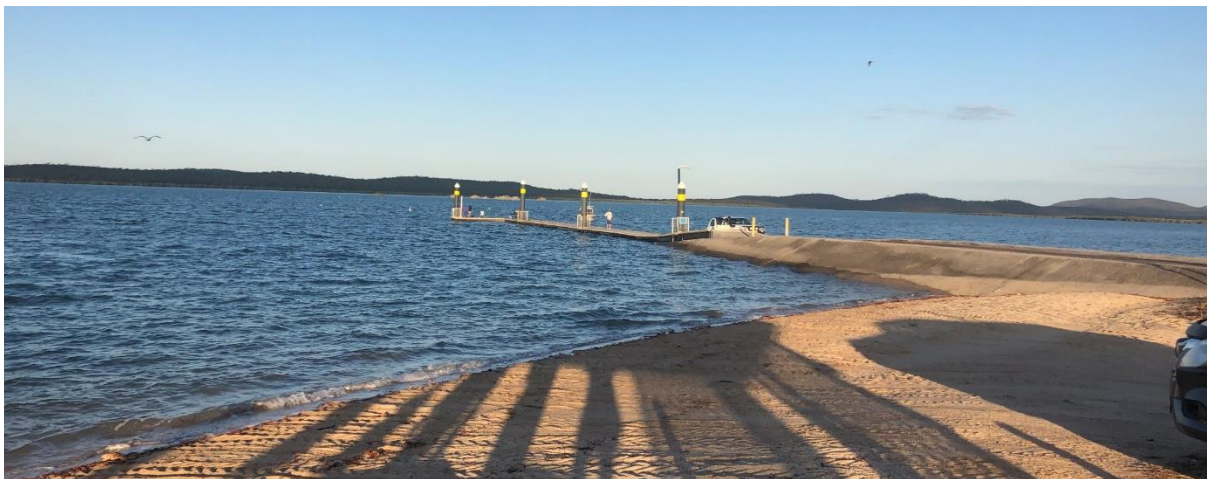
Minor erosion is also observed on the lee (north) side of the boat ramp (where minor recession has occurred – refer Section 2.4). The position of the boat ramp intercepts the northerly sediment transport, resulting in a build up of sand on the southern side of the ramp, and less sand reaching the north point shoreline. The lee (north) side of the boat ramp is also used for informal boat access.

Figure 20. Northern point shoreline - Lee (north) side of the boat ramp

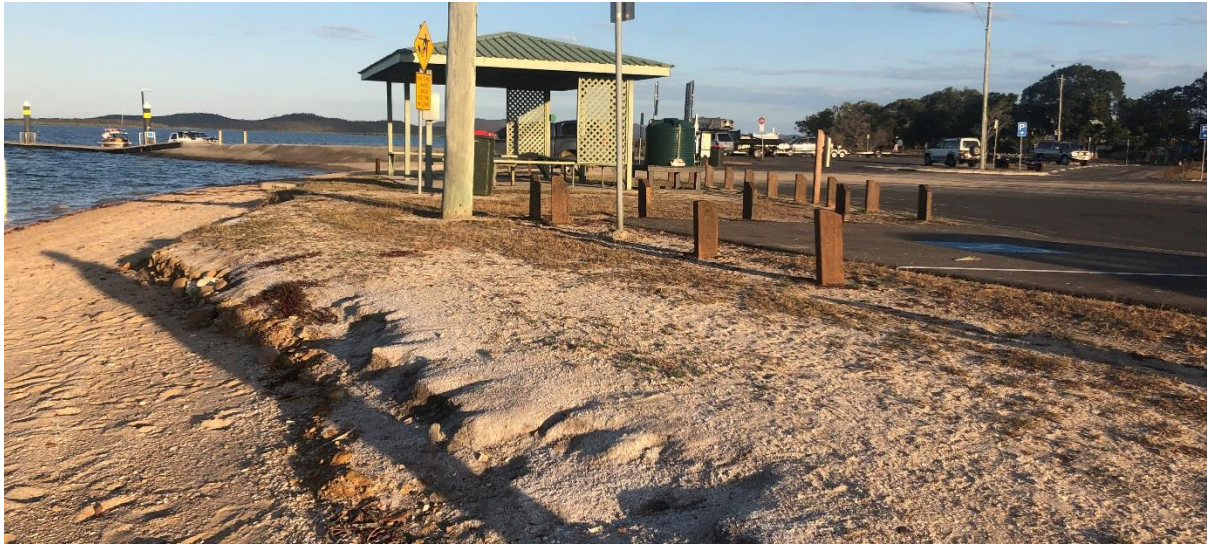
Erosion of the coarse sandy shoreline occurs periodically after storm events, and there is minimal dune re-building / recovery observed between events. As of August 2019 an erosion scarp along most of the beach length was observed, at approximately 0.2 m high. Also visible offshore is a sandbar, running parallel to the shoreline. Eroded sand along this reach is transported to the west (driven by tides and easterly winds – refer Section 2.2), moving around the point and extending the north-west sand bar offshore.

Figure 21. Northern point shoreline – erosion scarp behind swimming enclosure

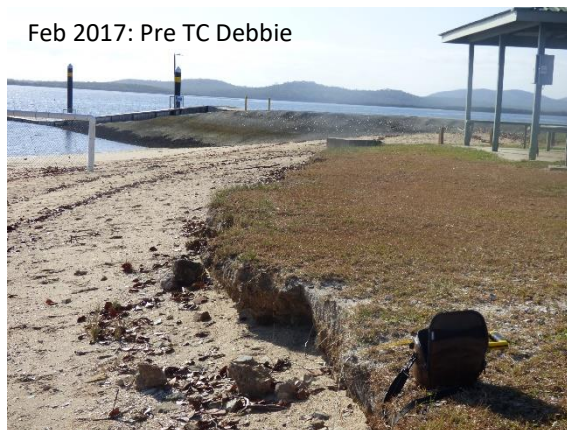
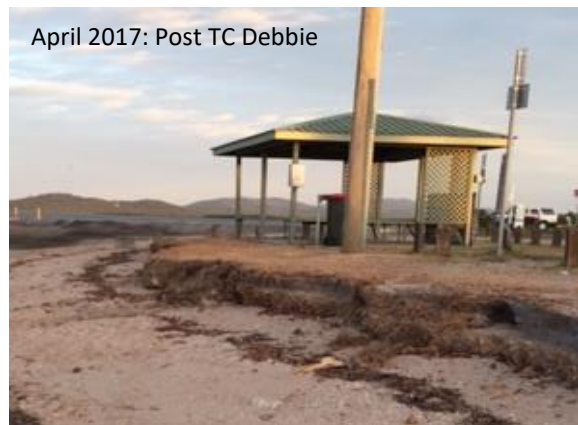
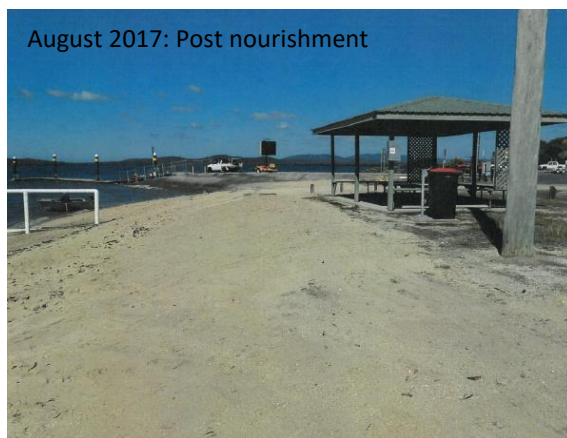
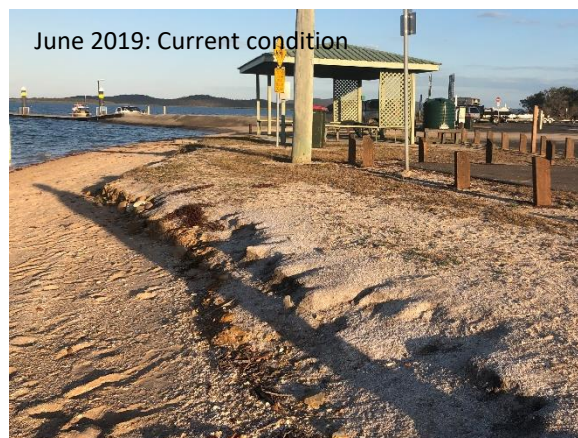
Beach nourishment via sand scarping was undertaken in August 2017 following erosion during Severe Tropical Cyclone (STC) Debbie in March 2017. Photos of the site condition pre-STC Debbie, post STC-Debbie, post beach nourishment and during the field visit are shown in Figure 22. These photos indicate an erosion scarp prior to STC Debbie, which was exacerbated following STC Debbie. Sand scraping was undertaken in August 2017, in the order of up to 5,000m³ to restore and smooth the beach profile.

Figure 22. Northern point shoreline - Beach profile in front of the boat ramp carpark located on The Esplanade, Turkey Beach – pre and post nourishment (All photos except current condition supplied by GRC)

The majority of the nourished volume has since been eroded, with the current conditions (as of June 2019) appearing similar to pre-STC Debbie.

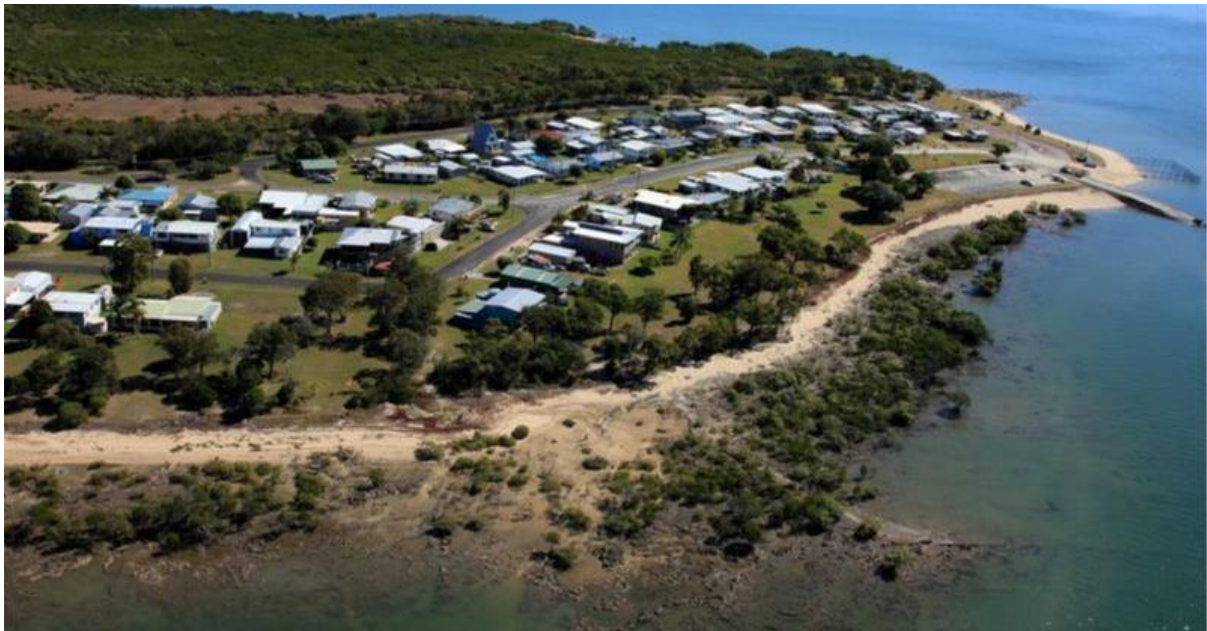
Figure 23. Eastern shoreline – south of the boat ramp (Source: <https://www.realestate.com.au/property-residential+land-qld-turkey+beach-201378922>)

The eastern shoreline extending south from the boat ramp is characterised by a sandy shoreline and intertidal rock and mud flats (Figure 30). Mangroves extend along much of the shoreline, although less dense than the western shoreline communities, and provide some protection from wind and wave energy.

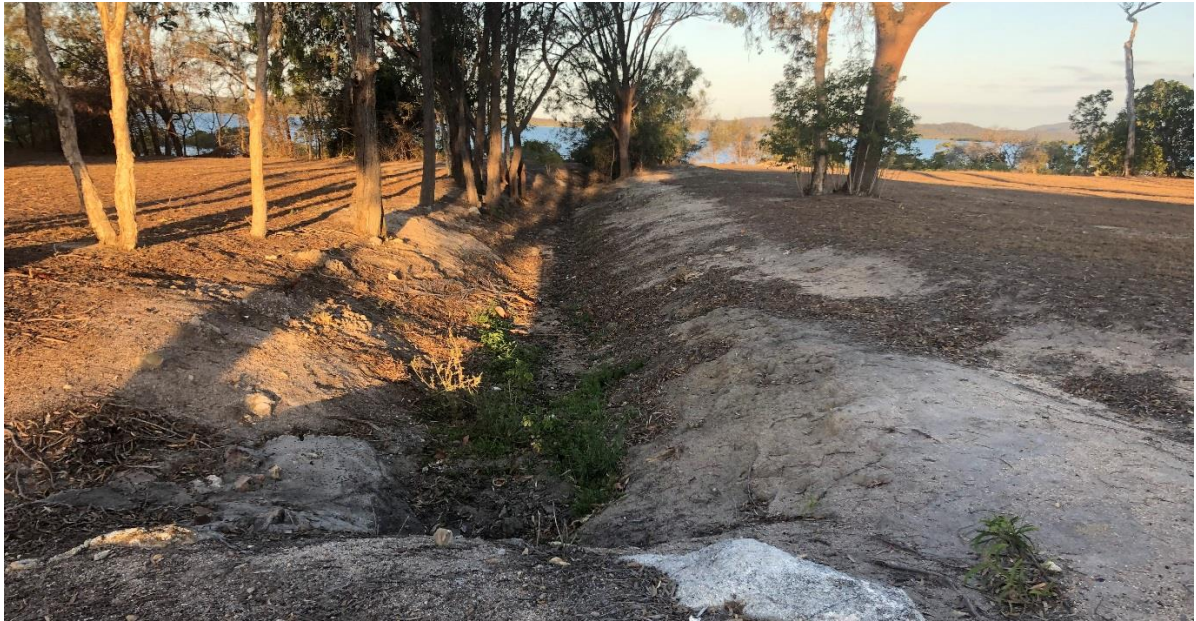
A small erosion scarp (0.2 m) is present in some areas behind the mangroves that aligns with observed shoreline recession (refer Section 2.4). Stormwater runoff drains to the beach (e.g. Bell Street drain, Figure 24). Timber bollards and signage indicating tidal influences and soft sands have been established to deter vehicle access in some areas (Figure 25).

Figure 24. Eastern shoreline - stormwater drainage at the northern section of beach at Bell Street

Stormwater runoff has potential to generate localised scour along the shoreline, exacerbate inundation extents and impact on foreshore vegetation communities. Impacts have been observed and reported by the community at a number of locations along the shoreline (including Bell Street).

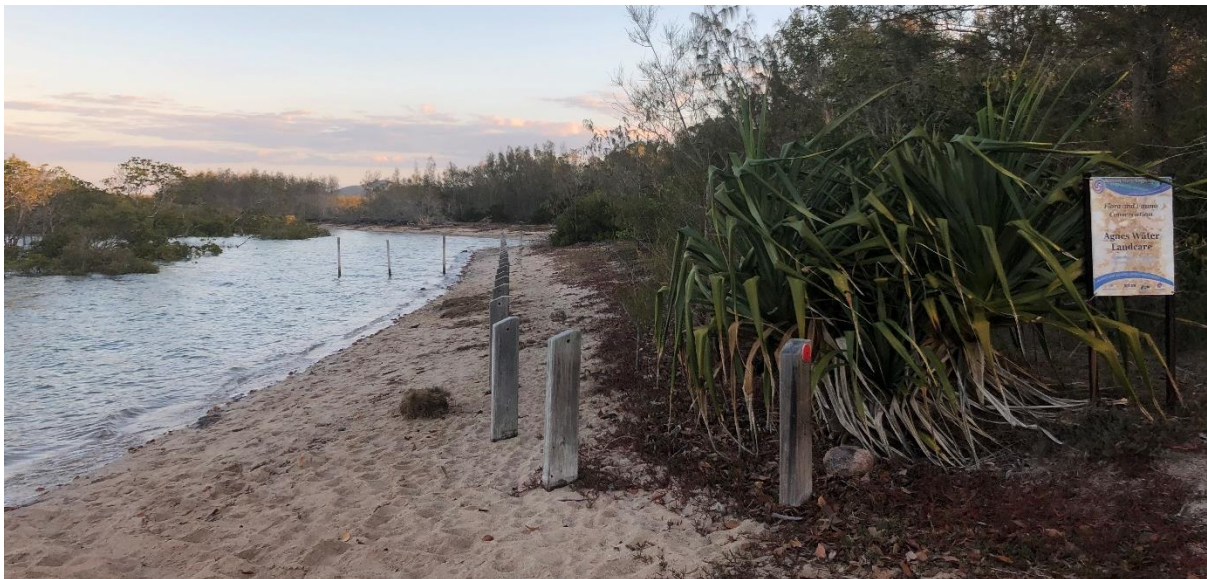
Figure 25. Eastern shoreline – timber bollards

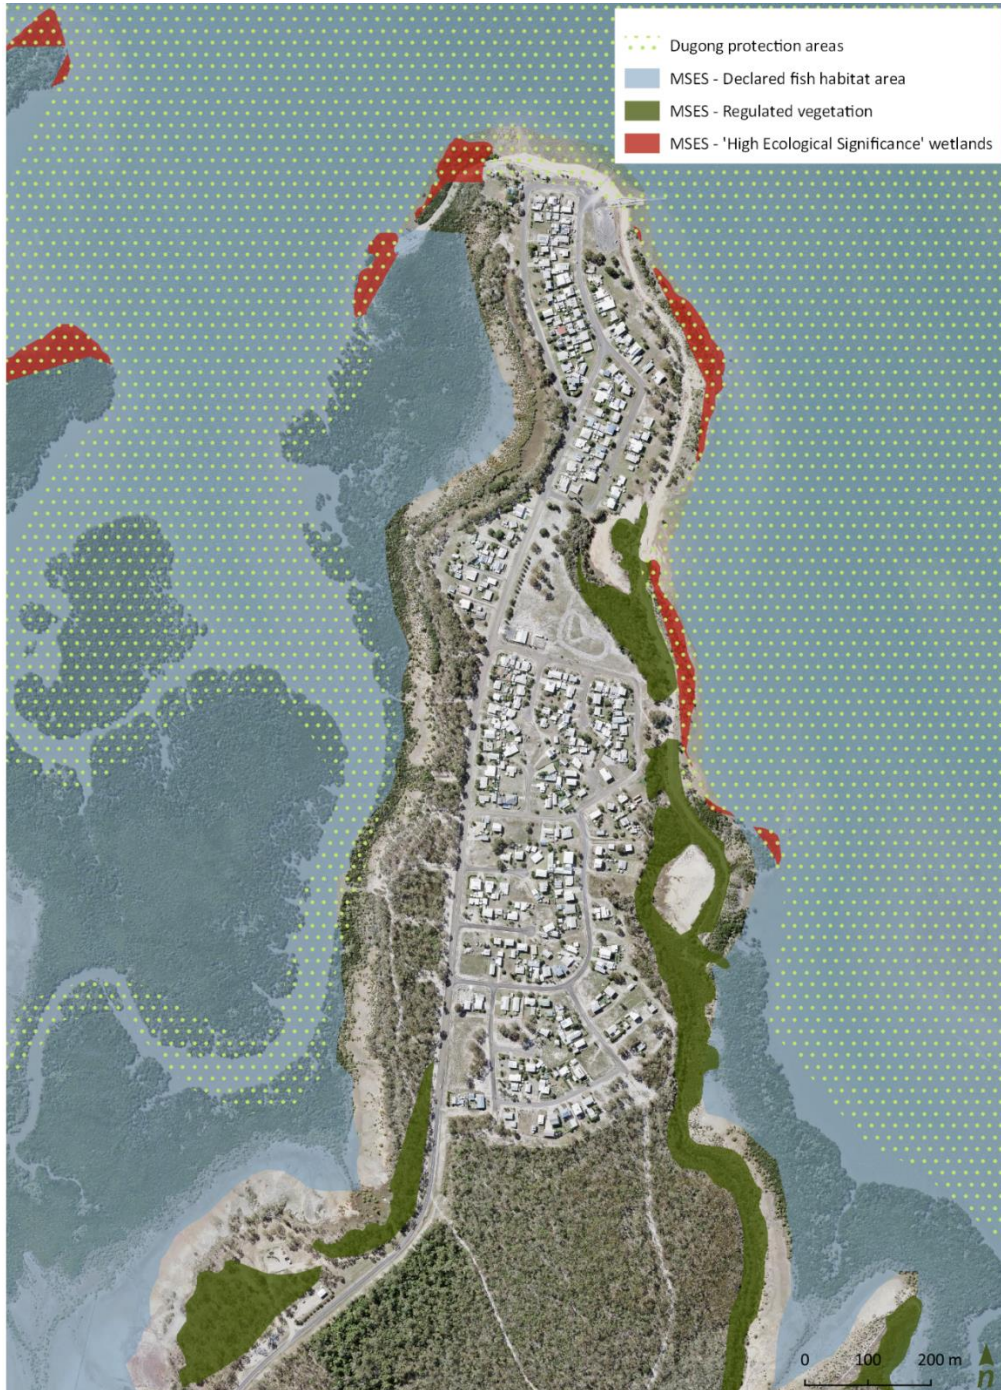
Figure 26. State mapped environmental values of Turkey Beach (MSES – Matters of State and Environmental Significance)

The Turkey Beach peninsula is located within the Rodd's Bay estuary and is surrounded by an abundance of vegetation and native wildlife habitat that is of state and national significance (Figure 26).

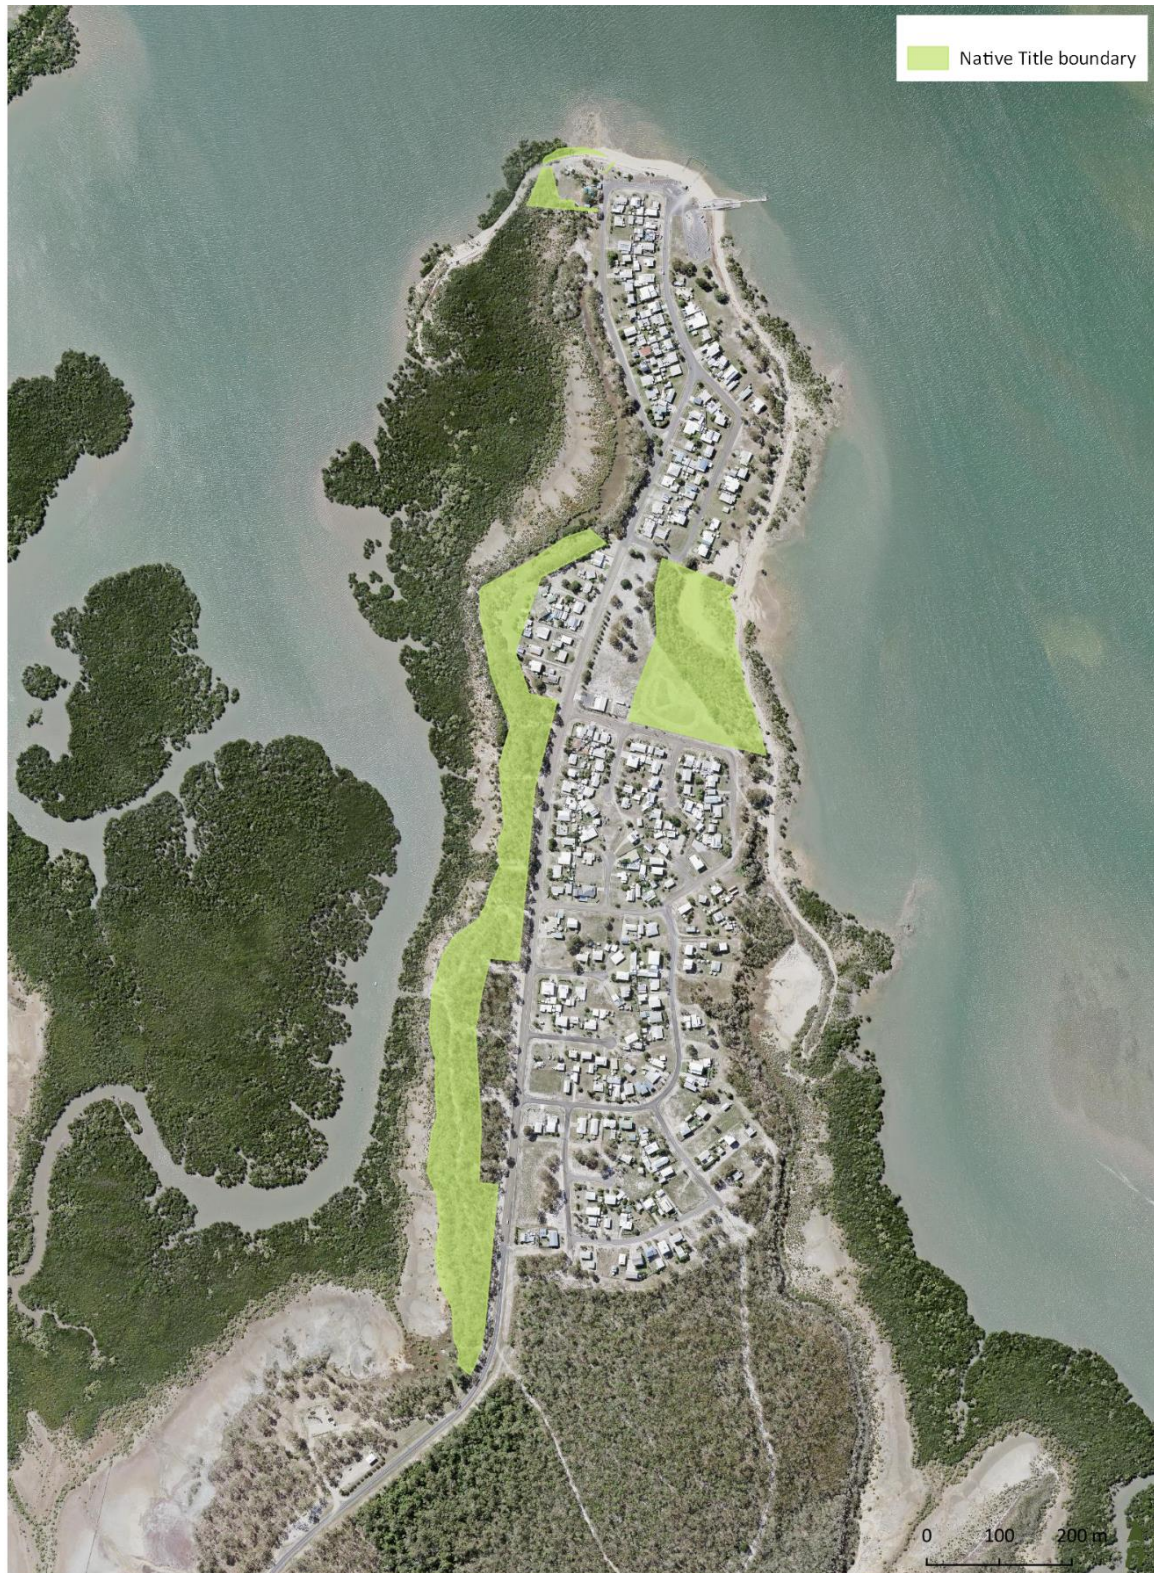
Figure 27. Native title boundaries within Turkey Beach

The Bailai, Gurang, Gooreng Gooreng and Taribeland Bunda People are the Traditional Owners within the Gladstone Region. The coastal region of the Gladstone LGA, including Turkey Beach, holds significant value to the Traditional Owners. Indigenous cultural identity is intrinsically linked to the condition of the natural components of the region (GBRMPA 2019). The Native Title hold within Turkey Beach is shown in Figure 27.
