FINAL REPORT:

Turkey Beach Shoreline Erosion Management Plan (SEMP)

April 2020

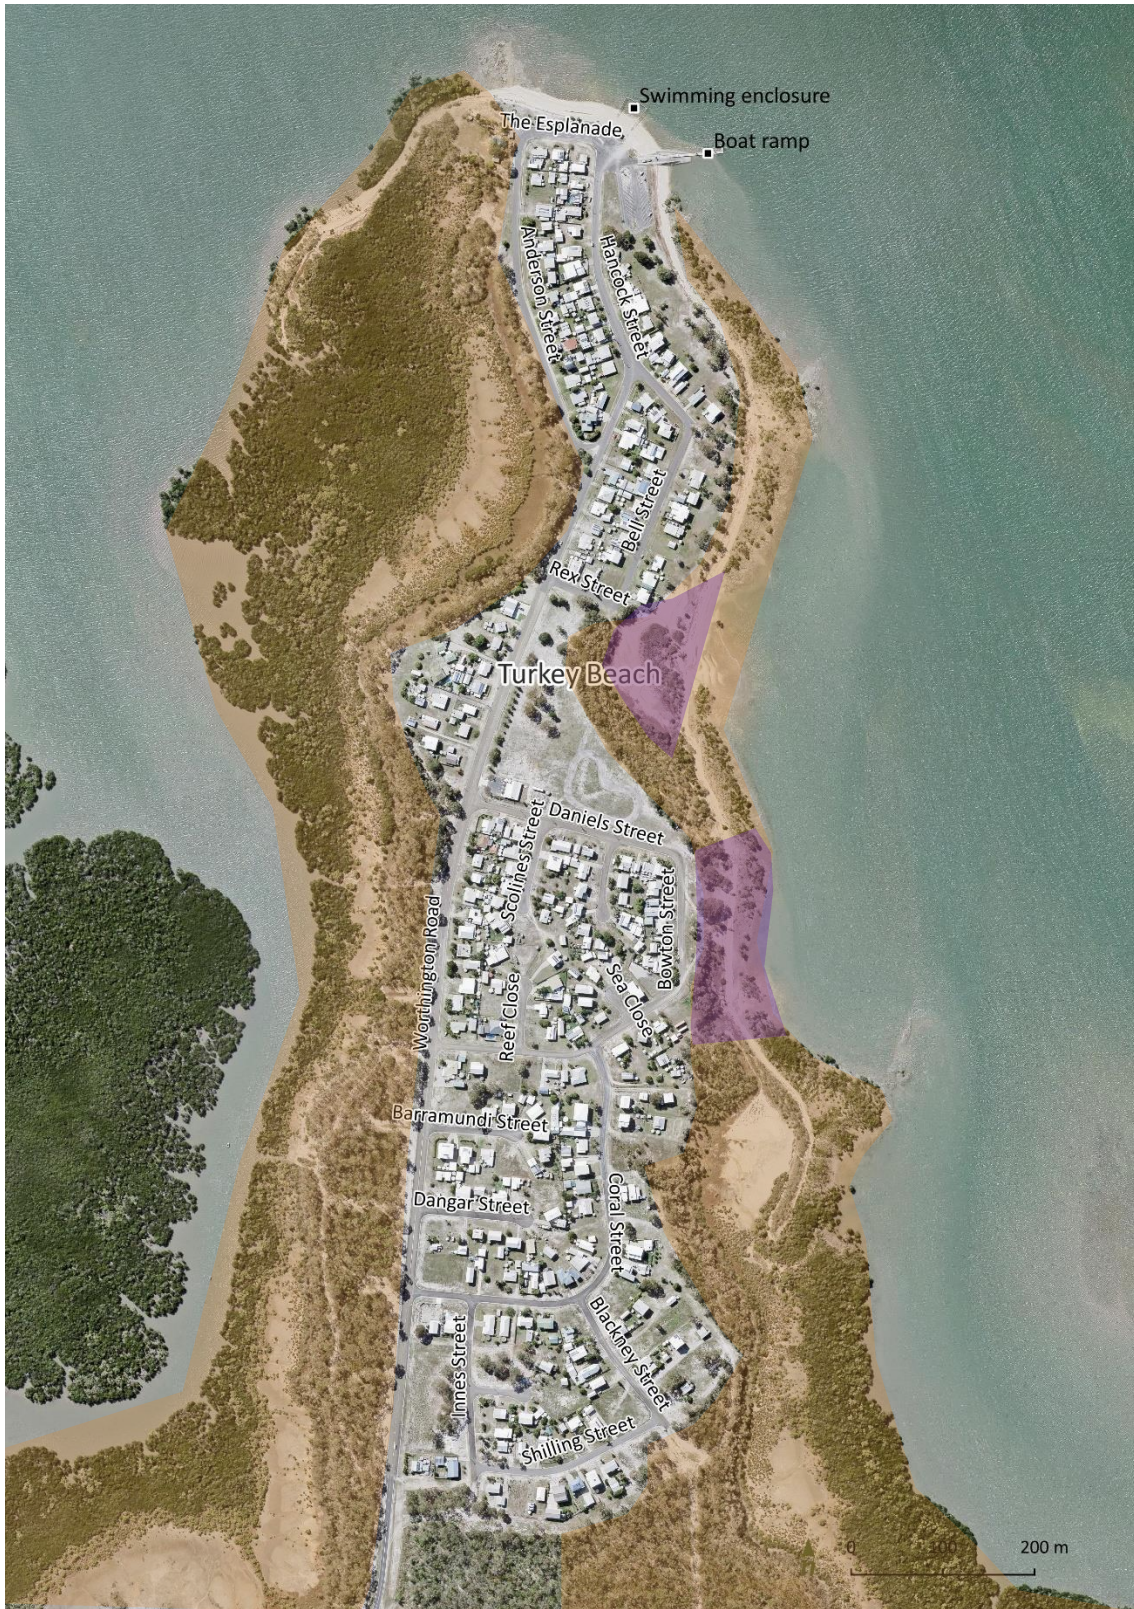
Figure 31. SEMP – Part A – Western and eastern shorelines – minimal disturbance zones (orange) where foot and vehicle disturbance should be limited to defined locations - and priority sites (purple) where access should be restricted if feasible

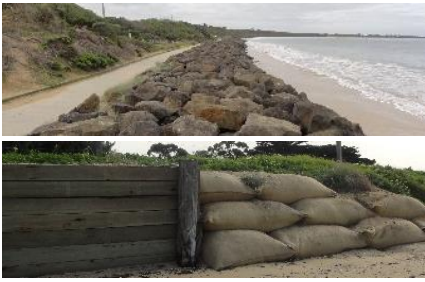
<p>Seawall / revetment Typically made of rock, concrete, geo-fabric bags or wood, seawalls provide an artificial barrier to erosive processes and protect the coastal assets behind them. They can be either exposed or buried and generally require extensive excavation. A seawall also has limited ability to dissipate energy and generally results in accelerated scour of sand from the base of the wall. Less formal revetments can also be implemented through placement of rock or geo-bags.</p>

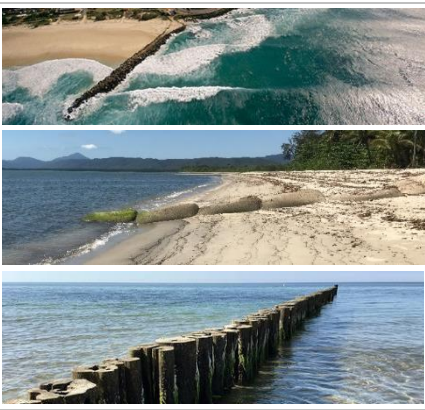
<p>Groynes Built perpendicular to the coast, groynes can be constructed from a variety of materials, including rock, geo-bags, concrete or wood. Groynes assist with sand retention in areas prone to longshore drift. Sediment is captured on the updrift side, while erosion generally occurs on the downdrift side. Groynes can be formally engineered with excavation, or less formally constructed. They can vary in length, dependent on the sediment transport environment at the site and level of protection required. In some cases, groynes can also be orientated to provide a barrier to wave energy.</p>

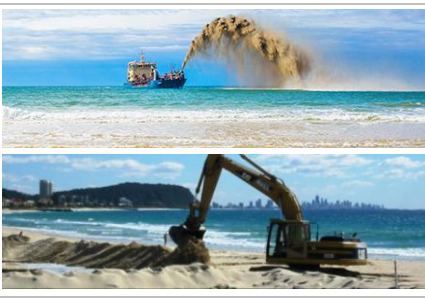
<p>Sand nourishment Sand can be sourced from offshore through dredging or other sources and can be imported or sprayed onto the beach to increase the volume of sand on the beach. Sand can be nourished utilising an external sand source (e.g. river mouth or offshore deposits), or sand scraping can be used to redistribute sand already on the beach. Sand can be shaped to provide a dune system that is stabilised with fencing and vegetation.</p>

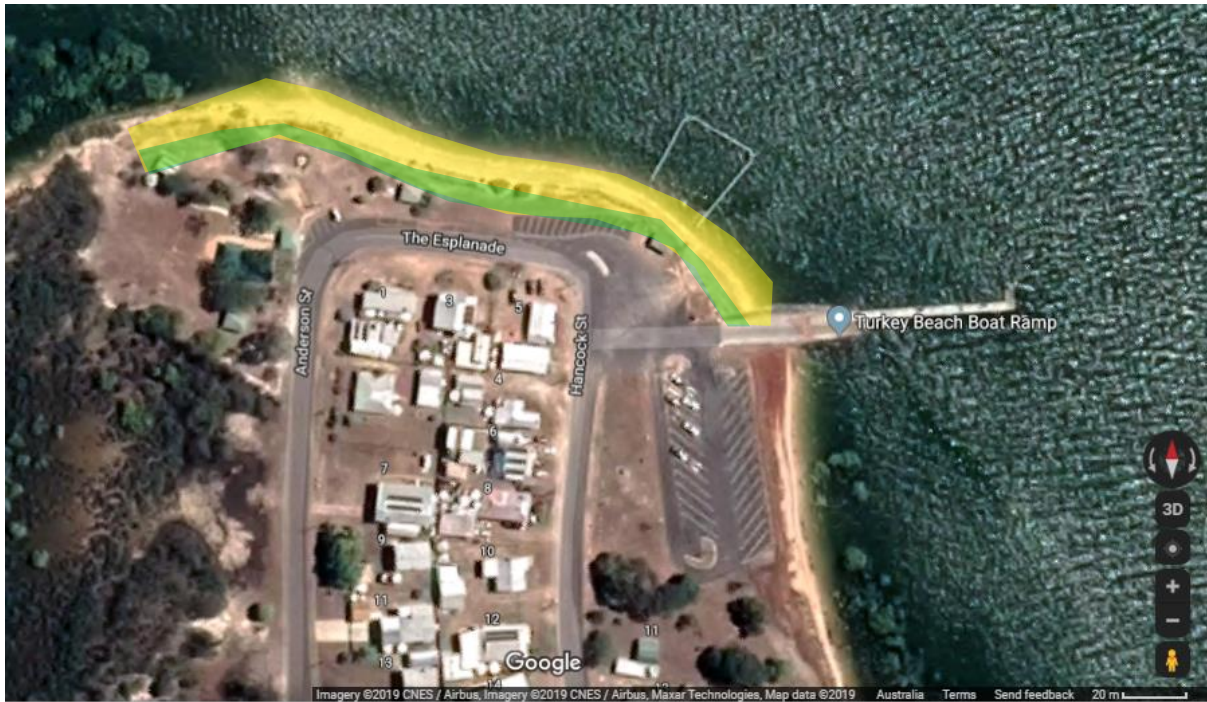
The treatment area and sand volumes estimated for nourishment along the northern shoreline are indicative only, and based on estimated sand volumes that will have longevity at the site and provide protection to the backshore environment from erosion events (i.e. the placed sand is eroded, not the shoreline where assets are located). Alternatively, more localised areas of sand scraping / pushing can be undertaken around the priority areas only (e.g. swimming enclosure, toilet block) as has been previously completed in the past. However smaller sand volumes and treatment areas are likely to be eroded more quickly (possibly annually), and the shoreline will remain vulnerable to major erosion in large events.

Figure 32. SEMP Part B – northern point – beach nourishment and revegetation – indicative nourishment area (4,000 - 5,000 m²) and vegetation area (2,000m²)

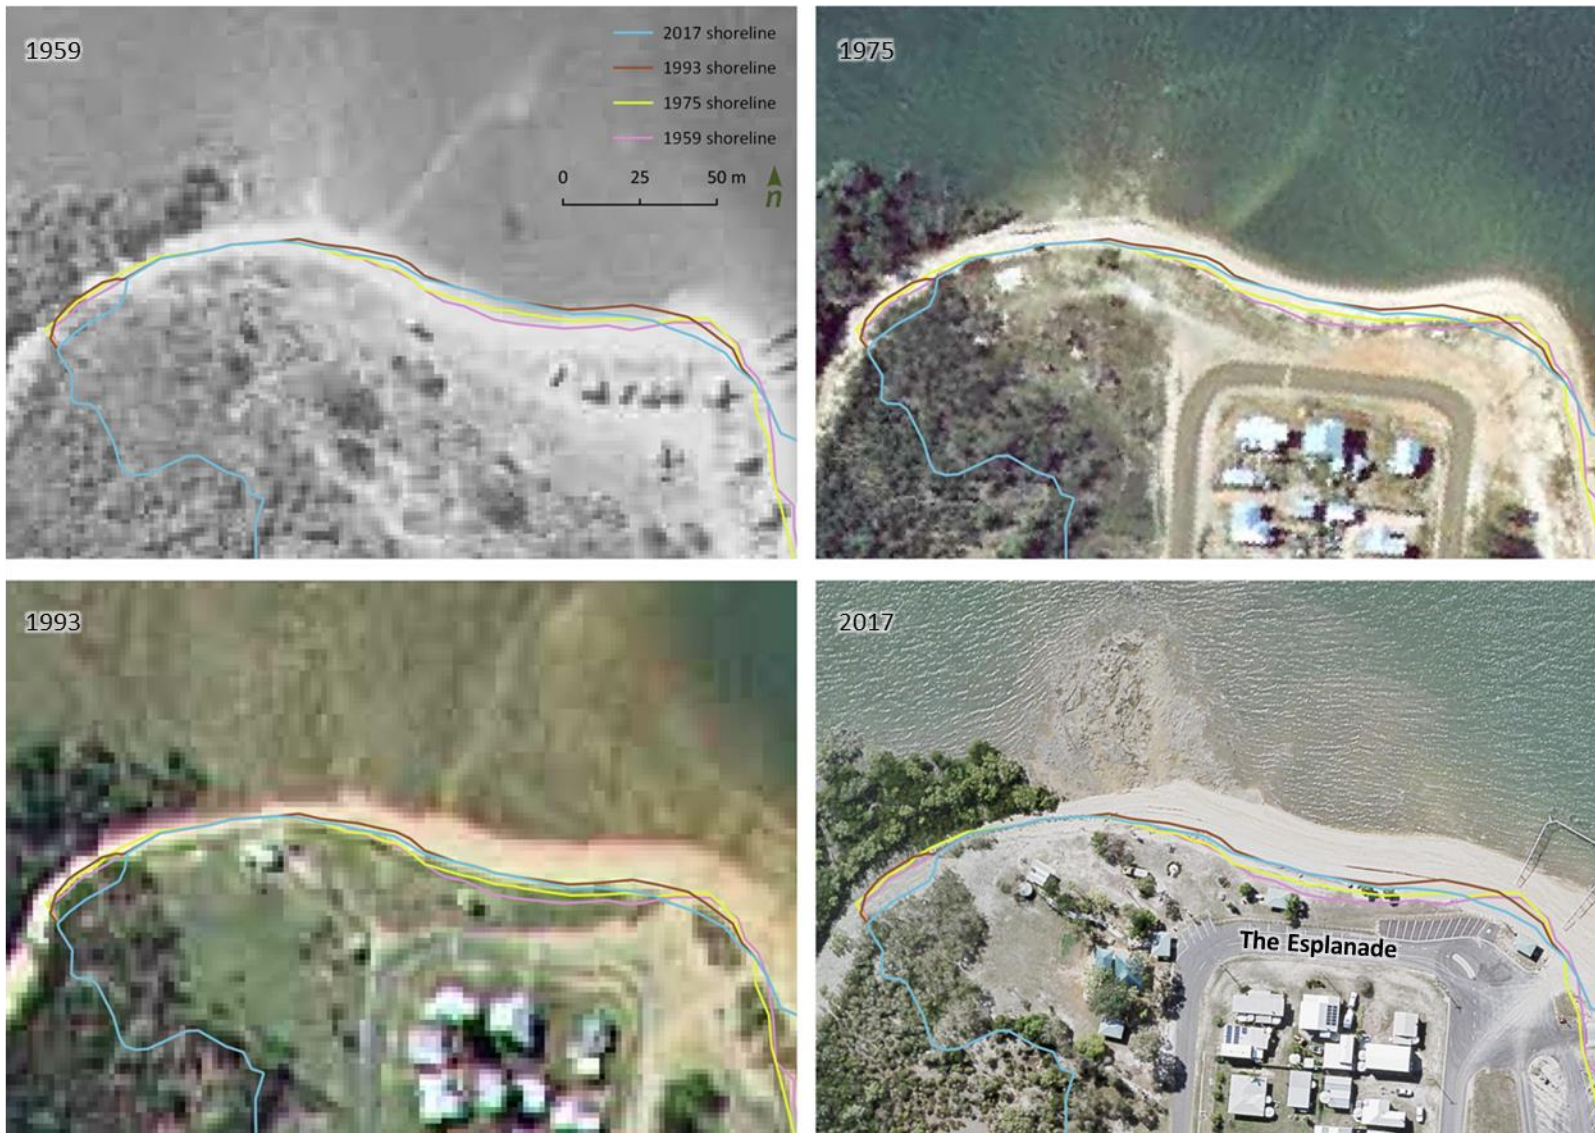
Figure 36. Historic aerial imagery comparison and shoreline position for Map 1 – The Esplanade.

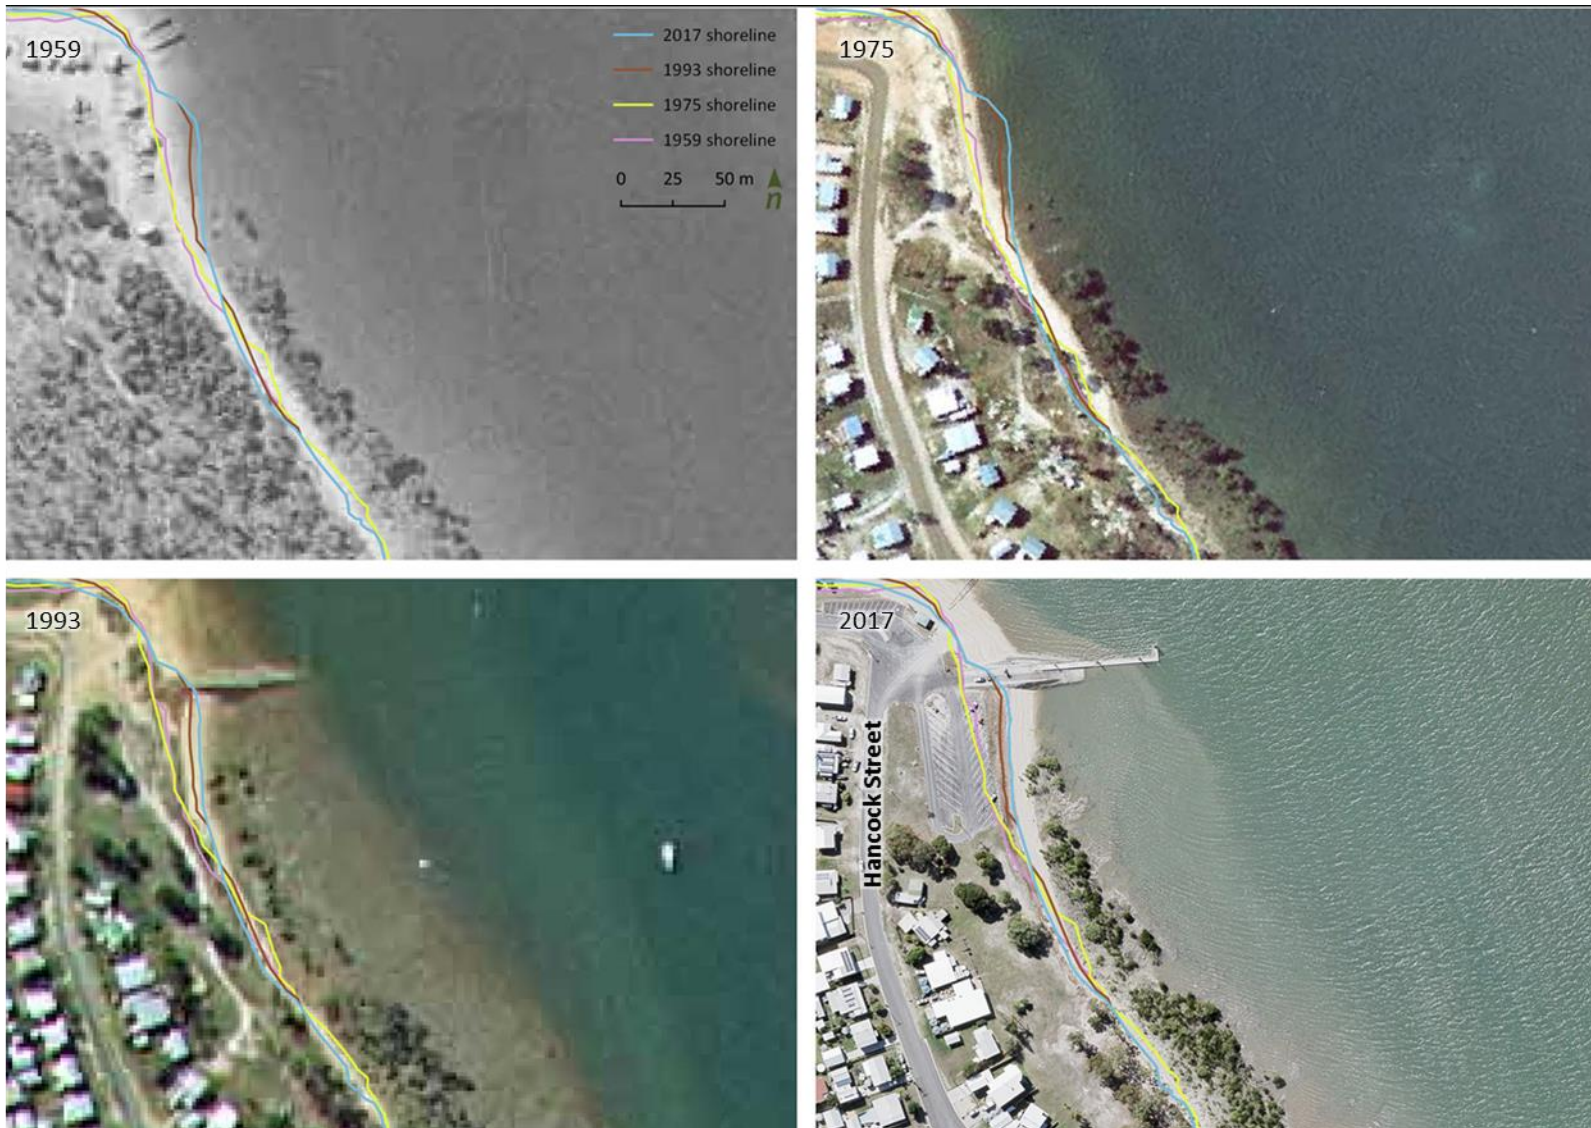
Figure 37. Historic aerial imagery comparison and shoreline position for Map 2 – Boat ramp.

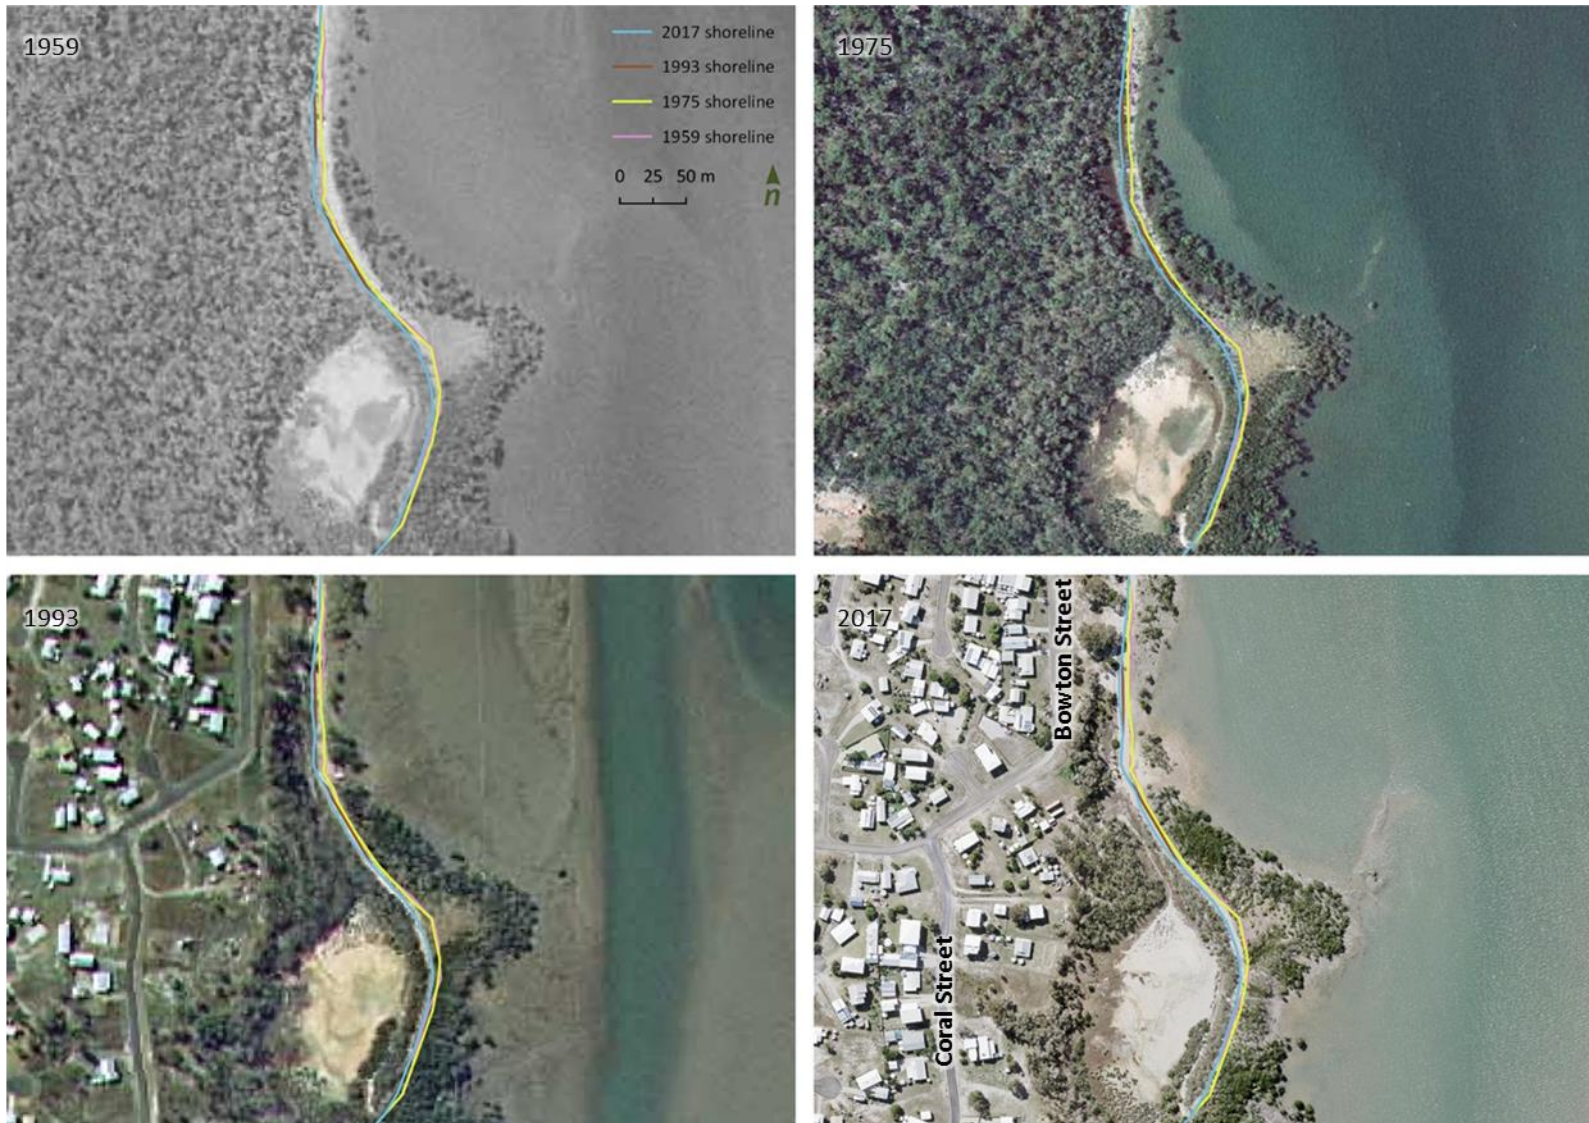
Figure 39. Historic aerial imagery comparison and shoreline position for Map 4 – Bowton Street

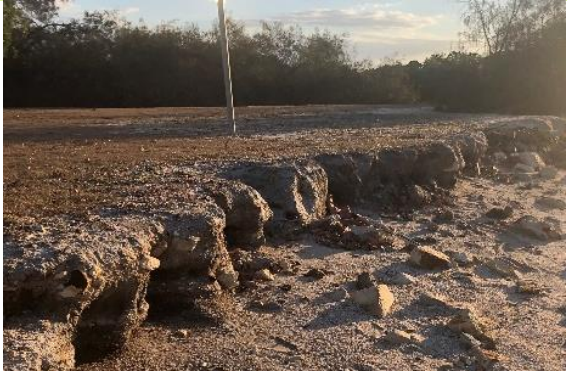
Adjacent to The Esplanade	
<p>Existing condition</p> <ul style="list-style-type: none"> • Relatively steep beach with limited vegetation along northern-facing shoreline • Scarp present along majority of length of beach, approximately 0.2 m high 	<p>Coastal management and engineering</p> <ul style="list-style-type: none"> • Evidence of previous rock protection at western end of beach • Visible offshore bar parallel to the beach • No clear sediment transport direction
<p>Infrastructure / assets</p> <ul style="list-style-type: none"> • Toilet block • War memorial (non-Council asset)

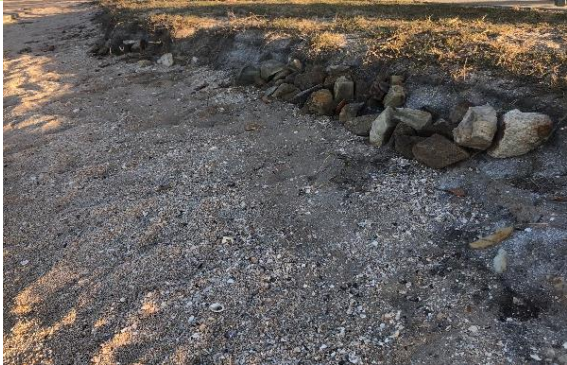
Turkey Beach swimming enclosure and boat ramp	
<p>Existing condition</p> <ul style="list-style-type: none"> • Shallow beach gradient with evidence of sediment loss 	<p>Coastal management and engineering</p> <ul style="list-style-type: none"> • Rock revetment covered by sandy beach
<p>Infrastructure / assets</p> <ul style="list-style-type: none"> • Boat ramp • Swimming enclosure (non-Council asset) • Road, shelter and bollards landward of beach

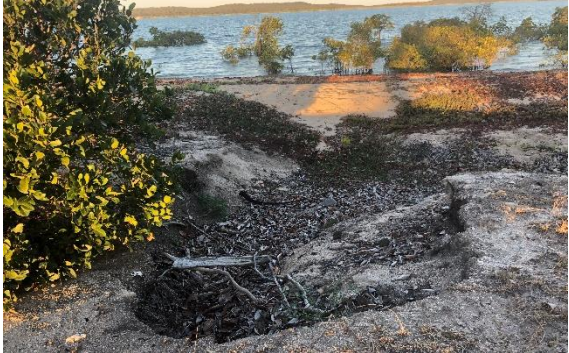
Bell Street, Turkey Beach	
Existing condition <ul style="list-style-type: none"> • Low-lying foreshore reserve with minimal berm • Foreshore receding and scarp behind mangroves ~0.2 m, visible until Brown Street • Watermark (leaves) in clear banks on beach • Stormwater discharges onto the beach • Visible bedrock • Roots of trees exposed 	Coastal management and engineering <ul style="list-style-type: none"> • Mangrove and mudflat in front of the beach
Infrastructure / assets <ul style="list-style-type: none"> • Tidal areas encroaching on property boundaries

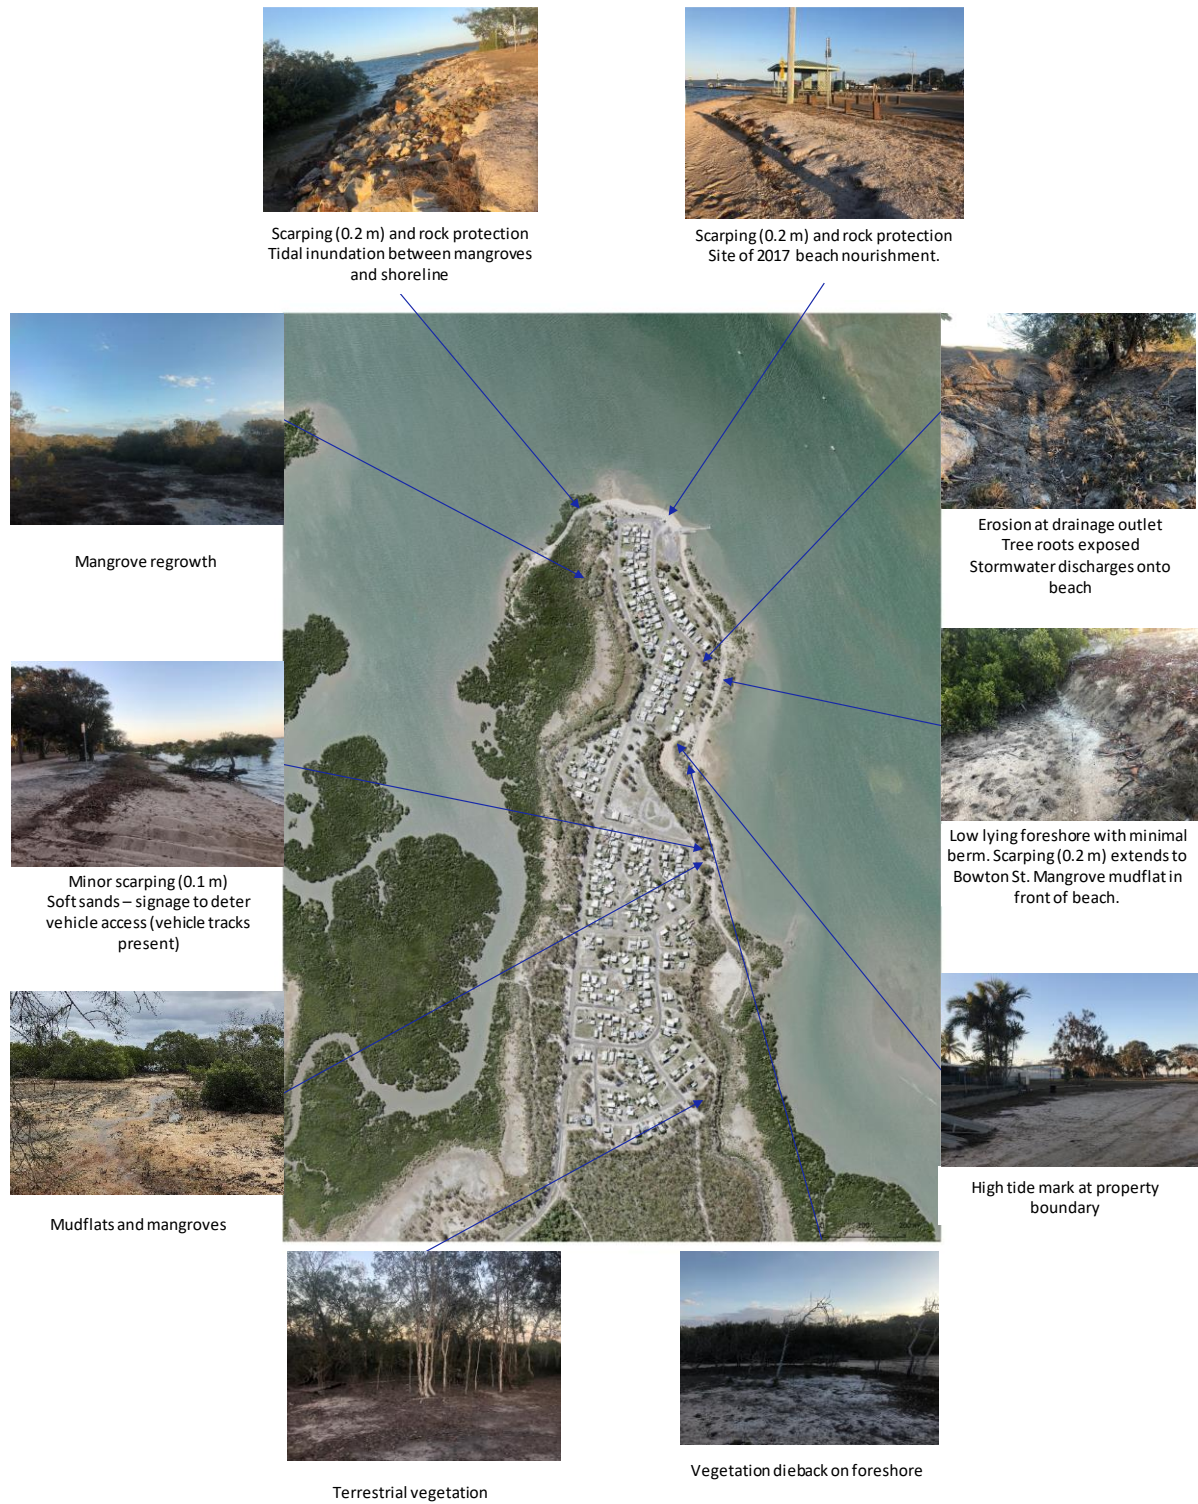
Figure 41. Summary of key site inspection observations
