DRAFT Gladstone Regional Council Roads Maintenance Guideline

November 2023

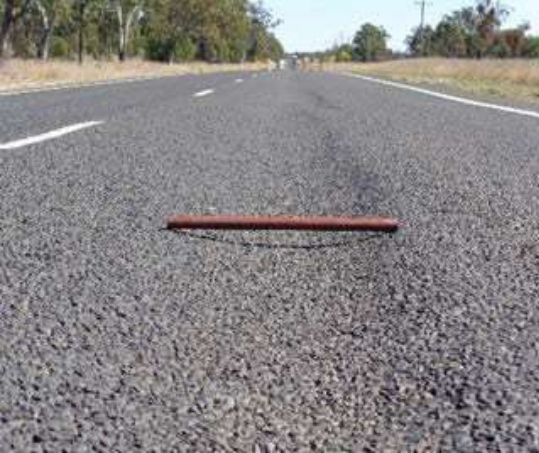
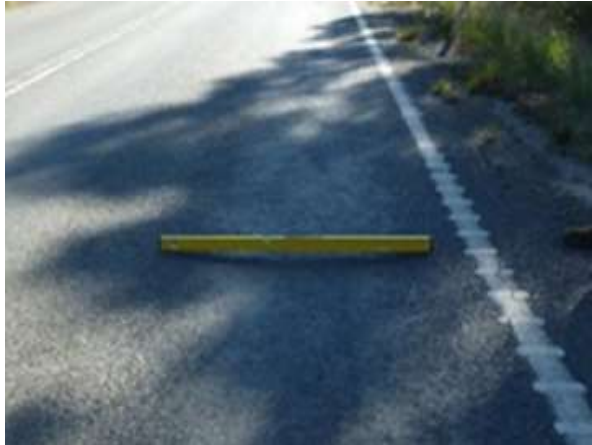
Defect Code	Defect Name	Image + Description	Possible Causes
		<p>Irregular bowl-shaped cavity extending into pavement layers. Small, bowl-shaped cavity in the pavement surface that penetrate all the way through the surfacing layer down to the base course.</p>	
<p>SR - road CS - carpark</p>	<p>Ruts in Bituminous Surface</p>	<div style="display: flex; justify-content: space-around;">

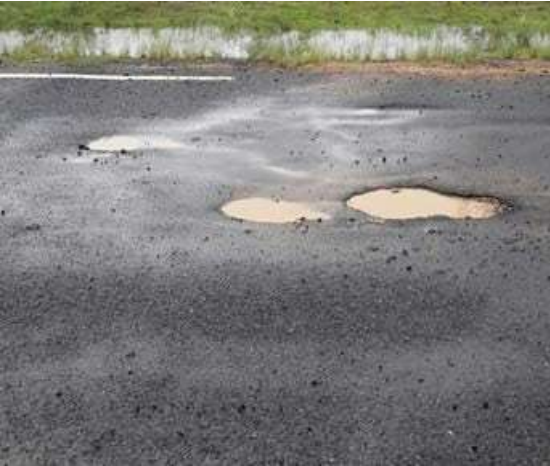
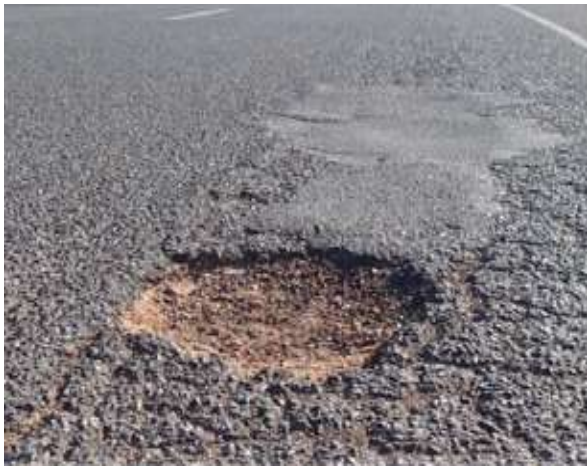
</div> <p>Ruts in pavements are channelised depressions in the wheel paths, generally appears in long sections due to consolidation or lateral movement of pavement or subgrade due to traffic action.</p>	<p>Pavement age, frequent presence of overloaded vehicles and/or heavy vehicles on the pavement.</p> <p>Inadequate pavement layer thickness. Inadequate compaction in surfacing or base layers. Inadequate strength in surfacing or base layers.</p>
<p>SP - road CP - carpark</p>	<p>Potholes in Bituminous Surface</p>	<div style="display: flex; justify-content: space-around;">

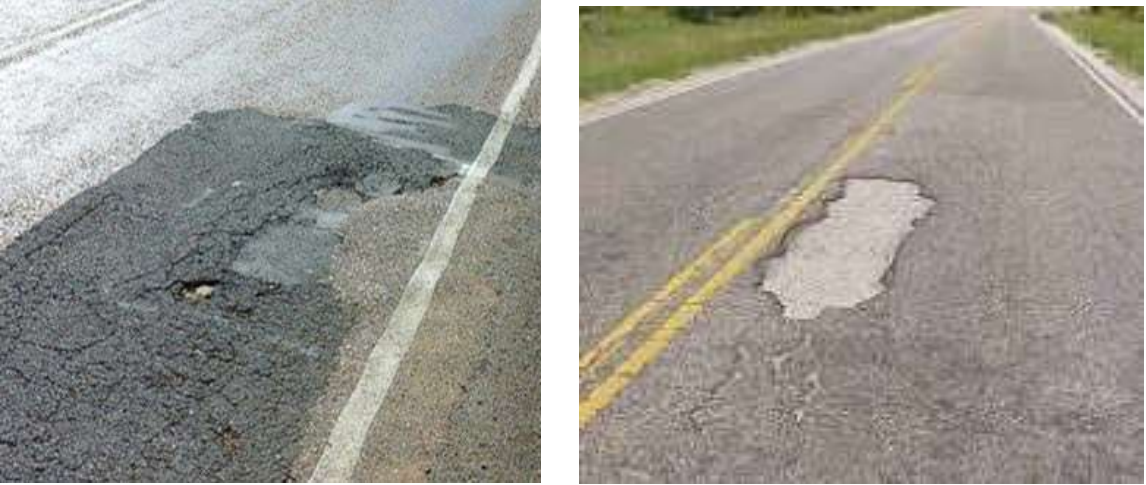
Defect Code	Defect Name	Image + Description	Possible Causes
SP - road CP - carpark	Delamination in Bituminous Surface

<p data-bbox="533 715 1693 770">Loss of a large, discrete area of the surfacing layer. Surfacing layer separation from the below layer is clearly visible in most situations.</p>	<p data-bbox="1720 220 2112 371">Poor bond between upper surfacing layer and layer below due to inadequate cleaning or inadequate tack coat before placement of upper surfacing layers</p> <p data-bbox="1720 395 2112 515">Weakening of the bond between surfacing layer and the below layer due to various reasons such as water ingress, traffic action.</p> <p data-bbox="1720 539 2112 595">Loss/damage surfacing layer due to binder adhesion to tyres.</p>
CC - road CR - carpark	Crocodile Cracking in Bituminous Surface

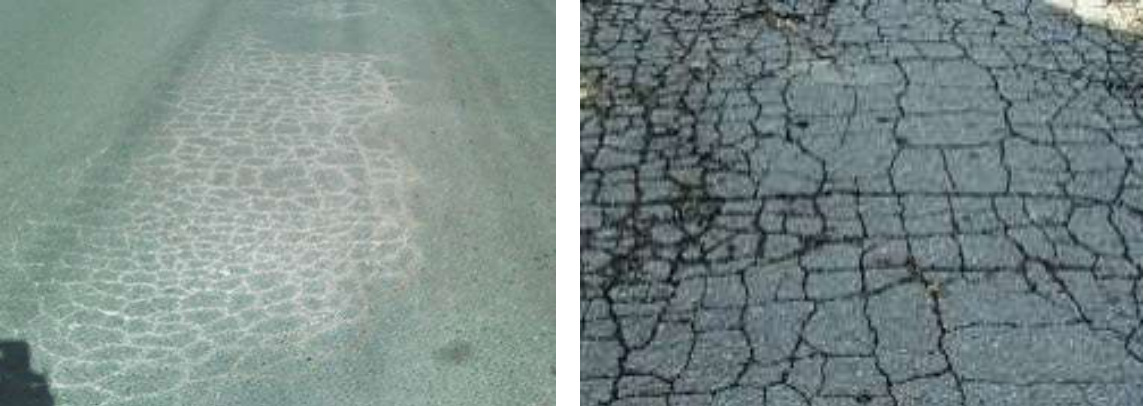
<p data-bbox="533 1233 1693 1321">Small irregular shape polygons formed generally in wheel paths. Plate/cell sizes are normally less than 150 mm. Crocodile cracking is load-related and it normally starts in the wheel path as longitudinal cracking and ends up as crocodile cracking after severe distress.</p>	<p data-bbox="1720 810 2112 834">Insufficient pavement layer thickness.</p> <p data-bbox="1720 858 2112 914">Brittle base or wearing course due to age or cemented base.</p> <p data-bbox="1720 938 2112 1026">The failure can be due to weakness in the surface, base or sub grade or poor drainage.</p>

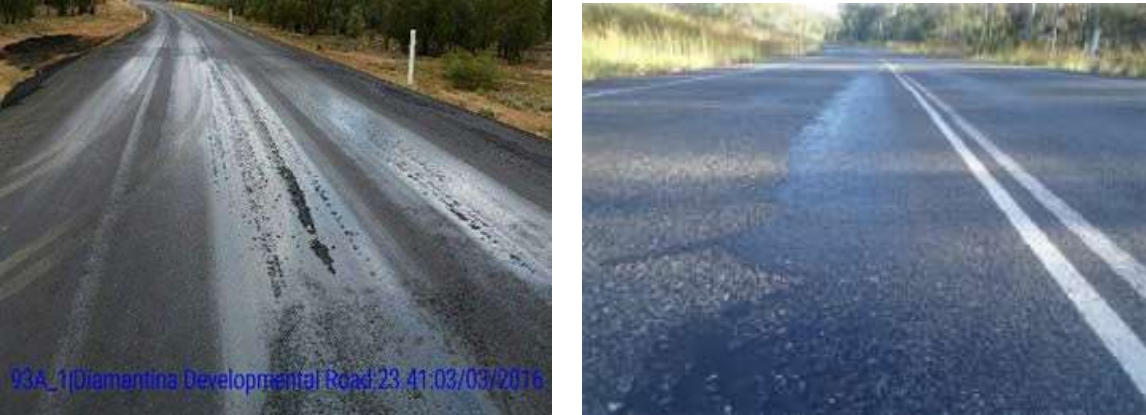
Defect Code	Defect Name	Image + Description	Possible Causes
SF - road CF - carpark	Flushing, Bleeding Seal

<p data-bbox="533 576 1077 608">03A_1(Diamantina Developmental Road) 23 41 03/03/2016</p> <p data-bbox="533 647 1666 703">Presence of excess bitumen in the pavement surface layer which creates patches with low skid resistance due to inadequate tyre- to-stone contact.</p>	<p data-bbox="1720 217 2141 408">Excessive application rate of binder, with respect to stone size. Excessive prime coat being incorporated into the seal. Excess binder in underlying patch or flushed area. Penetration of aggregate into low strength base.</p> <p data-bbox="1720 424 2141 480">Primer seal covered before volatiles in primer binder have evaporated.</p>
SS - road CT - carpark	Ravelling Seal

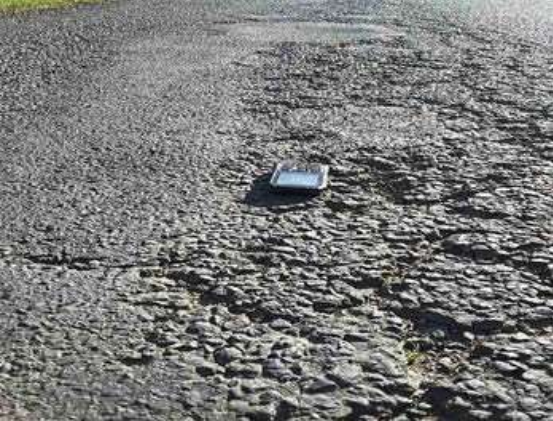
<p data-bbox="533 1174 1599 1230">Initially fine aggregate breaks loose and leave small patches in the pavement surface. That leads to progressive disintegration of the pavement surface by loss of both binder and aggregates.</p>	<p data-bbox="1720 738 2085 799">Insufficient adhesion between the asphalt and the aggregate.</p> <p data-bbox="1720 815 2141 903">Deterioration of binder and/or stone. Inadequate compaction or construction during wet or cold weather.</p> <p data-bbox="1720 919 2141 975">Hydrophilic aggregates used during the constructions.</p>

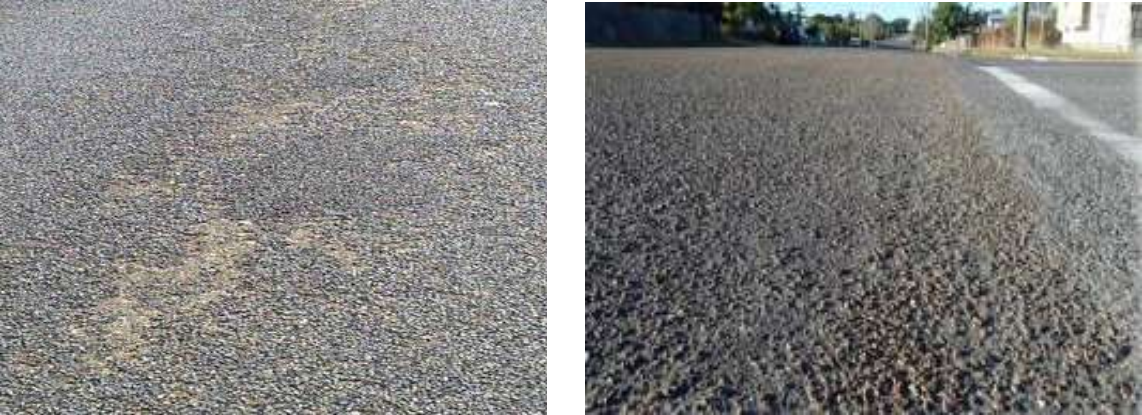
Defect Code	Defect Name	Image + Description	Possible Causes
SS - road CT - carpark	Stripping Seal

<p data-bbox="533 644 1686 703">Removal of the coarse aggregate of a sprayed seal leaving the binder exposed to tyre contact - can happen at the loss of individual stones, or as the complete loss of stone in a localised area.</p>	<p data-bbox="1720 217 2136 472">Low binder contents. Poor binder to stone adhesion (dirty or hydrophilic aggregates, without effective precoating with adhesion agent or wet stone etc.). Aging or absorption of binder. Stone deterioration. Incorrect blending of binder. Inadequate rolling before opening the seal to traffic.</p>
SS - road CT - carpark	Polishing Seal

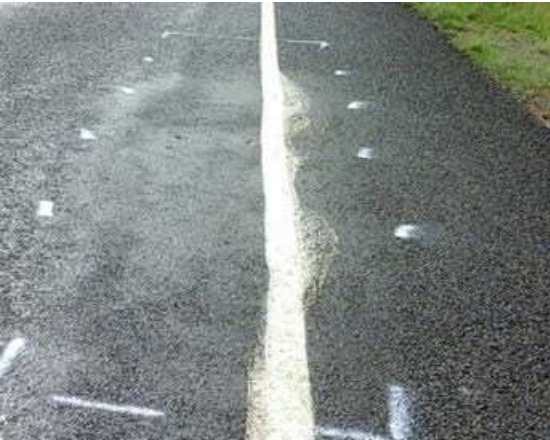
<p data-bbox="533 1187 1659 1281">Smoothing and rounding of the upper surface of the roadstone, usually occurs in the wheel tracks. Identified partly by relative appearance and feel of trafficked and un-trafficked areas. Polished areas will feel relatively smooth and will sometimes be noticeably shiny.</p>	<p data-bbox="1720 735 2119 991">Inadequate resistance to polishing of surface aggregates, particularly in areas of heavy traffic movements, or where high stresses are developed between surface and tyres (e.g. corners, grades). Use of naturally smooth uncrushed aggregate (e.g. water-worn gravel).</p>

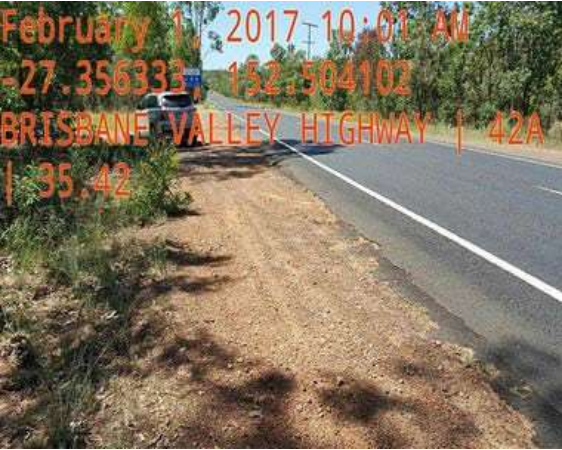
<p data-bbox="533 1278 1653 1342">Longitudinal and relatively smoothly shaped deformation on the shoulder. Wet weather ruts tend to be steep sided and reflect the impression of the tyre into the road surfaces.</p>	Inadequate wet strength of subgrade or pavement layer. Wear by attrition due to traffic or erosion of surface material. Excessive loose material. Traffic compaction of pavement or subgrade.

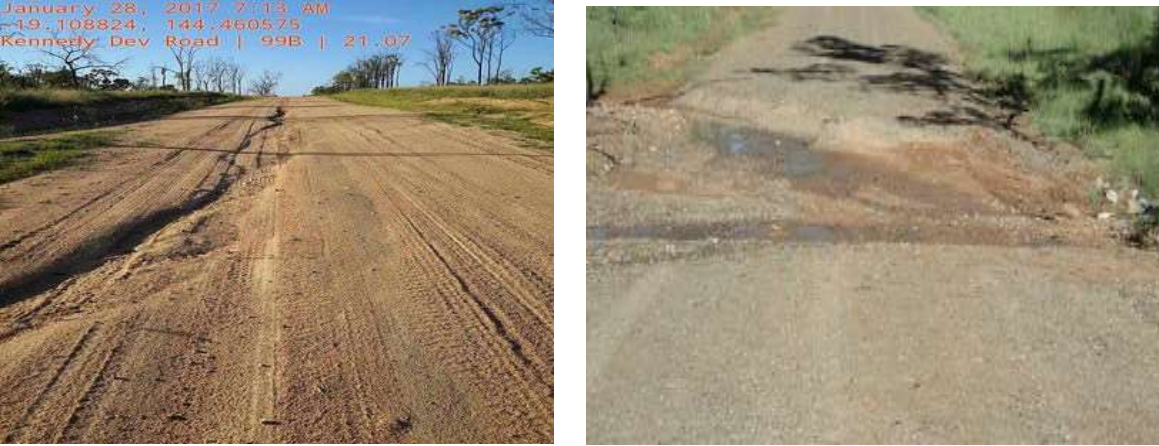
Defect Code	Defect Name	Image + Description	Possible Causes
GS	Scour Channels

<p data-bbox="533 675 1659 730">Steep, irregularly sided, relatively linear feature, commonly in the direction of maximum slope or along a wheel path.</p>	<p data-bbox="1720 217 2141 272">Erodible surfacing materials. Concentration of water flows owing to:</p> <ul style="list-style-type: none"> <li data-bbox="1733 293 2007 352">a) blocked or inadequate road drainage system <li data-bbox="1733 371 2029 400">b) rutting and corrugations.
GD	Loose Stone/Material

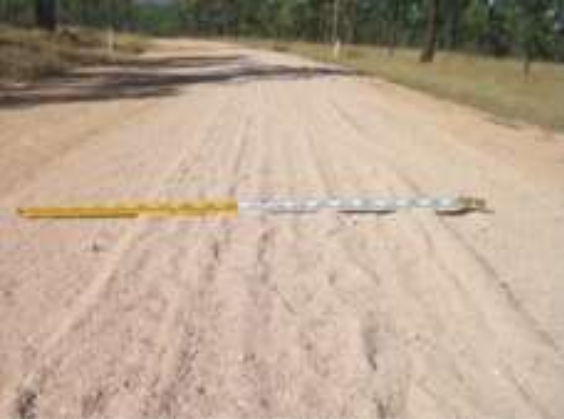
<p data-bbox="533 1203 1659 1294">Unbound fine or coarse gravel materials on the pavement surface. Can occur as a variable thickness layer (sheet) over the whole surface, or in narrow continuous mounds between wheel paths or lanes, or between the outer wheel path and table drains.</p>	<p data-bbox="1720 767 2130 922">Loosening of weakly bound pavement materials due to environmental or traffic actions. Wind or water transportation of materials onto or away from the roadway surface.</p>

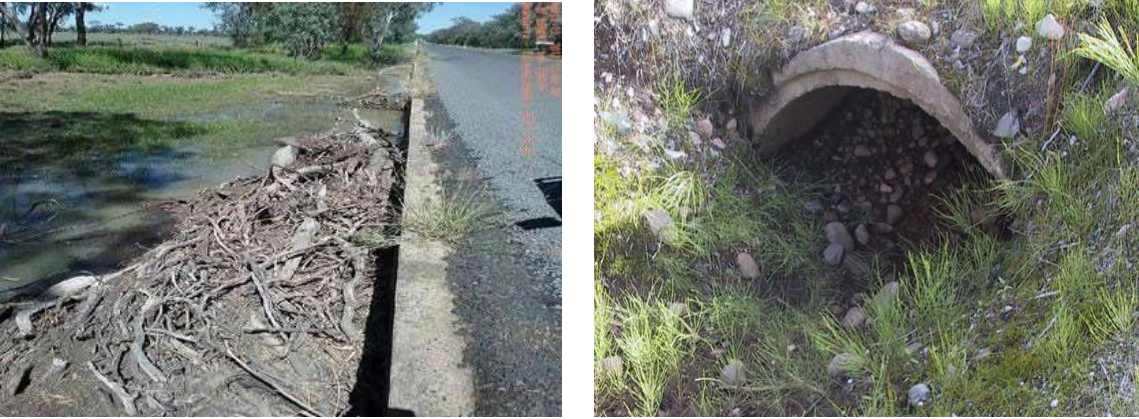
<p data-bbox="533 1241 1668 1302">Any drainage obstruction creating water ponding and not free draining on pavement edge or on shoulder (free draining means water disperses without action of traffic)</p>	<p data-bbox="1720 804 2130 927">Damaged or missing sections of drain. Blocked by debris, stones, roots and branches caused by environmental or human intervention.</p> <p data-bbox="1720 948 2130 1038">Culvert blocked by debris, stones, roots and branches caused by environmental or human intervention.</p>

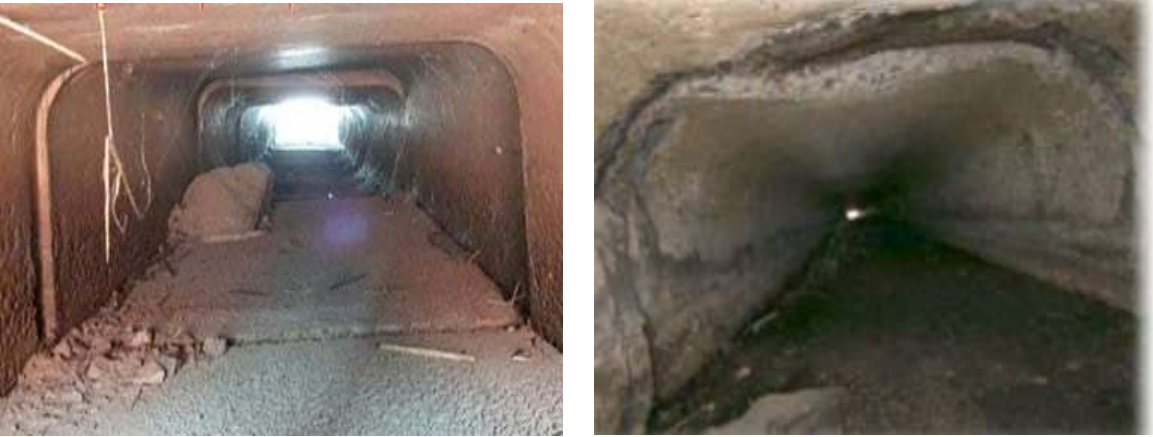
Defect Code	Defect Name	Image + Description	Possible Causes
DC	Misalignment/ separation of culvert components

<p data-bbox="533 667 1137 695">Misalignment and /or separation of culvert components.</p>	<p data-bbox="1720 217 2107 309">Settling or movement of the culvert components due to traffic loading, environmental actions or aging.</p> <p data-bbox="1720 328 2123 421">Culvert and associated drainage work not constructed / installed in accordance with approved design.</p> <p data-bbox="1720 440 2107 501">Inspections during construction & maintenance period not carried out.</p>
DC	Corrosion/ loss of section of steel components (including reinforcement in concrete structures)	  <p data-bbox="533 1182 1675 1211">Corrosion/ loss of section of steel components. Peeling off the reinforcement cover in concrete structures.</p>	<p data-bbox="1720 727 2136 979">Peeling off concrete cover due to extended cracking in the culvert components. Pipe, Culvert, Pit, Floodway and associated drainage works not constructed / installed in accordance with approved design. Proper inspections during construction & maintenance period not carried out.</p>

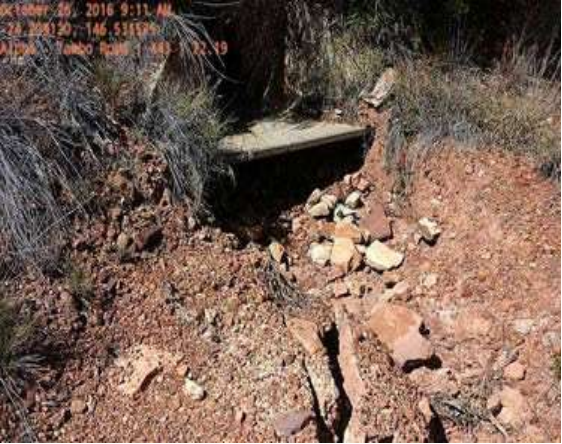
Defect Code	Defect Name	Image + Description	Possible Causes
DC	Scouring around culvert components

<p data-bbox="533 675 936 702">Scouring around culvert components.</p>	Culvert blocked by debris, stones, roots and branches caused by environmental or human intervention. Outlet not free flowing.
CR	Cracks in Concrete Roadway		
CR	Block Cracks

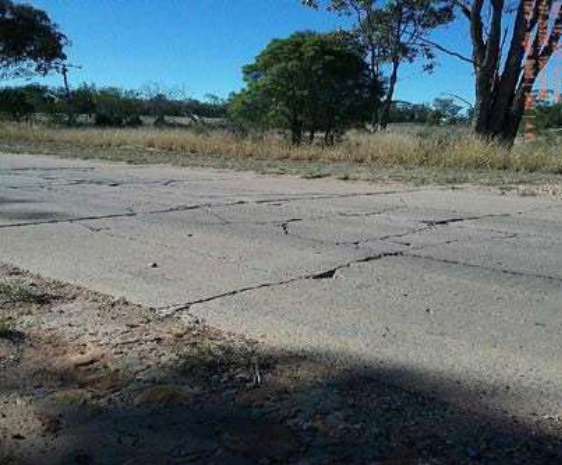
<p data-bbox="533 1275 1576 1334">Interconnected cracks forming a series of blocks, approximately rectangular in shape, commonly distributed over the full pavement. Cell sizes are usually greater than 1 m.</p>	Generally a combination of traffic loading and loss of support. Insufficient slab thickness. Loss of sub-base or subgrade support. Subgrade settlement.

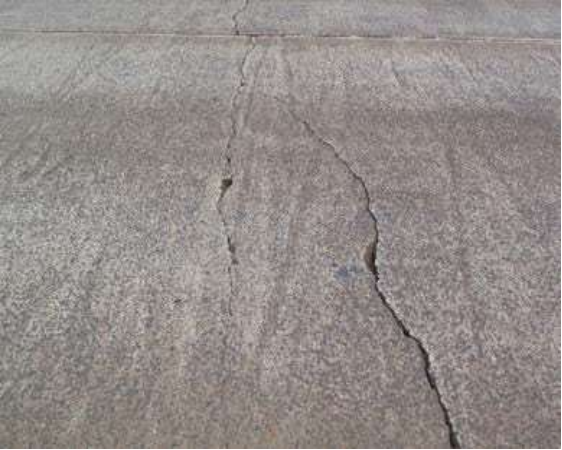
Defect Code	Defect Name	Image + Description	Possible Causes
CR	Longitudinal Cracks

<p data-bbox="533 679 1626 735">Unconnected crack running longitudinally along the pavement. Can occur singly or as series of almost parallel cracks.</p>	<p data-bbox="1720 217 2145 451">Generally a combination of traffic loading and loss of support. Differential settlement. Lateral shrinkage associated with excessive slab width. Longitudinal joint too close to traffic lane. Longitudinal joint too shallow. Insufficient slab thickness.</p>
CR	Transverse Cracks

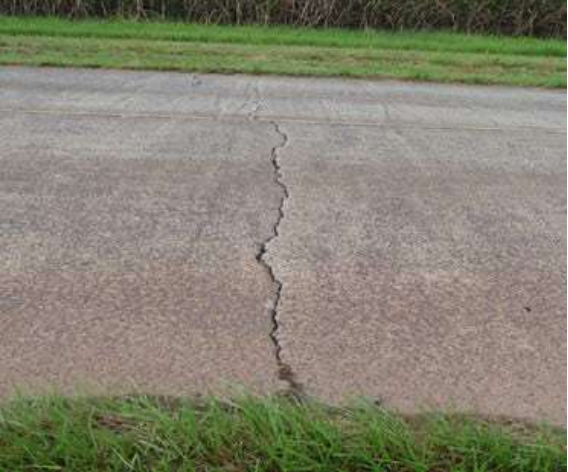
<p data-bbox="533 1257 1256 1286">Unconnected crack running transversely across the pavement/slab.</p>	<p data-bbox="1720 770 2123 927">Normal shrinkage. Shrinkage of slab during curing, associated with excess slab lengths or joints sawn too late. Insufficient slab thickness. Rocking of slab.</p>

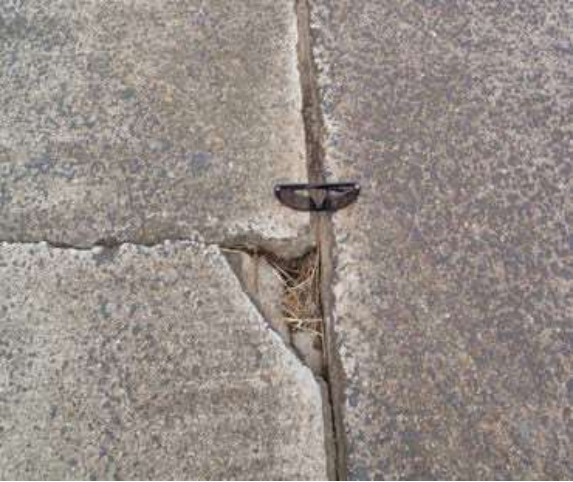
<p data-bbox="533 711 1637 767">A crack that intersects the slab joints near the corner. A crack extending diagonally from a longitudinal edge to a transverse joint.</p>	<p data-bbox="1720 217 2130 373">Severe corner stresses caused by load repetitions combined with a loss support, poor load transfer across the joint. Insufficient slab thickness. Loss of sub-base or subgrade support.</p>
CR	Spalling of Joints - Concrete Pavement

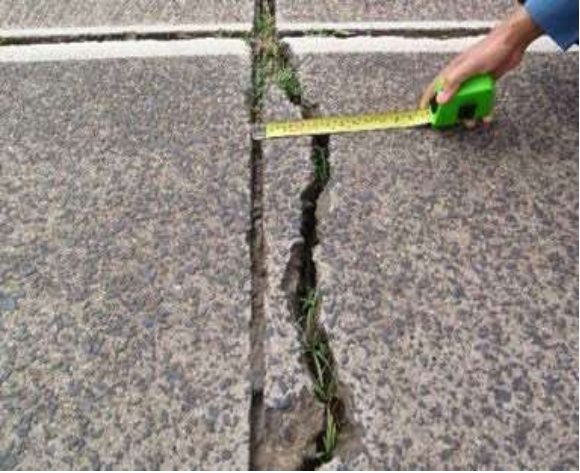
<p data-bbox="533 1289 1070 1318">Cracking, breaking or chipping of joint/crack edge.</p>	<p data-bbox="1720 802 2119 994">Reduces slab contact area and provides incompressible materials fill the joint or crack. Severe corner stresses caused by load repetitions combined with a loss support, poor load transfer across the joint.</p> <p data-bbox="1720 1010 2130 1137">Corrosion of reinforcing or dowel bars. Misalignment of dowel bars. Sub-base movement. Poor quality concrete aggregate.</p>

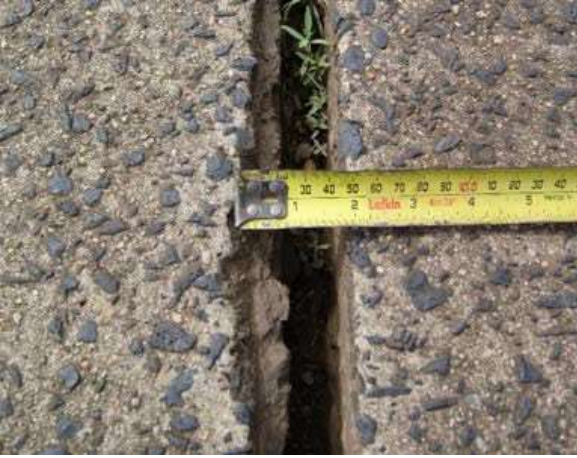
<p data-bbox="533 687 1619 746">Loss and/or cracking of the seal resulting in foreign material in the joints. Extrusion of sealant leaving mound at the joint.</p>	<p data-bbox="1720 217 2145 507">Ageing and weathering of sealant. Poor preparation or quality of sealant (for example, overheating of poured sealant). Lack of adhesion of sealant to joint wall. Poor cyclic tension and compression properties. Too much sealant in the joint. Poor shape of sealing joint. Insufficient sealant in the joint. Pumping. Slab rocking.</p>
CR	Sunken Concrete Pavement Slab (Stepping)

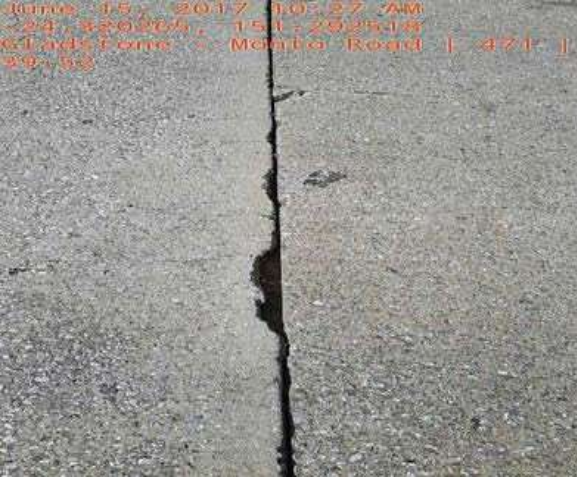
<p data-bbox="533 1270 1686 1329">A difference in elevation across a joint or crack. Usually, the approach slab is higher than the leave slab due to pumping.</p>	<p data-bbox="1720 778 2134 906">Stepping is commonly due to slab settlement, slab pumping, curling and warping. Poor compaction of sub-base layers. Poor subgrade support.</p> <p data-bbox="1720 922 2107 1018">Differential settlement of subgrade. Loss of fines from sub-base or subgrade through pumping.</p>

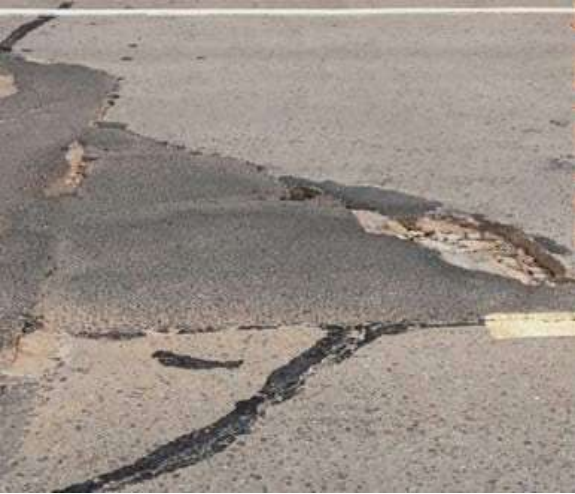
<p data-bbox="533 722 1563 751">An area of pavement that has been replaced with new material to repair the existing pavement.</p>	<p data-bbox="1720 217 2130 373">Previous localised pavement deterioration that has been removed and patched. Correction of surface or structural deficiencies. Reinstatement after excavation for services.</p>
LT	Litter and Gross Pollutant Trap Defects

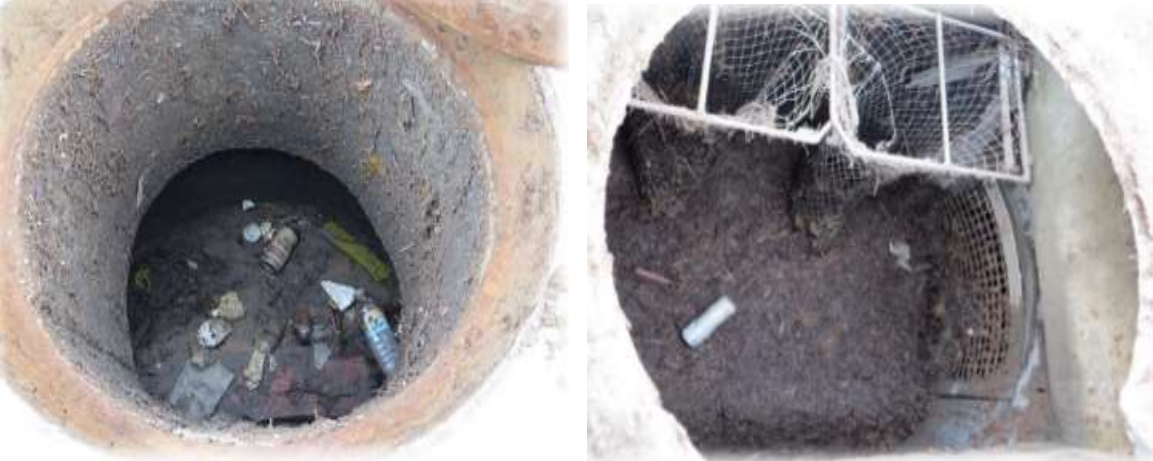
<p data-bbox="533 1262 1615 1321">Any non-functional, blocked or inoperable decayed element of the trap system causing reduced flow capacity or drainage integrity.</p>	<p data-bbox="1720 783 2130 874">Blocked by soil, stones, roots and any other caused by environmental or human intervention.</p>

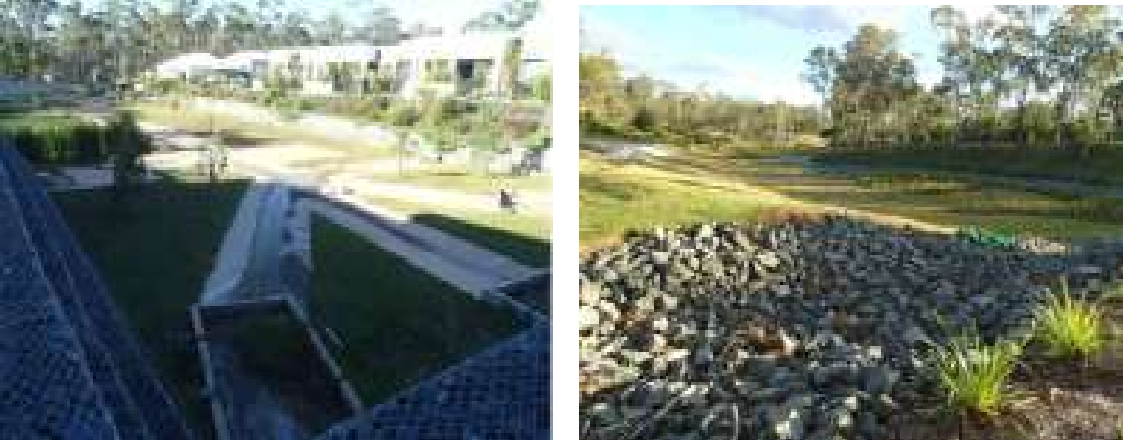
<p data-bbox="533 1211 943 1238">Silted or unserviceable basin facilities.</p>	<p data-bbox="1720 754 2114 847">Basins not acting in accordance with design. No proper periodic maintenance program in place.</p>

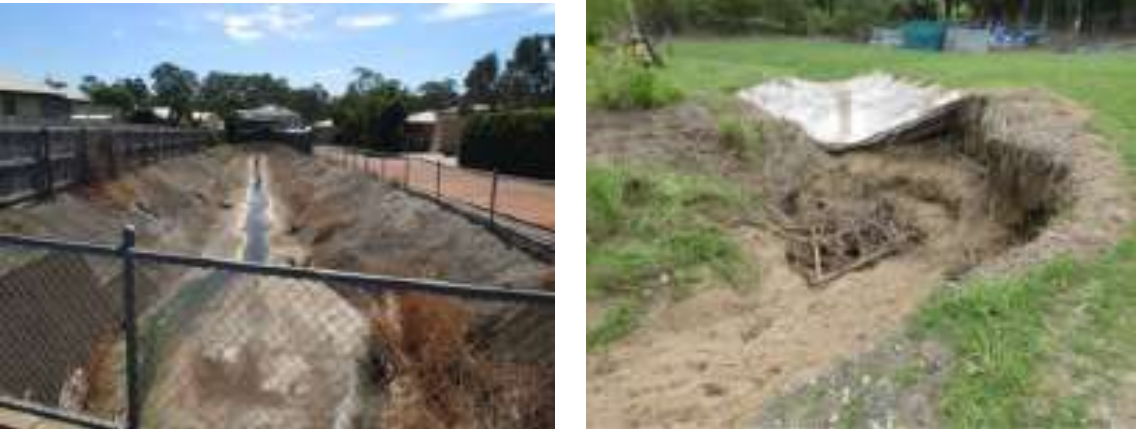
<p data-bbox="533 1187 1162 1216">Silted or unserviceable concrete lined open drain facilities.</p>	Concrete lined open drain not acting in accordance with design. No proper periodic maintenance program in place.

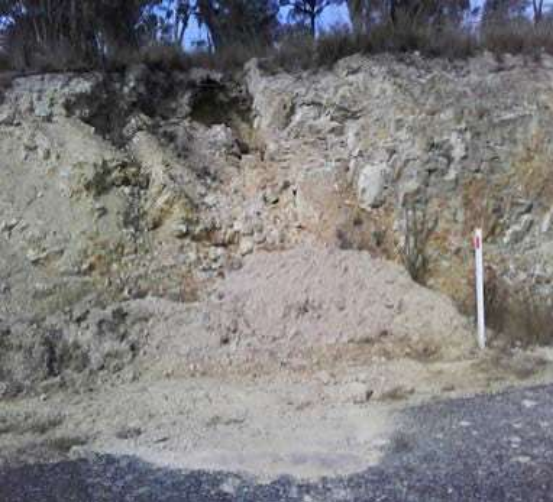
<p data-bbox="533 735 1568 794">Cut or Embankment with cracks, erosion or instability that may create dangerous or unsafe road environment.</p>	Material of poor quality, insufficient compaction of material, material scoured away due to excessive water run-off. Unstable batter or cut due wet weather conditions.
AC	Damaged Concrete or Paving Blocks

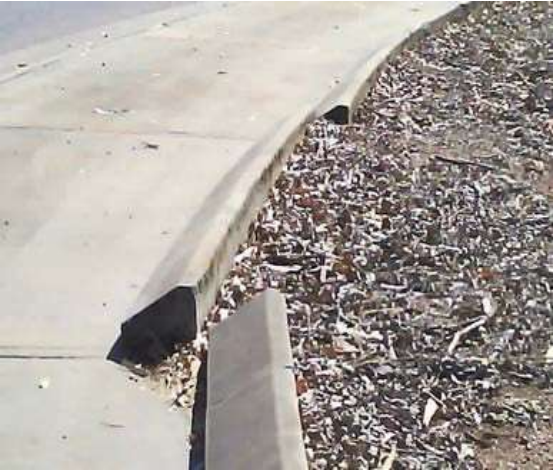
<p data-bbox="533 1310 1456 1337">Damaged, displaced concrete or paving blocks in pedestrian areas, road environment.</p>	Damage to concrete or pavement block caused by environmental, human or vehicular intervention.

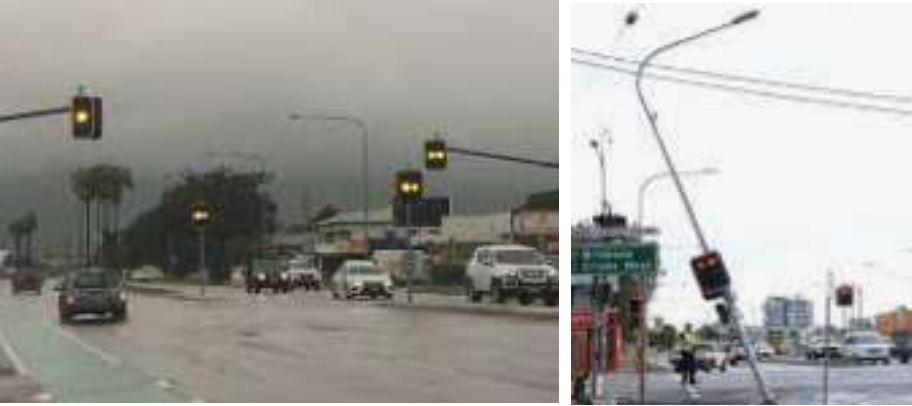
<p>Flashing Yellow:</p> <ul style="list-style-type: none"> • Confusing signal displays; Loss of displays • Misaligned lantern causing confusing signal displays • Damaged or open door on lantern • Damaged lantern or lantern parts at risk of falling • Twisted & non confusing lantern arrangement • Missing or damaged hardware (i.e. missing pole and/or associated hardware) • Lamp outages; Visors, cowls, louvers or target boards missing or damaged • Poor lantern aiming • Pit marker post missing 	<p>Broken or operationally degraded traffic signal controller due to one or a number of internal components being compromised. Access compromised as a result of vandals.</p> <p>Broken or operationally degraded signal lanterns.</p> <p>Electrical faults or damage of the traffic signal</p> <p>Broken or missing traffic signal hardware.</p>

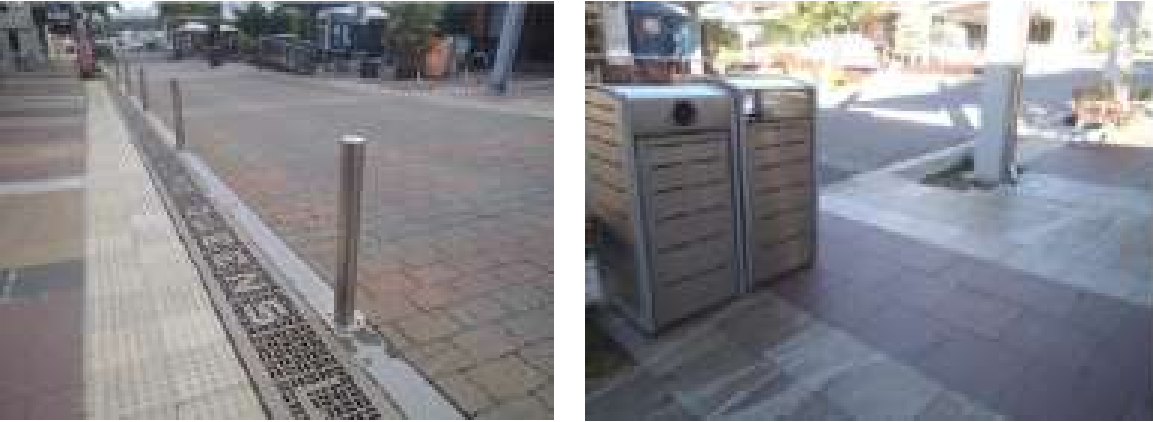
AZ – road CA - carpark	Streetscape Defects

Streetscape is damaged due to environmental, human or vehicular intervention.

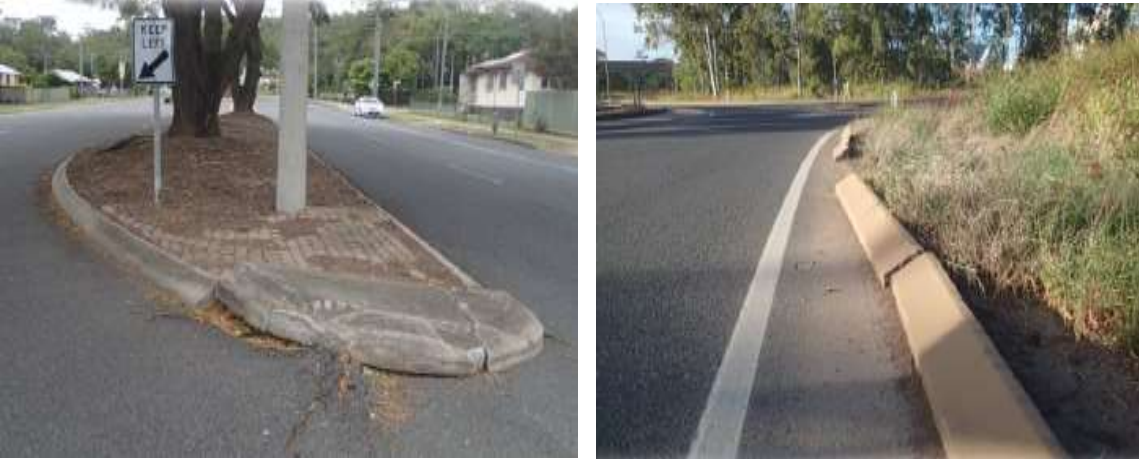
<p data-bbox="533 691 741 715">Kerb displacement.</p>	Kerb or paved median is missing or damaged due to environmental, human or vehicular intervention.
RL - road CM- carpark	Missing or Faded Painted Road Lines and Markings

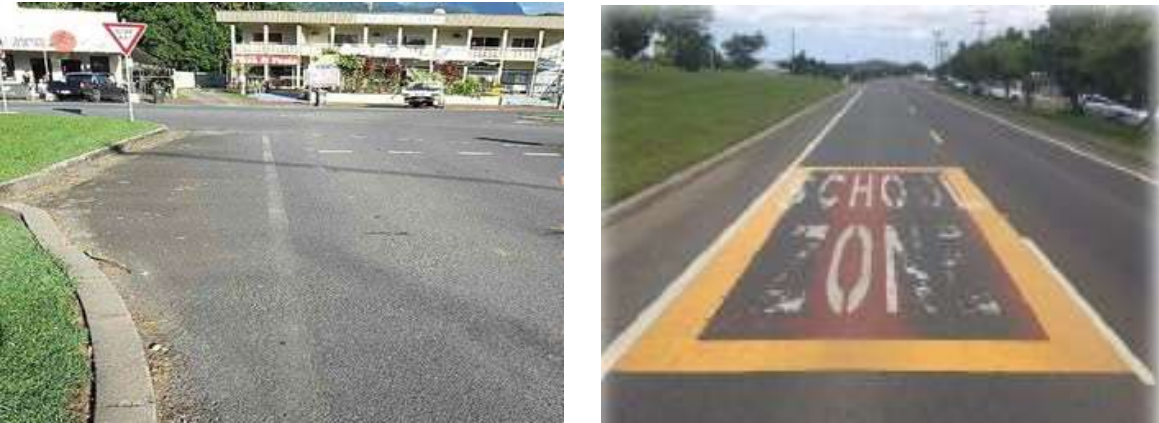
<p data-bbox="533 1185 1211 1209">Road marking are faded, missing, incomplete or unsatisfactory.</p>	Road Lines and Markings are missing or damaged due to environmental, human or vehicular intervention.

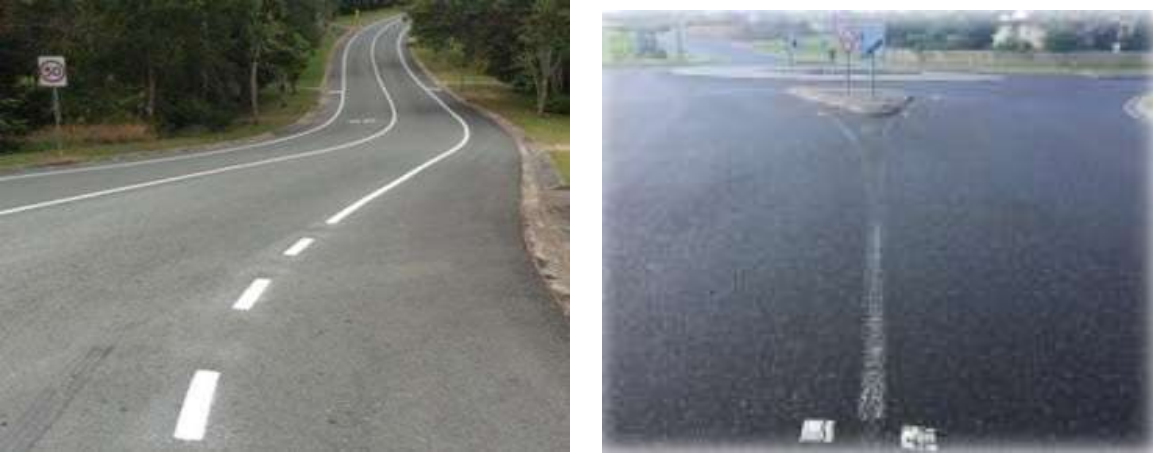
<p data-bbox="533 683 1435 711">Loss of, or loss of reflectivity (%) of markers or any consecutive markers are missing.</p>	<p data-bbox="1720 217 2130 308">Raised Pavement Marker is missing or damaged due to environmental, human or vehicular intervention.</p>
LS – road CY - carpark	Lighting Switchboard Defects

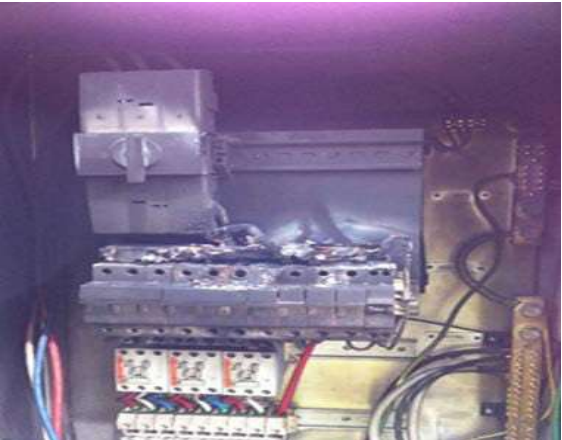
<p data-bbox="533 1198 1570 1257">Unsafe, unrestricted, broken and/or operationally degraded lighting switchboard. (e.g. failure of switchboard, door open or pillar cover dislodged).</p>	<p data-bbox="1720 743 2085 834">Lighting switchboard is missing or damaged due to environmental, human or vehicular intervention.</p>

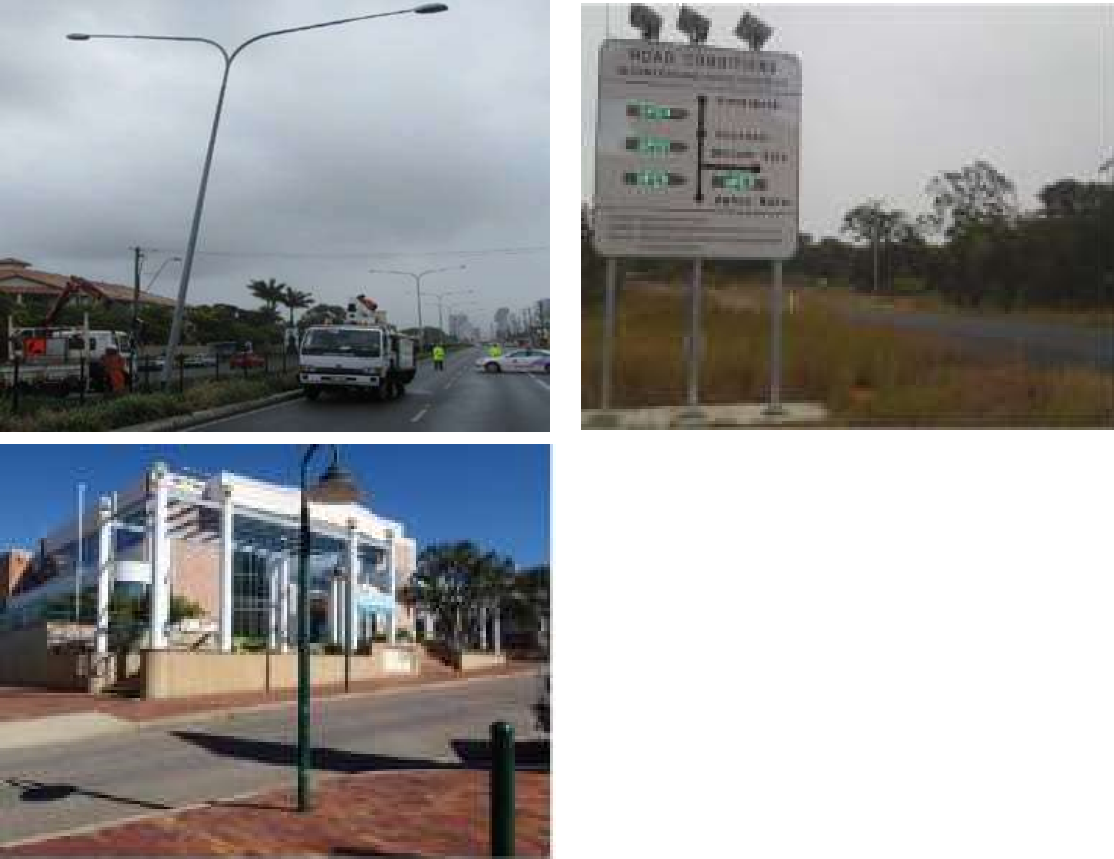
<p>Unsafe, missing, broken and/or operationally degraded lighting hardware. (e.g. pole knocked down, luminaire visor/diffuser not secure/hanging Or light is displaced/ re-aligned).</p>	<p>Lighting hardware is missing or damaged due to environmental, human or vehicular intervention.</p>

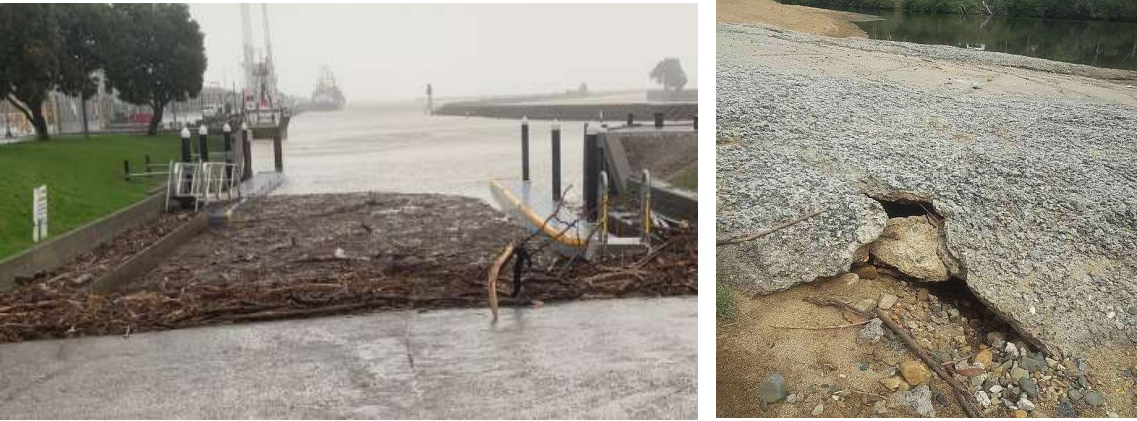
<p data-bbox="533 651 1167 679">Debris that is likely to affect the usability of the jetty/ramp.</p>	Boat Ramp/Jetty defects caused by environmental, human or vehicular intervention.
FS	Footpath Surface Defects

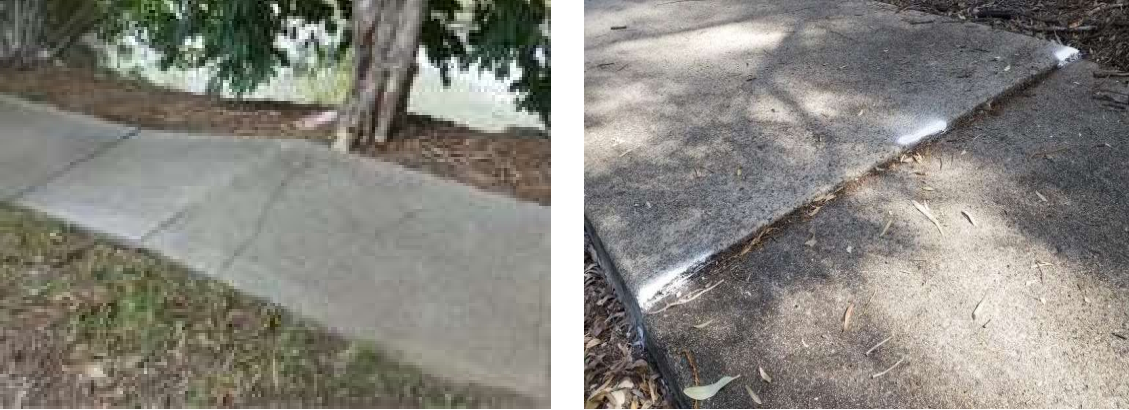
Footpath / Lane Surface is missing or damaged due to environmental, human or vehicular intervention.

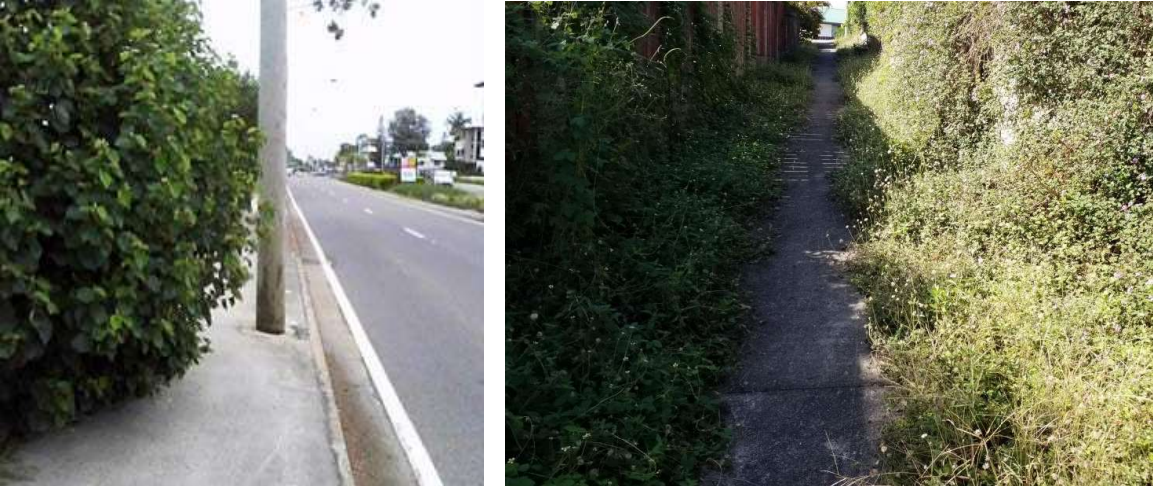
<p data-bbox="533 715 1682 778">Trees, overhanging branches or broken limbs most likely to fall on footpath to be a hazard. Unwanted trees and shrubs or grass obscures in sightlines.</p>	Ongoing maintenance not carried out in accordance with departmental requirements & standards.
FR	Footpath Pram Ramp Defects

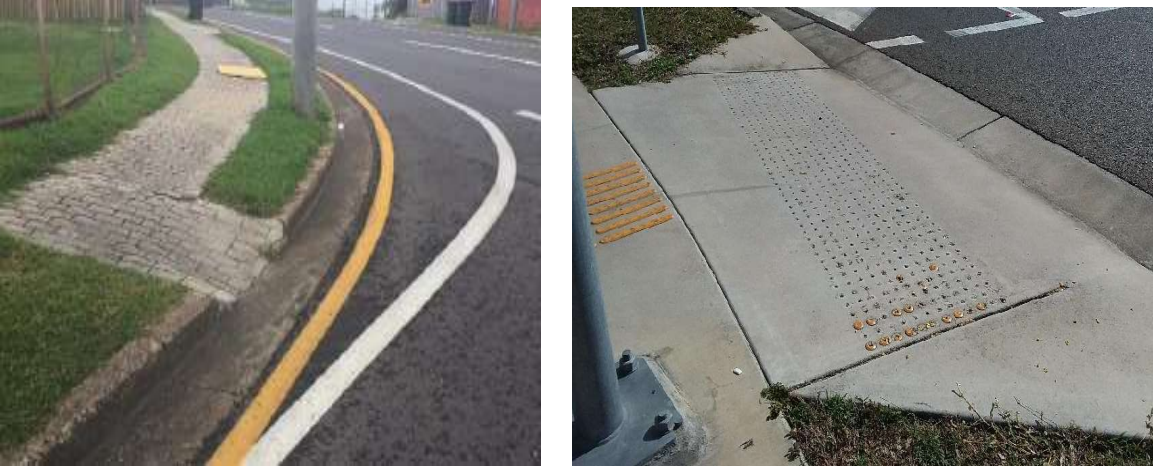
<p data-bbox="533 1289 1646 1353">Pram Ramp is non-compliant with current standards, and existing footpath geometry and surroundings would enable a compliant Pram Ramp to be constructed.</p>	Ongoing maintenance not carried out in accordance with requirements & standards.

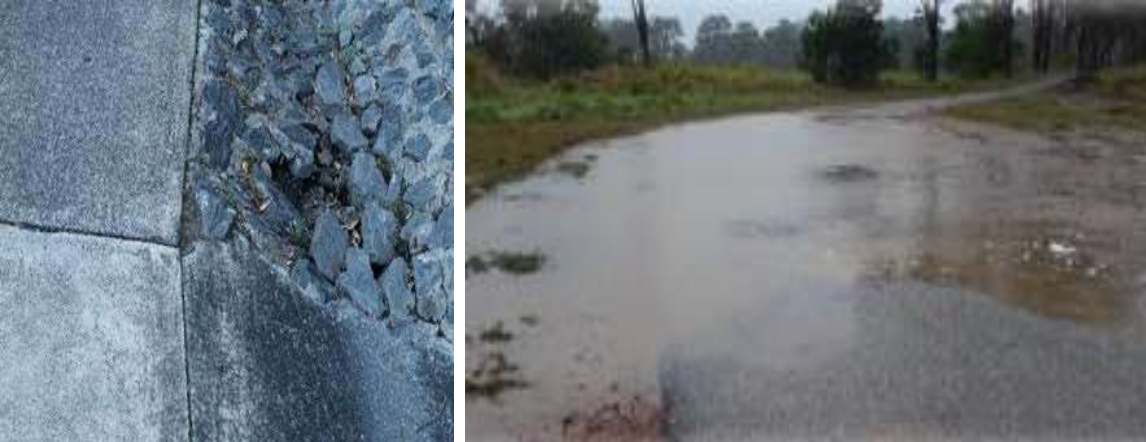
<p data-bbox="533 675 1630 730">Culverts, pipes and pits defects likely to impact on the integrity of the unit. Obstructed drainage cause water ponding on or adjacent to footpath or private property.</p>	<p data-bbox="1720 217 2074 371">Drainage system not acting in accordance with design. Periodic maintenance not carried out in accordance with departmental guidelines.</p>
FB	Footpath Pedestrian Bridge and Elevated Walkway defects

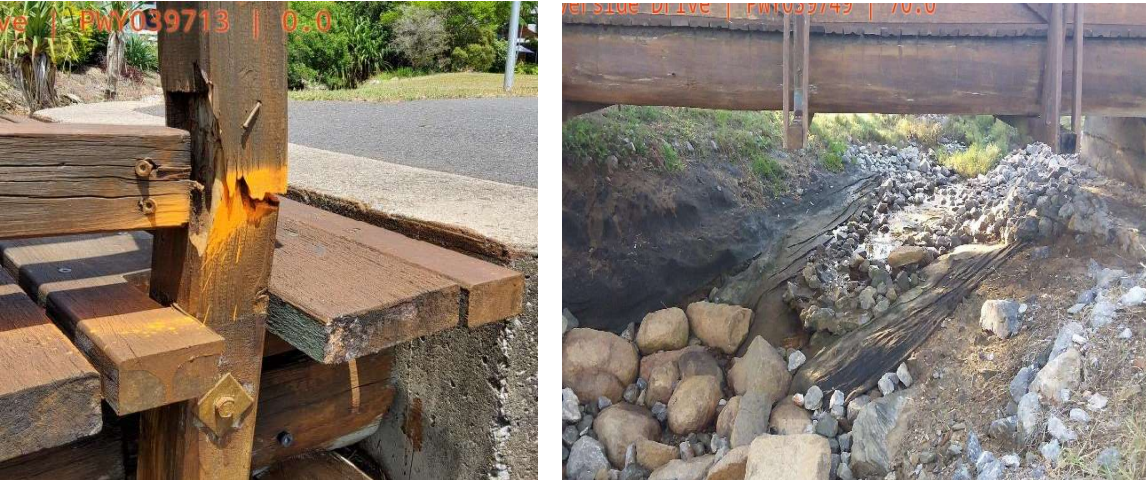
<p data-bbox="533 1262 1671 1318">Debris on footpath bridges that is likely to interrupt the drainage facility, operation or expansion joints or affect the usability of the bridge.</p>	<p data-bbox="1720 766 2107 855">Footpath bridge defects caused by environmental, human or vehicular intervention.</p>

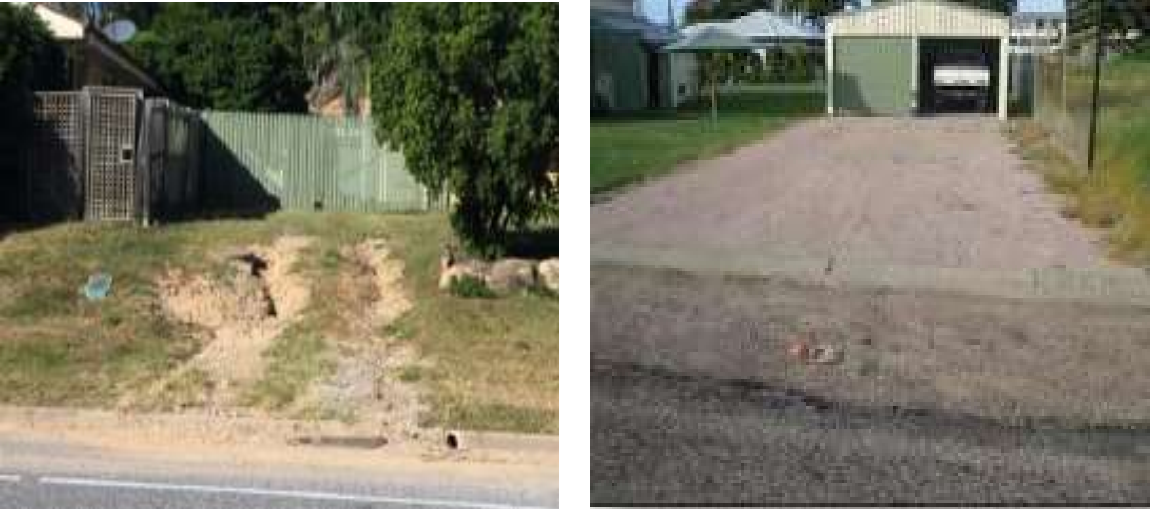
<p data-bbox="533 740 1576 804">Property access is the responsibility of the Property Owner. Property access to be constructed in accordance with Council building regulations.</p>	<p data-bbox="1720 213 2101 277">Property access not constructed in accordance with regulations.</p> <p data-bbox="1720 293 2101 357">Vehicles accessing properties using non-access area.</p> <p data-bbox="1720 373 2136 469">Property access is missing or damaged due to environmental, human or vehicular intervention.</p>
