Gladstone Regional Council Roads Maintenance Guideline

November 2023

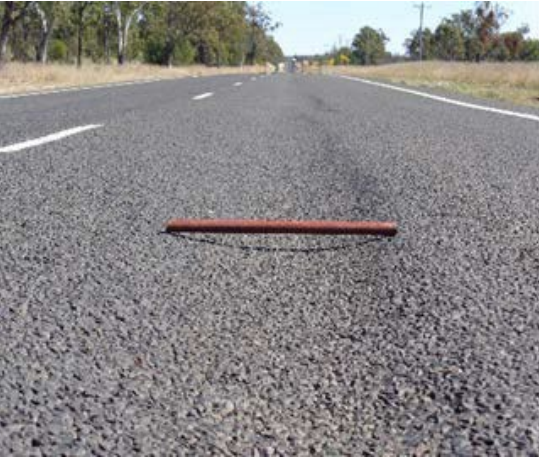
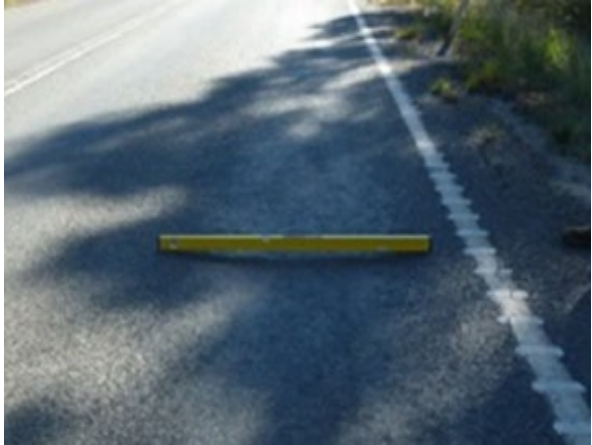
</div> <p>Ruts in pavements are channelised depressions in the wheel paths, generally appears in long sections due to consolidation or lateral movement of pavement or subgrade due to traffic action.</p>	<p>Pavement age, frequent presence of overloaded vehicles and/or heavy vehicles on the pavement.</p> <p>Inadequate pavement layer thickness. Inadequate compaction in surfacing or base layers. Inadequate strength in surfacing or base layers.</p>
<p>SP - road CP - carpark</p>	<p>Potholes in Bituminous Surface</p>	<div style="display: flex; justify-content: space-around;">     </div> <p>Loss of a large, discrete area of the surfacing layer. Surfacing layer separation from the below layer is clearly visible in most situations.</p>	<p>Poor bond between upper surfacing layer and layer below due to inadequate cleaning or inadequate tack coat before placement of upper surfacing layers</p> <p>Weakening of the bond between surfacing layer and the below layer due to various reasons such as water ingress, traffic action.</p> <p>Loss/damage surfacing layer due to binder adhesion to tyres.</p>

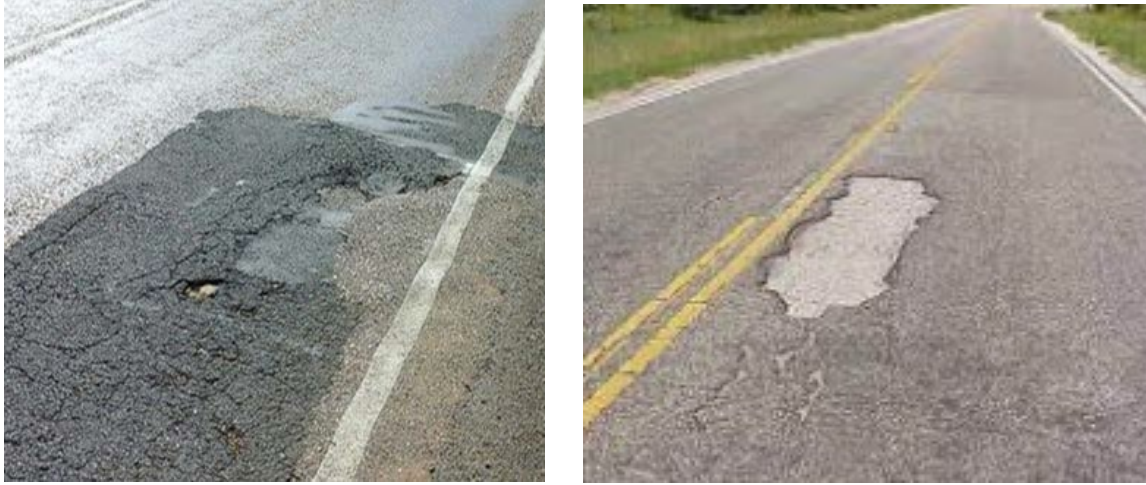
Defect Code	Defect Name	Image + Description	Possible Causes
SP - road CP - carpark	Delamination in Bituminous Surface

<p data-bbox="528 715 1693 770">Loss of a large, discrete area of the surfacing layer. Surfacing layer separation from the below layer is clearly visible in most situations.</p>	<p data-bbox="1715 217 2112 371">Poor bond between upper surfacing layer and layer below due to inadequate cleaning or inadequate tack coat before placement of upper surfacing layers</p> <p data-bbox="1715 392 2112 515">Weakening of the bond between surfacing layer and the below layer due to various reasons such as water ingress, traffic action.</p> <p data-bbox="1715 536 2112 595">Loss/damage surfacing layer due to binder adhesion to tyres.</p>
CC - road CR - carpark	Crocodile Cracking in Bituminous Surface

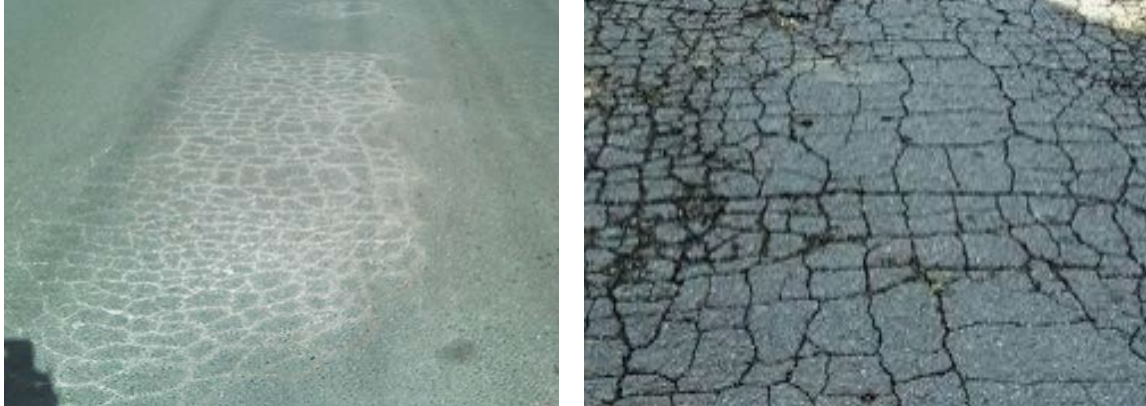
<p data-bbox="528 1230 1693 1318">Small irregular shape polygons formed generally in wheel paths. Plate/cell sizes are normally less than 150 mm. Crocodile cracking is load-related and it normally starts in the wheel path as longitudinal cracking and ends up as crocodile cracking after severe distress.</p>	<p data-bbox="1715 807 2112 834">Insufficient pavement layer thickness.</p> <p data-bbox="1715 855 2112 914">Brittle base or wearing course due to age or cemented base.</p> <p data-bbox="1715 935 2112 1026">The failure can be due to weakness in the surface, base or sub grade or poor drainage.</p>

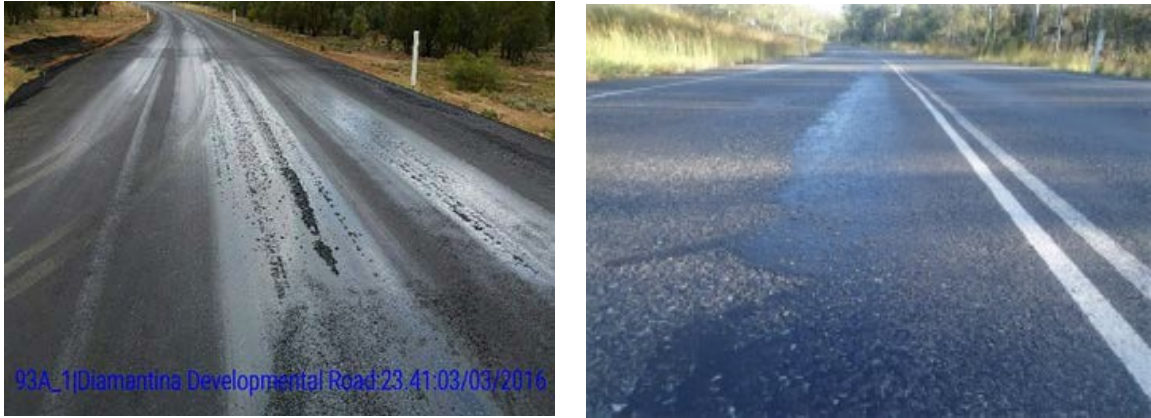
Defect Code	Defect Name	Image + Description	Possible Causes
SF - road CF - carpark	Flushing, Bleeding Seal

<p data-bbox="528 644 1675 703">Presence of excess bitumen in the pavement surface layer which creates patches with low skid resistance due to inadequate tyre- to-stone contact.</p>	<p data-bbox="1715 213 2145 405">Excessive application rate of binder, with respect to stone size. Excessive prime coat being incorporated into the seal. Excess binder in underlying patch or flushed area. Penetration of aggregate into low strength base.</p> <p data-bbox="1715 421 2145 485">Primer seal covered before volatiles in primer binder have evaporated.</p>
SS - road CT - carpark	Ravelling Seal

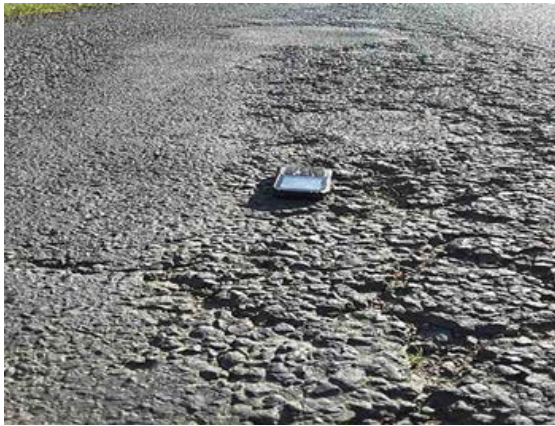
<p data-bbox="528 1173 1597 1232">Initially fine aggregate breaks loose and leave small patches in the pavement surface. That leads to progressive disintegration of the pavement surface by loss of both binder and aggregates.</p>	<p data-bbox="1715 735 2085 799">Insufficient adhesion between the asphalt and the aggregate.</p> <p data-bbox="1715 815 2145 906">Deterioration of binder and/or stone. Inadequate compaction or construction during wet or cold weather.</p> <p data-bbox="1715 911 2145 975">Hydrophilic aggregates used during the constructions.</p>

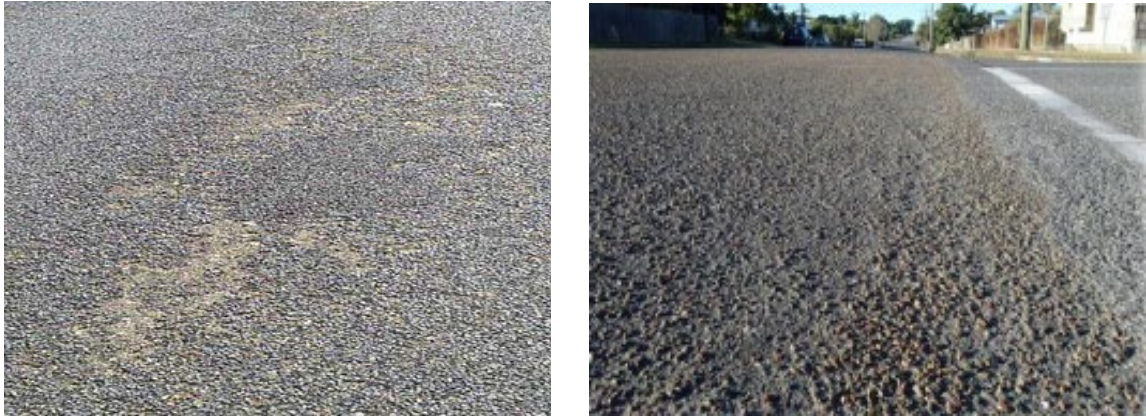
Defect Code	Defect Name	Image + Description	Possible Causes
SS - road CT - carpark	Stripping Seal

<p data-bbox="528 643 1682 703">Removal of the coarse aggregate of a sprayed seal leaving the binder exposed to tyre contact - can happen at the loss of individual stones, or as the complete loss of stone in a localised area.</p>	<p data-bbox="1715 213 2136 472">Low binder contents. Poor binder to stone adhesion (dirty or hydrophilic aggregates, without effective precoating with adhesion agent or wet stone etc.). Aging or absorption of binder. Stone deterioration. Incorrect blending of binder. Inadequate rolling before opening the seal to traffic.</p>
SS - road CT - carpark	Polishing Seal

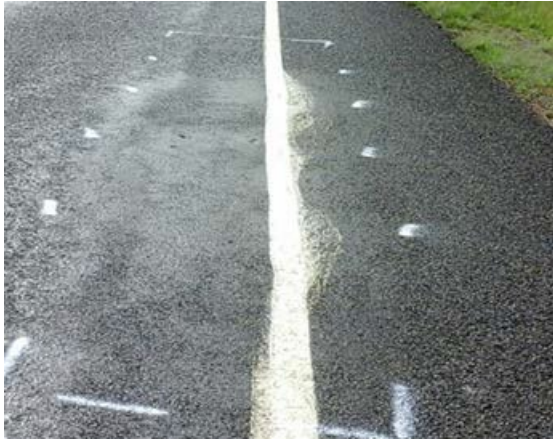
<p data-bbox="528 1185 1659 1278">Smoothing and rounding of the upper surface of the roadstone, usually occurs in the wheel tracks. Identified partly by relative appearance and feel of trafficked and un-trafficked areas. Polished areas will feel relatively smooth and will sometimes be noticeably shiny.</p>	<p data-bbox="1715 730 2119 991">Inadequate resistance to polishing of surface aggregates, particularly in areas of heavy traffic movements, or where high stresses are developed between surface and tyres (e.g. corners, grades). Use of naturally smooth uncrushed aggregate (e.g. water-worn gravel).</p>

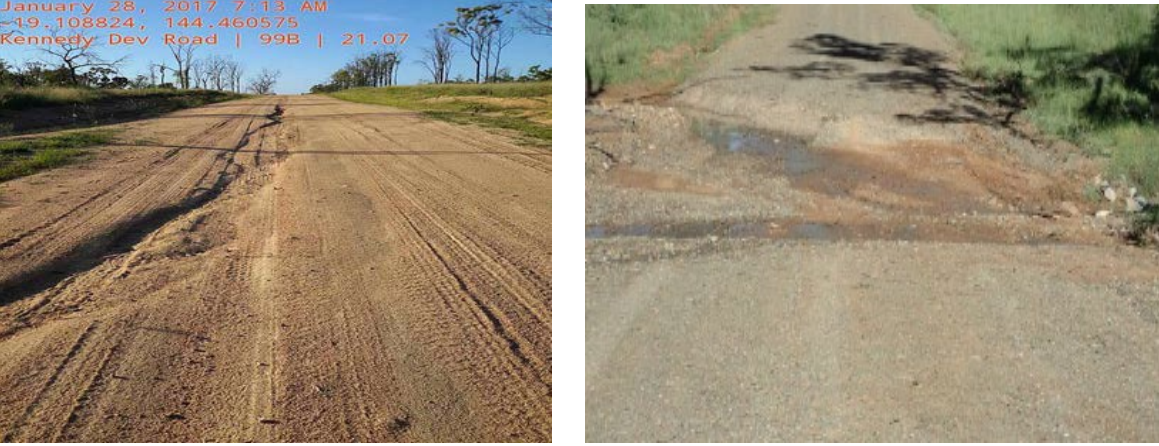
Defect Code	Defect Name	Image + Description	Possible Causes
GS	Scour Channels

<p data-bbox="533 675 1659 730">Steep, irregularly sided, relatively linear feature, commonly in the direction of maximum slope or along a wheel path.</p>	<p data-bbox="1720 212 2141 276">Erodible surfacing materials. Concentration of water flows owing to:</p> <ul style="list-style-type: none"> <li data-bbox="1731 292 2007 355">a) blocked or inadequate road drainage system <li data-bbox="1731 371 2029 403">b) rutting and corrugations.
GD	Loose Stone/Material

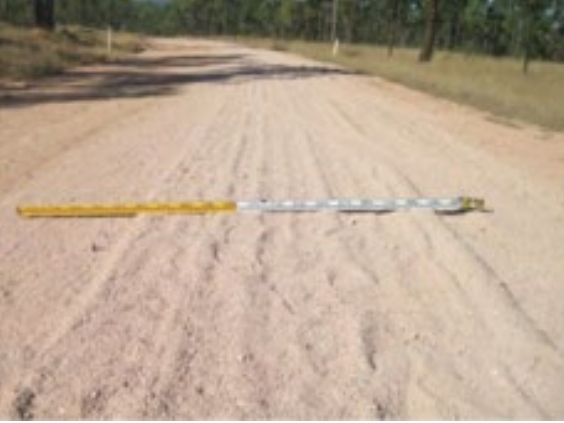
<p data-bbox="533 1201 1659 1297">Unbound fine or coarse gravel materials on the pavement surface. Can occur as a variable thickness layer (sheet) over the whole surface, or in narrow continuous mounds between wheel paths or lanes, or between the outer wheel path and table drains.</p>	<p data-bbox="1720 762 2130 922">Loosening of weakly bound pavement materials due to environmental or traffic actions. Wind or water transportation of materials onto or away from the roadway surface.</p>

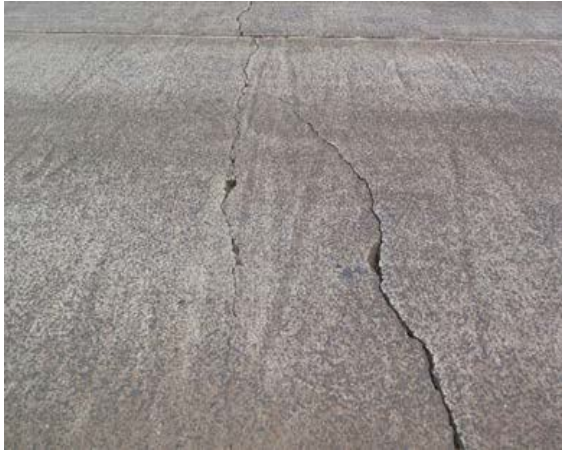
Defect Code	Defect Name	Image + Description	Possible Causes
CR	Longitudinal Cracks

<p data-bbox="528 676 1626 735">Unconnected crack running longitudinally along the pavement. Can occur singly or as series of almost parallel cracks.</p>	<p data-bbox="1715 213 2148 448">Generally a combination of traffic loading and loss of support. Differential settlement. Lateral shrinkage associated with excessive slab width. Longitudinal joint too close to traffic lane. Longitudinal joint too shallow. Insufficient slab thickness.</p>
CR	Transverse Cracks

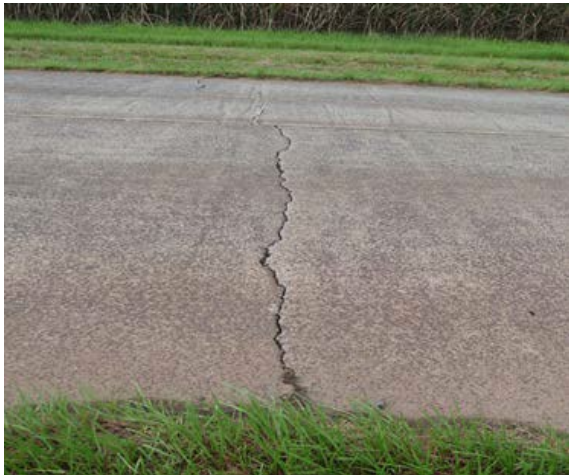
<p data-bbox="528 1254 1252 1281">Unconnected crack running transversely across the pavement/slab.</p>	<p data-bbox="1715 767 2119 927">Normal shrinkage. Shrinkage of slab during curing, associated with excess slab lengths or joints sawn too late. Insufficient slab thickness. Rocking of slab.</p>

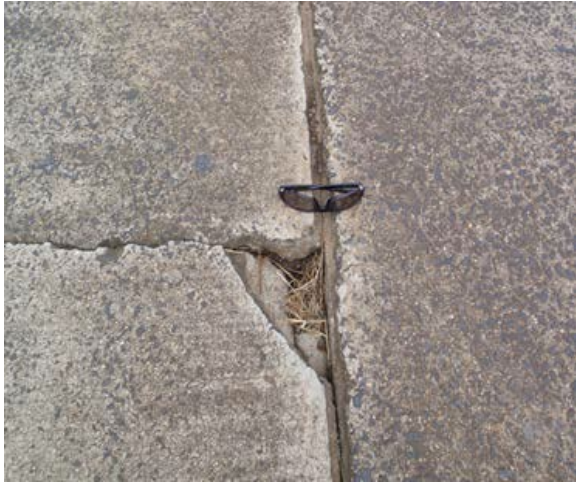
Defect Code	Defect Name	Image + Description	Possible Causes
CR	Corner Cracks

<p data-bbox="528 708 1637 767">A crack that intersects the slab joints near the corner. A crack extending diagonally from a longitudinal edge to a transverse joint.</p>	<p data-bbox="1715 213 2130 373">Severe corner stresses caused by load repetitions combined with a loss support, poor load transfer across the joint. Insufficient slab thickness. Loss of sub-base or subgrade support.</p>
CR	Spalling of Joints - Concrete Pavement

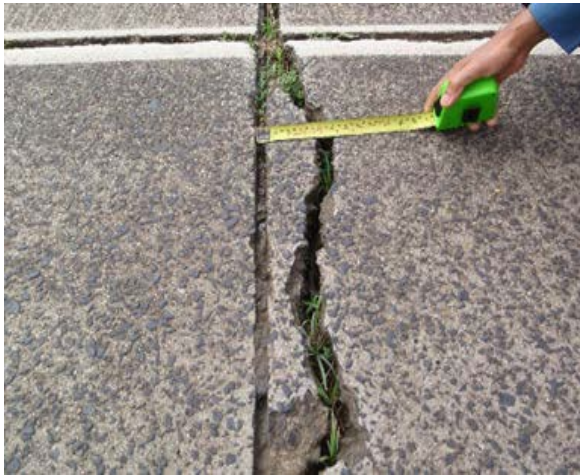
<p data-bbox="528 1286 1070 1315">Cracking, breaking or chipping of joint/crack edge.</p>	<p data-bbox="1715 799 2119 991">Reduces slab contact area and provides incompressible materials fill the joint or crack. Severe corner stresses caused by load repetitions combined with a loss support, poor load transfer across the joint.</p> <p data-bbox="1715 1007 2130 1134">Corrosion of reinforcing or dowel bars. Misalignment of dowel bars. Sub-base movement. Poor quality concrete aggregate.</p>

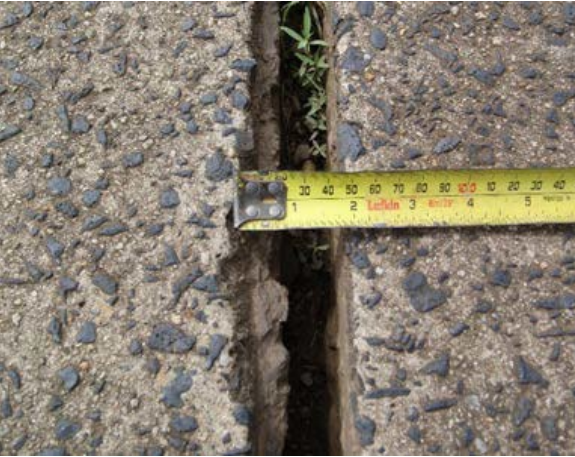
Defect Code	Defect Name	Image + Description	Possible Causes
CR	Joint Sealant Defects in Concrete Pavement

<p data-bbox="533 683 1619 746">Loss and/or cracking of the seal resulting in foreign material in the joints. Extrusion of sealant leaving mound at the joint.</p>	<p data-bbox="1720 213 2145 507">Ageing and weathering of sealant. Poor preparation or quality of sealant (for example, overheating of poured sealant). Lack of adhesion of sealant to joint wall. Poor cyclic tension and compression properties. Too much sealant in the joint. Poor shape of sealing joint. Insufficient sealant in the joint. Pumping. Slab rocking.</p>
CR	Sunken Concrete Pavement Slab (Stepping)

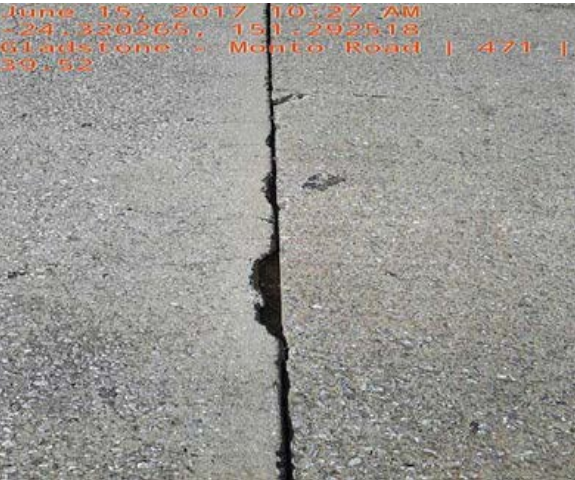
<p data-bbox="533 1267 1686 1331">A difference in elevation across a joint or crack. Usually, the approach slab is higher than the leave slab due to pumping.</p>	<p data-bbox="1720 775 2134 903">Stepping is commonly due to slab settlement, slab pumping, curling and warping. Poor compaction of sub-base layers. Poor subgrade support.</p> <p data-bbox="1720 919 2107 1015">Differential settlement of subgrade. Loss of fines from sub-base or subgrade through pumping.</p>

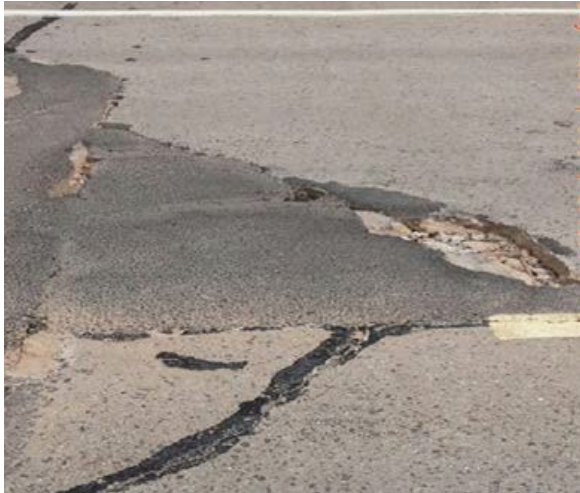
Defect Code	Defect Name	Image + Description	Possible Causes
CP	Potholes in Concrete Pavement

<p data-bbox="528 719 1563 746">An area of pavement that has been replaced with new material to repair the existing pavement.</p>	Previous localised pavement deterioration that has been removed and patched. Correction of surface or structural deficiencies. Reinstatement after excavation for services.
LT	Litter and Gross Pollutant Trap Defects

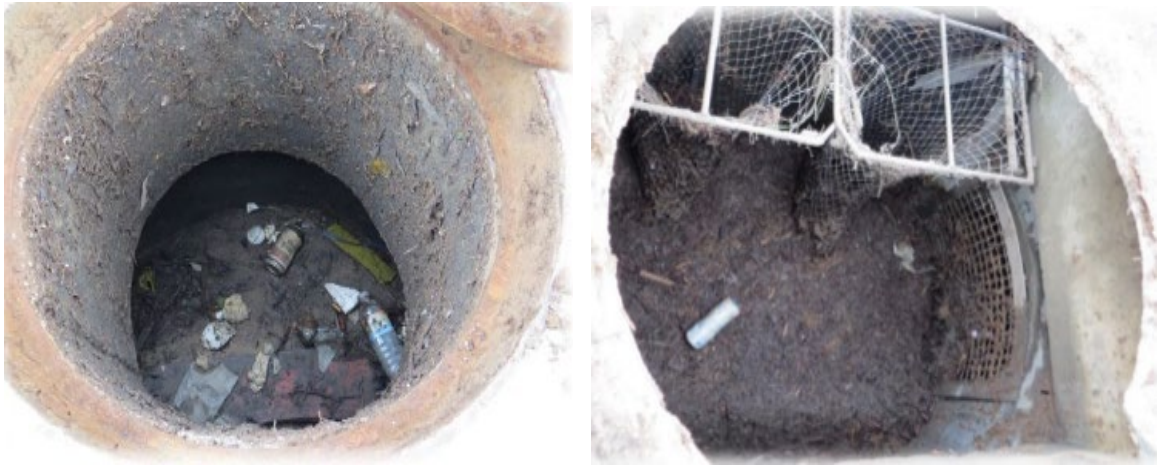
<p data-bbox="528 1257 1615 1321">Any non-functional, blocked or inoperable decayed element of the trap system causing reduced flow capacity or drainage integrity.</p>	Blocked by soil, stones, roots and any other caused by environmental or human intervention.

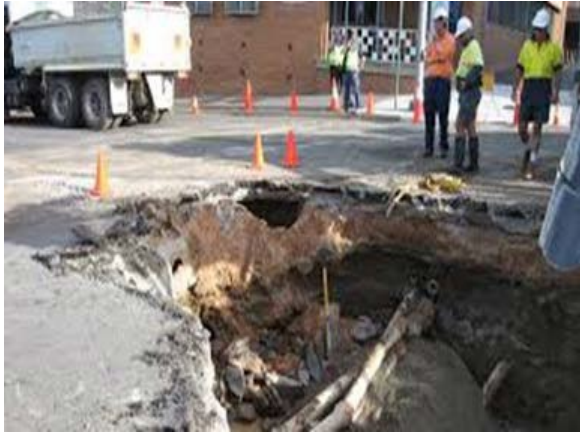
Defect Code	Defect Name	Image + Description	Possible Causes
DS	Subsoil Drain Defects

<p data-bbox="528 660 1599 722">Any non-functional, blocked or inoperable decayed element of the subsoil drainage system causing reduced flow capacity or drainage integrity.</p>	<p data-bbox="1715 213 2148 339">Damaged or missing sections of subsoil drain. Blocked by soil, stones, roots and any other caused by environmental or human intervention.</p>
DD	Detention/Retention Basin Defects

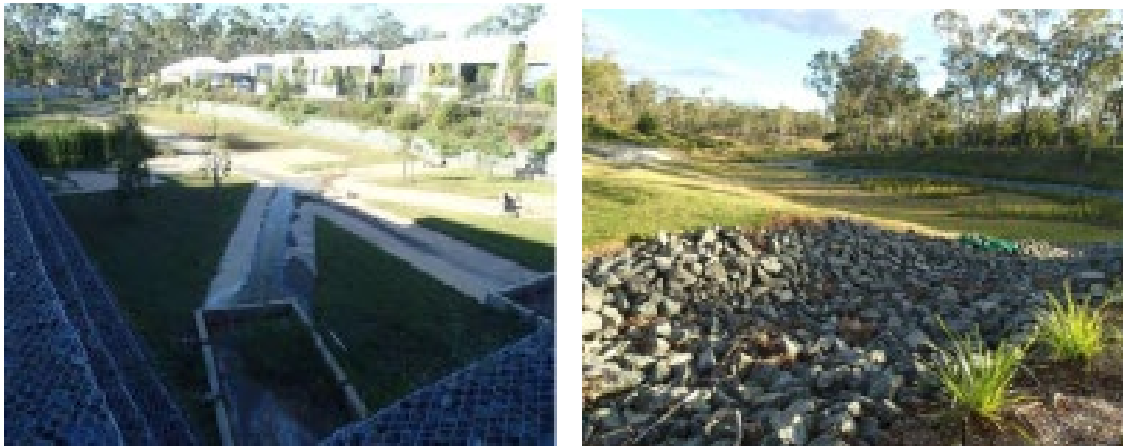
<p data-bbox="528 1209 943 1236">Silted or unserviceable basin facilities.</p>	<p data-bbox="1715 751 2114 847">Basins not acting in accordance with design. No proper periodic maintenance program in place.</p>

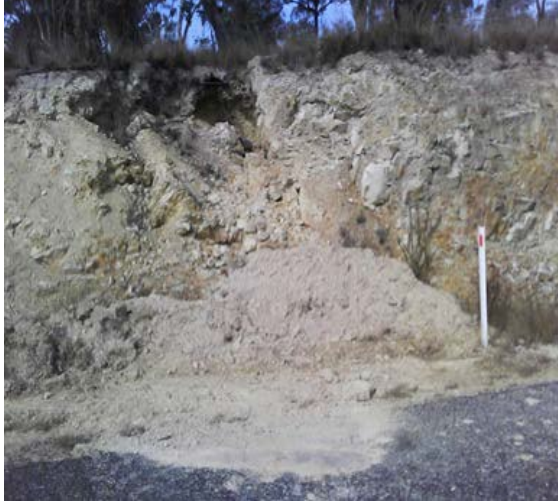
Defect Code	Defect Name	Image + Description	Possible Causes
AB	Unstable Batter/ Embankment, Missing Material

<p data-bbox="528 730 1568 794">Cut or Embankment with cracks, erosion or instability that may create dangerous or unsafe road environment.</p>	Material of poor quality, insufficient compaction of material, material scoured away due to excessive water run-off. Unstable batter or cut due wet weather conditions.
AC	Damaged Concrete or Paving Blocks

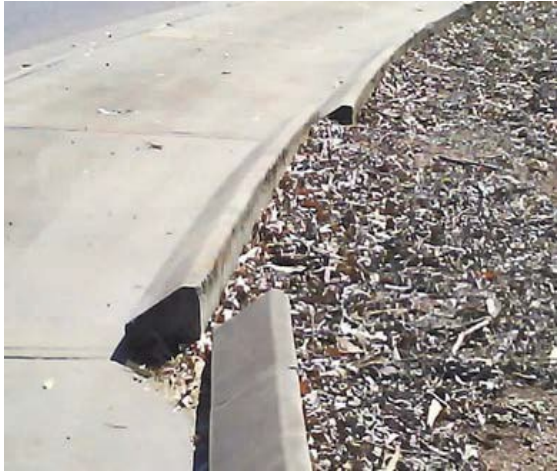
<p data-bbox="528 1310 1456 1340">Damaged, displaced concrete or paving blocks in pedestrian areas, road environment.</p>	Damage to concrete or pavement block caused by environmental, human or vehicular intervention.

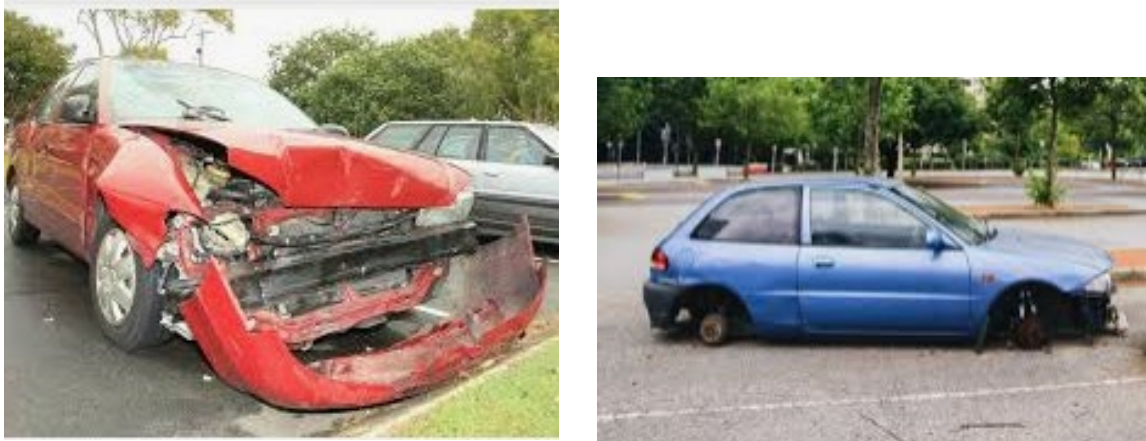
Defect Code	Defect Name	Image + Description	Possible Causes
AV	Abandoned Vehicles

<p data-bbox="528 671 1066 699">Abandoned vehicle or equipment in road reserve.</p>	Person or persons leave or abandon vehicle in road reserve.
RA	Deceased Animals/ Straying Stock on Roads and Footpaths

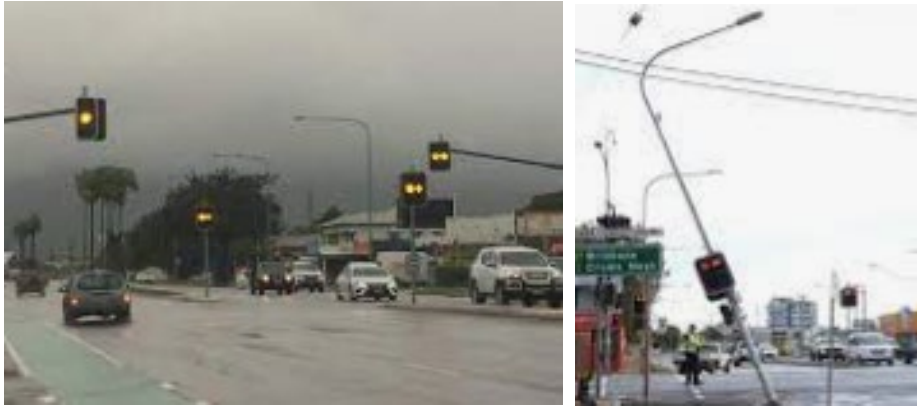
Defect Code	Defect Name	Image + Description	Possible Causes
ST	Traffic Signal and School Zone Lights Defects

<p>Flashing Yellow:</p> <ul style="list-style-type: none"> • Confusing signal displays; Loss of displays • Misaligned lantern causing confusing signal displays • Damaged or open door on lantern • Damaged lantern or lantern parts at risk of falling • Twisted & non confusing lantern arrangement • Missing or damaged hardware (i.e. missing pole and/or associated hardware) • Lamp outages; Visors, cowls, louvers or target boards missing or damaged • Poor lantern aiming • Pit marker post missing 	<p>Broken or operationally degraded traffic signal controller due to one or a number of internal components being compromised. Access compromised as a result of vandals.</p> <p>Broken or operationally degraded signal lanterns.</p> <p>Electrical faults or damage of the traffic signal</p> <p>Broken or missing traffic signal hardware.</p>

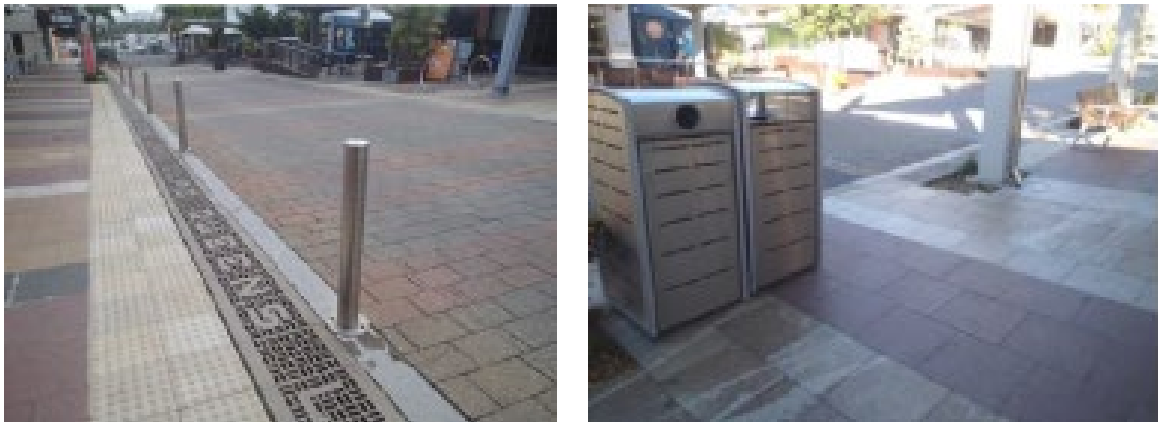
AZ – road CA - carpark	Streetscape Defects

<p>Streetscape is damaged due to environmental, human or vehicular intervention.</p>

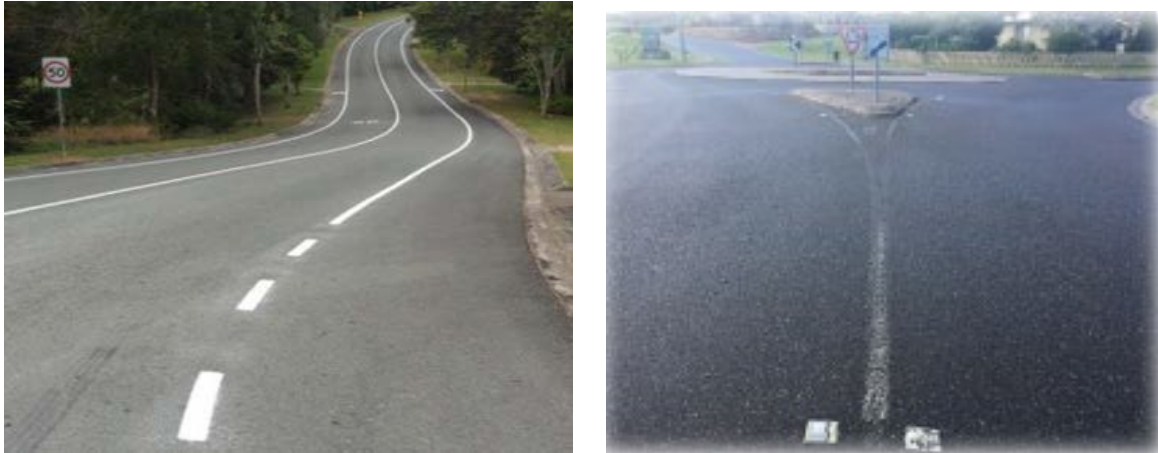
Defect Code	Defect Name	Image + Description	Possible Causes
RL	Raised Pavement Marker Defects

<p data-bbox="528 679 1435 708">Loss of, or loss of reflectivity (%) of markers or any consecutive markers are missing.</p>	<p data-bbox="1715 217 2130 304">Raised Pavement Marker is missing or damaged due to environmental, human or vehicular intervention.</p>
LS – road CY - carpark	Lighting Switchboard Defects

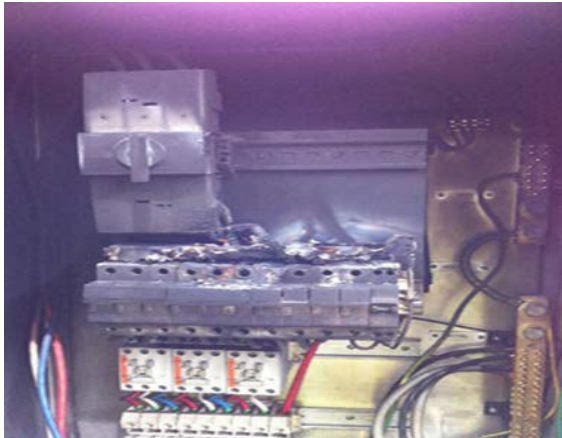
<p data-bbox="528 1193 1570 1254">Unsafe, unrestricted, broken and/or operationally degraded lighting switchboard. (e.g. failure of switchboard, door open or pillar cover dislodged).</p>	<p data-bbox="1715 738 2085 826">Lighting switchboard is missing or damaged due to environmental, human or vehicular intervention.</p>

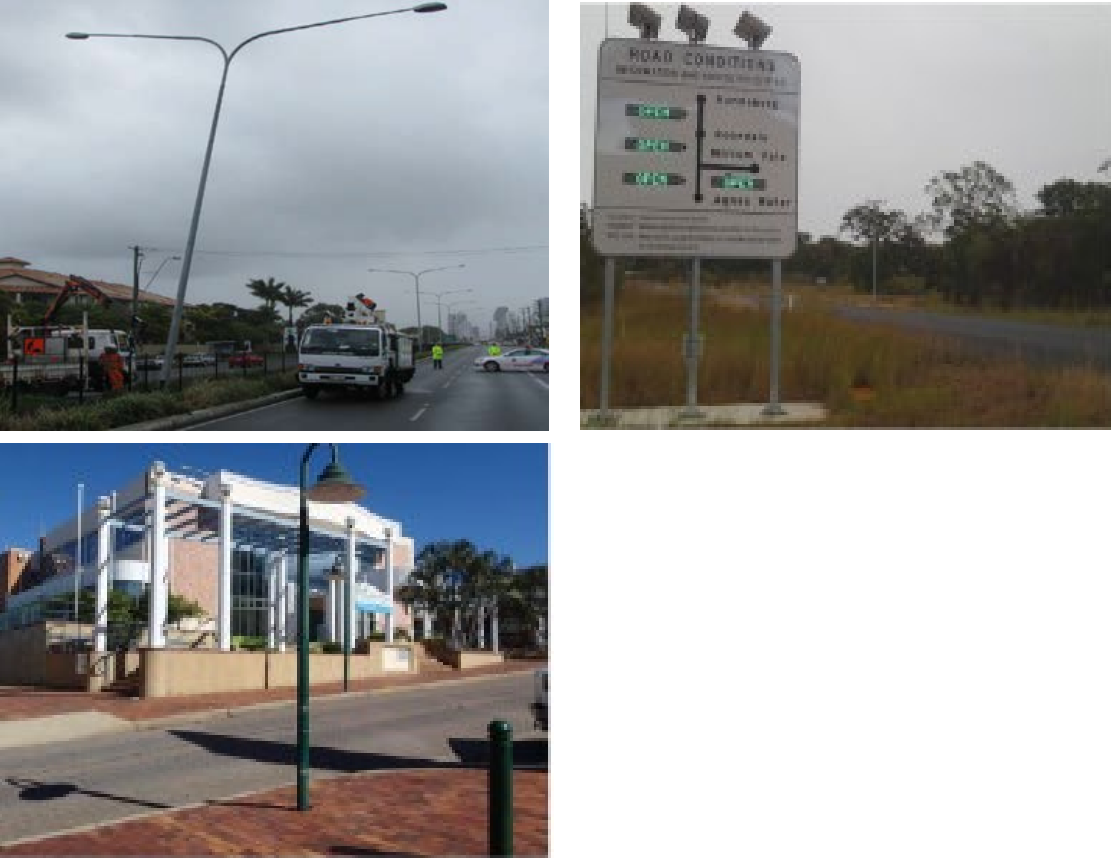
Defect Code	Defect Name	Image + Description	Possible Causes
<p>LH – road CH - carpark</p>	<p>Lighting Hardware Defects (Council Owned Lights Only)</p>

<p>Unsafe, missing, broken and/or operationally degraded lighting hardware. (e.g. pole knocked down, luminaire visor/diffuser not secure/hanging Or light is displaced/ re-aligned).</p>	<p>Lighting hardware is missing or damaged due to environmental, human or vehicular intervention.</p>

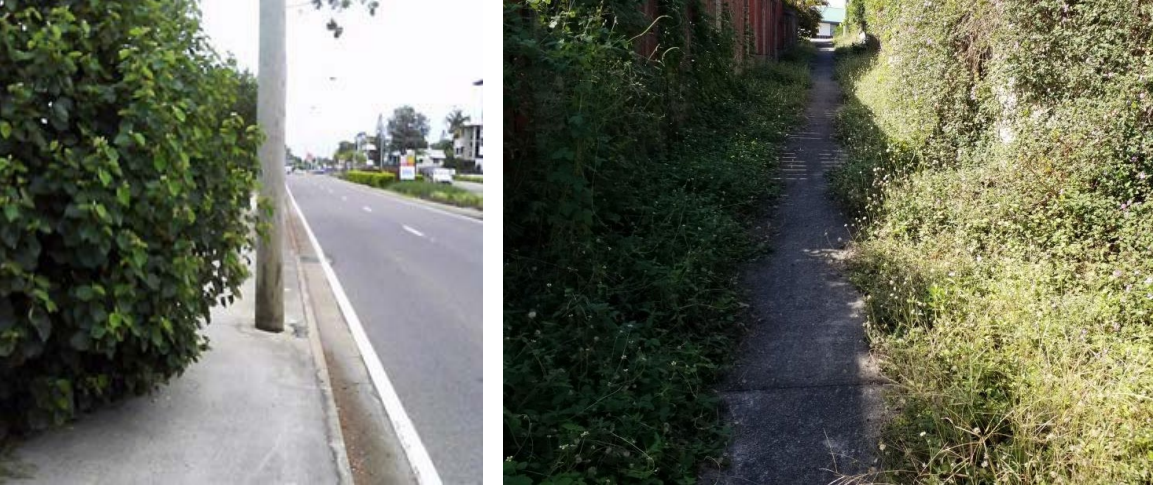
Defect Code	Defect Name	Image + Description	Possible Causes
FV	Footpath Vegetation Defects

<p data-bbox="533 715 1682 778">Trees, overhanging branches or broken limbs most likely to fall on footpath to be a hazard. Unwanted trees and shrubs or grass obscures in sightlines.</p>	Ongoing maintenance not carried out in accordance with departmental requirements & standards.
FR	Footpath Pram Ramp Defects

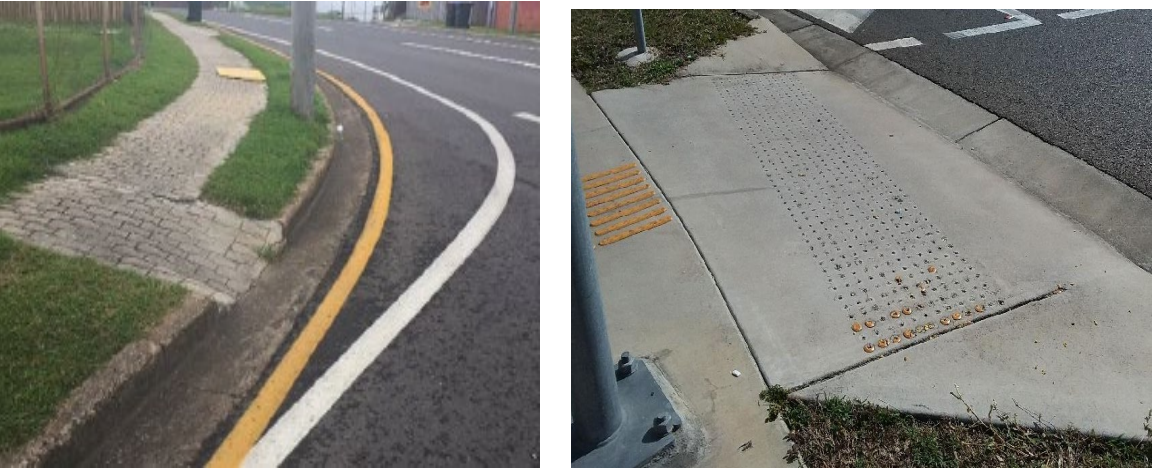
<p data-bbox="533 1289 1682 1353">Pram Ramp is non-compliant with current standards, and existing footpath geometry and surroundings would enable a compliant Pram Ramp to be constructed.</p>	Ongoing maintenance not carried out in accordance with requirements & standards.

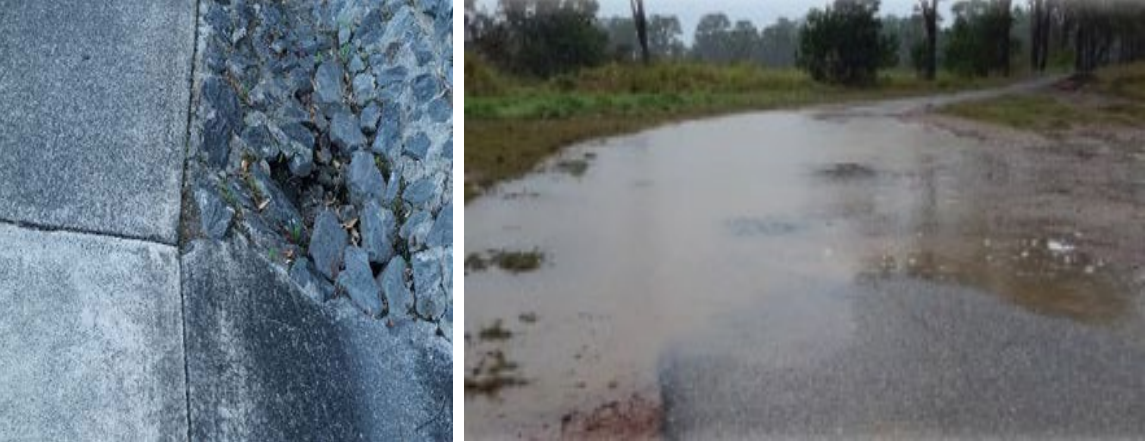
Defect Code	Defect Name	Image + Description	Possible Causes
FD	Footpath Drainage Defects

<p data-bbox="533 671 1630 730">Culverts, pipes and pits defects likely to impact on the integrity of the unit. Obstructed drainage cause water ponding on or adjacent to footpath or private property.</p>	<p data-bbox="1720 212 2074 368">Drainage system not acting in accordance with design. Periodic maintenance not carried out in accordance with departmental guidelines.</p>
FB	Footpath Pedestrian Bridge and Elevated Walkway defects

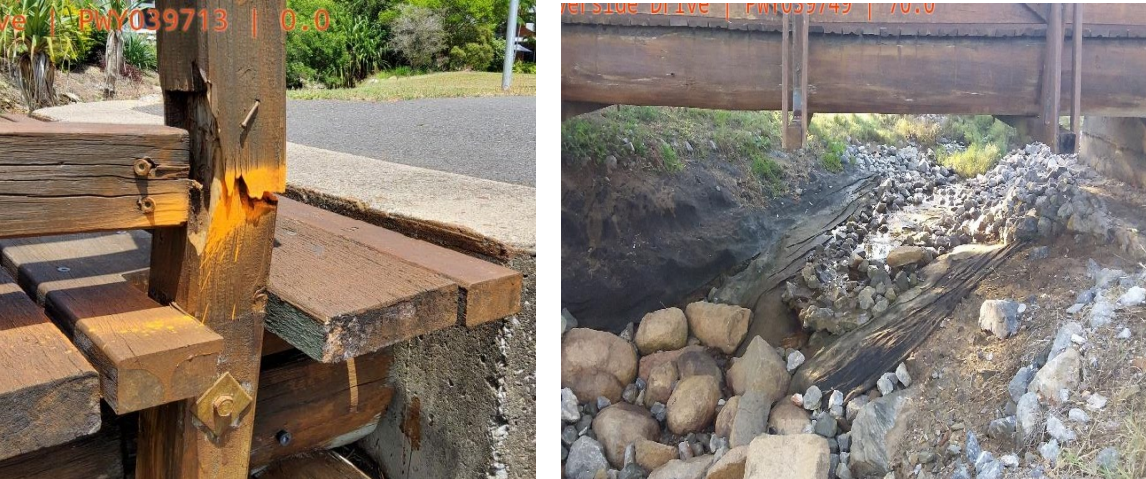
<p data-bbox="533 1257 1671 1316">Debris on footpath bridges that is likely to interrupt the drainage facility, operation or expansion joints or affect the usability of the bridge.</p>	<p data-bbox="1720 761 2107 852">Footpath bridge defects caused by environmental, human or vehicular intervention.</p>
